Intermediate Shelters in Bam and Permanent Shelter Reconstruction in Villages Following the 2003 Bam, Iran, Earthquake

Bijan Khazai,^{a)} M.EERI, and Elizabeth Hausler,^{b)} M.EERI

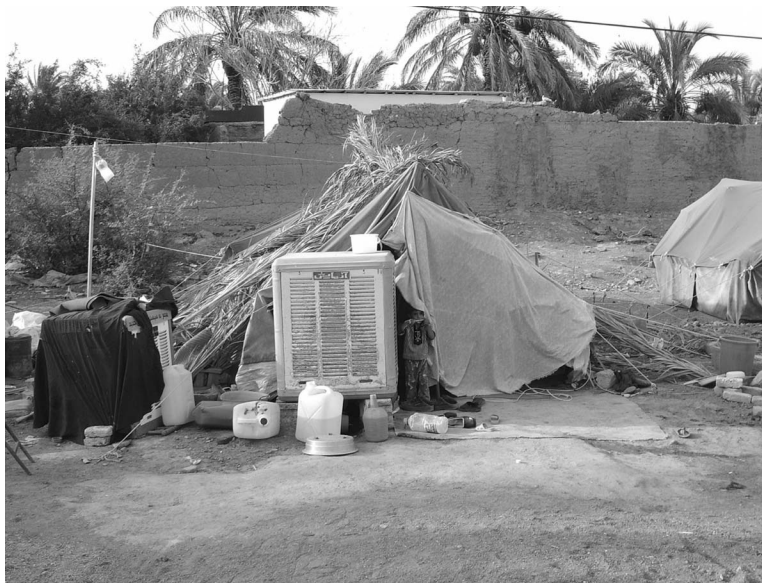
Figure 1. Tents placed near homes.

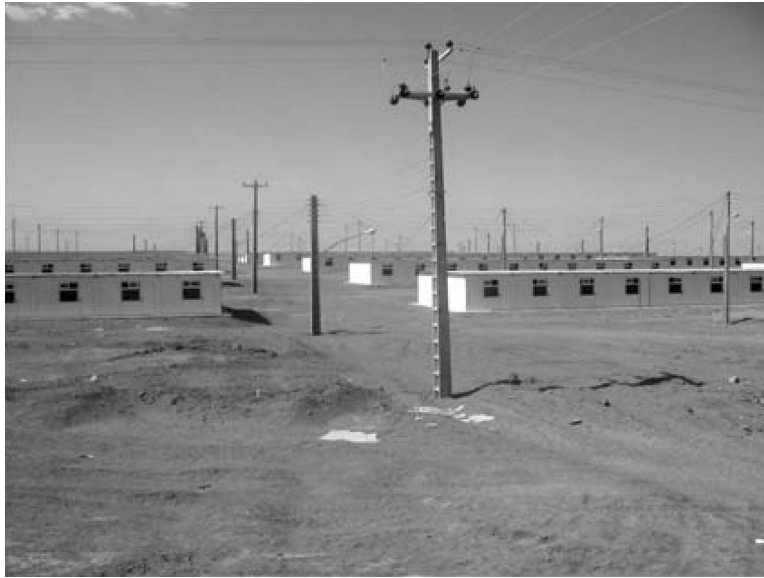
Figure 2. Intermediate shelter construction on the outskirts of the city (photo from Rashestan Co.).

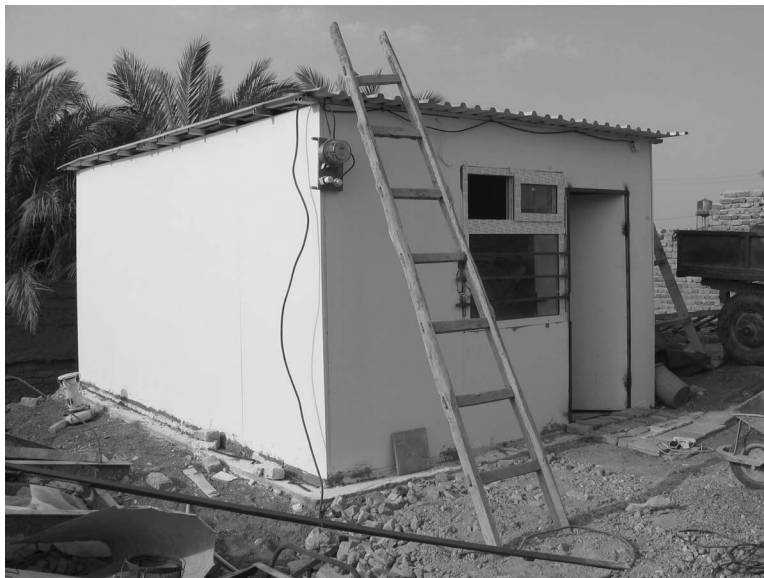
Figure 3. Intermediate shelters located on private property.

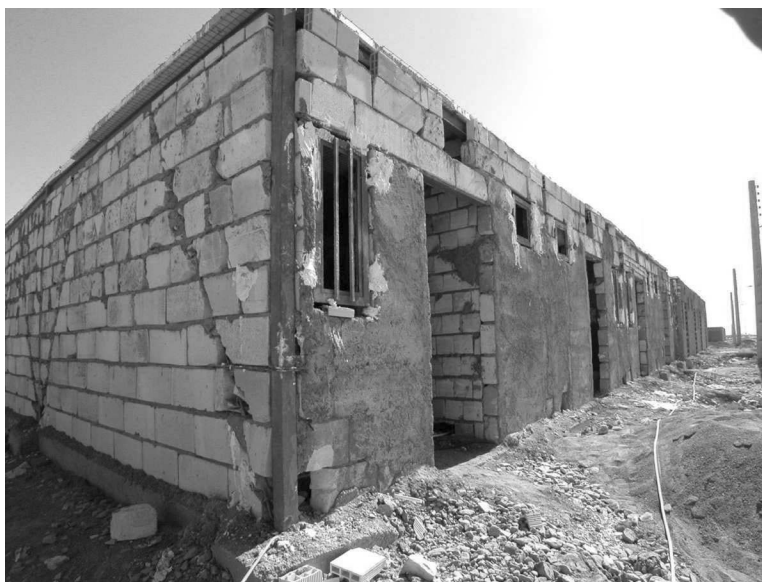
Figure 4. Intermediate shelters in camps later finished with plaster on the inside and outside (photo by R. Langenbach).

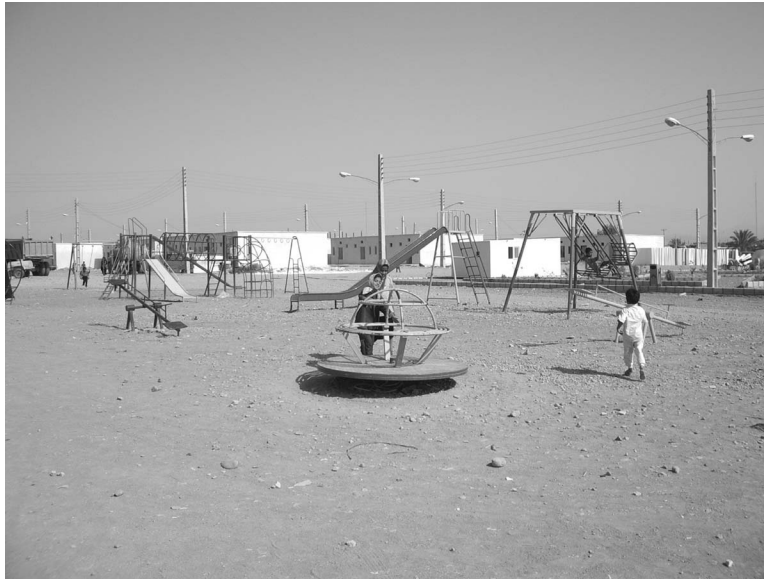
While the intermediate shelters produced from prefabricated components can be constructed quickly, require little maintenance, and exhibit a lightweight, earthquake-resistant design, they are poorly adapted to the hot, arid desert climate of Bam. To compensate for this shortcoming, air conditioners have been provided or were being planned for most of the intermediate shelter occupants by the Housing Foundation. Also, the intermediate shelters lack an extended overhang or lintels over the windows. Most intermediate shelter camps have no tall trees; the lack of shade in the intermediate shelter camps creates very unfavorable conditions given the extreme desert temperatures (Figure 5). Shelters on private property allow for better living conditions, largely because they are built within gardens where tall trees provide cool shade in the morning and evening (Figure 6).

Figure 5. Lack of shade in intermediate shelter camps creating very unfavorable conditions.

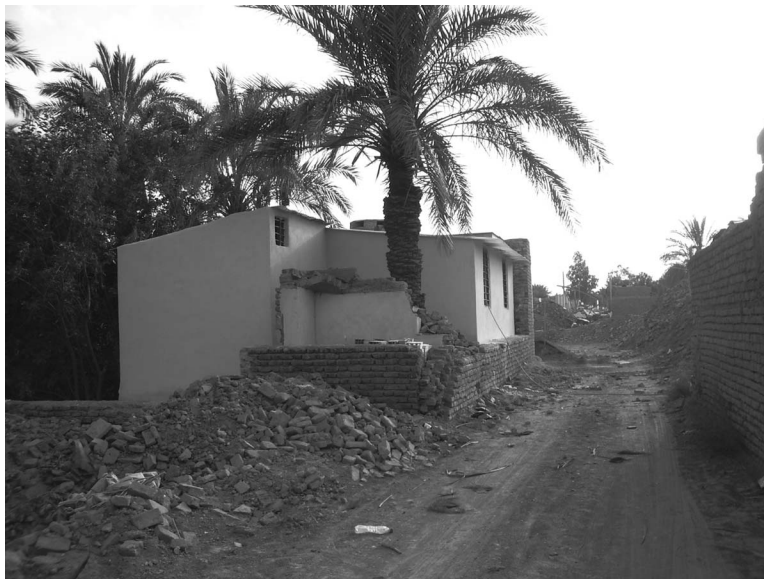
Figure 6. Many shelters on private property are built in areas where tall trees provide cool shade. Here the shelter footprint has been increased by combining two units.

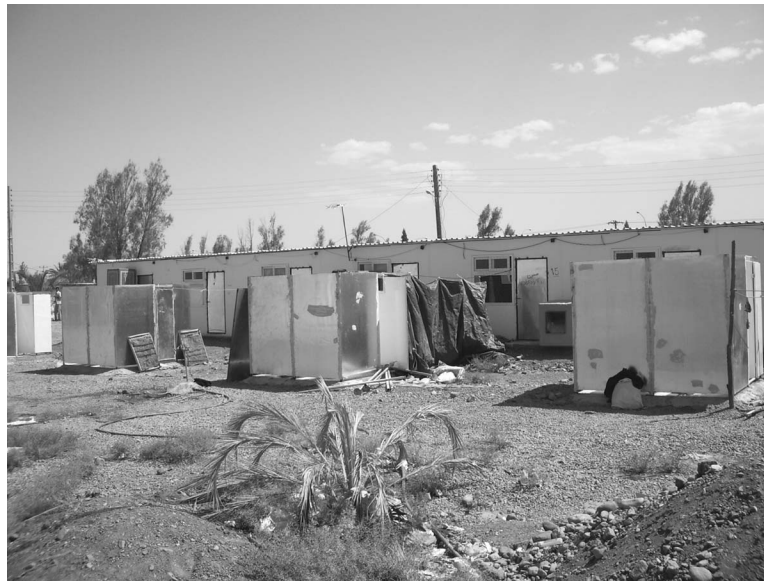
Figure 7. Makeshift curtains separate adjacent units from each other to provide some privacy.

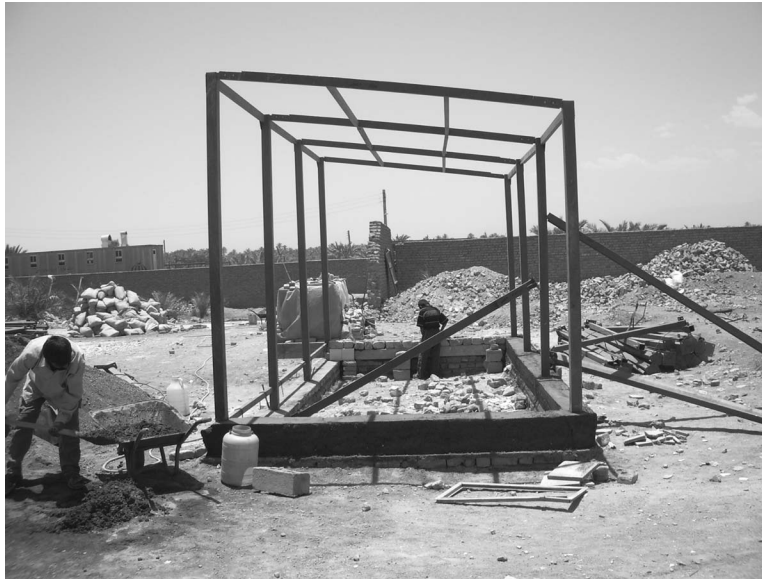
Figure 8. An 18 m² steel frame structure, concrete being mixed by hand.

The foundation supporting the 18m² structure (Figure 8) consists of a shallow strip footing of burned brick masonry in cement mortar. The steel channel sections that form

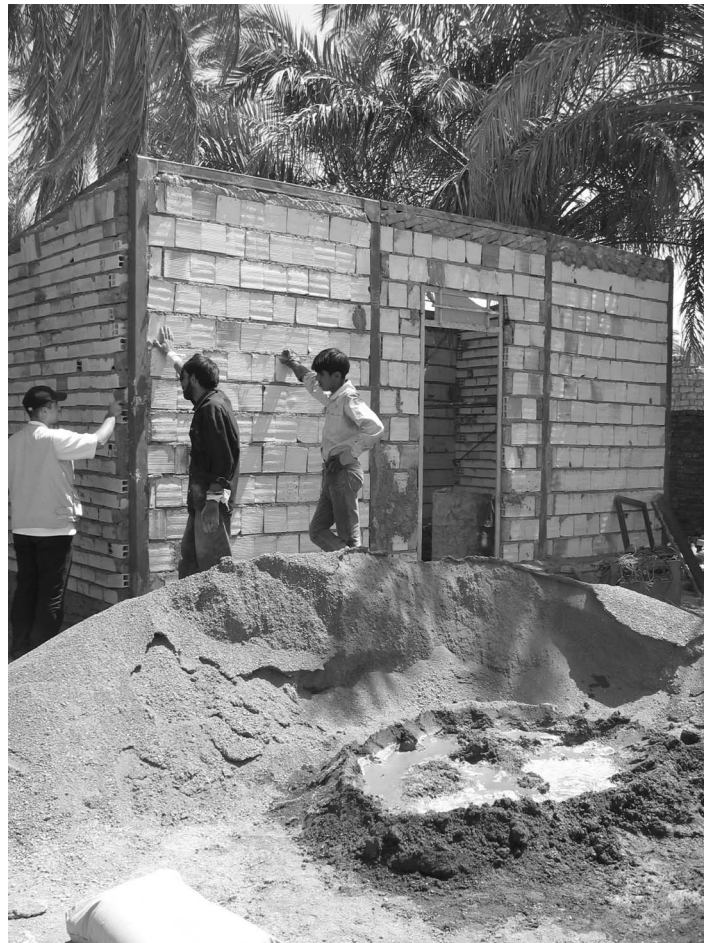
Figure 9. An 18 m² structure with air entrained ceramic hollow block infill.

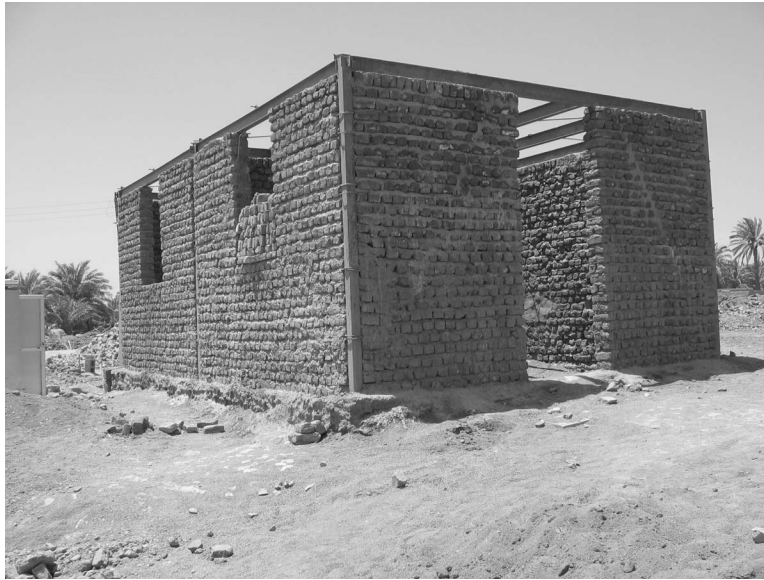
Figure 10. A 43 m² steel frame structure with solid fired-brick masonry infill.

results in an undesirable continuous vertical joint. Head (vertical) joints are not completely filled with mortar, and bed (horizontal) joints are thicker than common practice. Steel shear connectors are placed every six courses, instead of every three, as recommended by the design drawings. Also, the hooks do not extend into the brickwork for the full 90 cm, as recommended in the design drawings. Floor-to-ceiling doorways in all three panels in the short direction of the buildings result in a significant difference in stiffness in the two orthogonal directions (Figure 10).

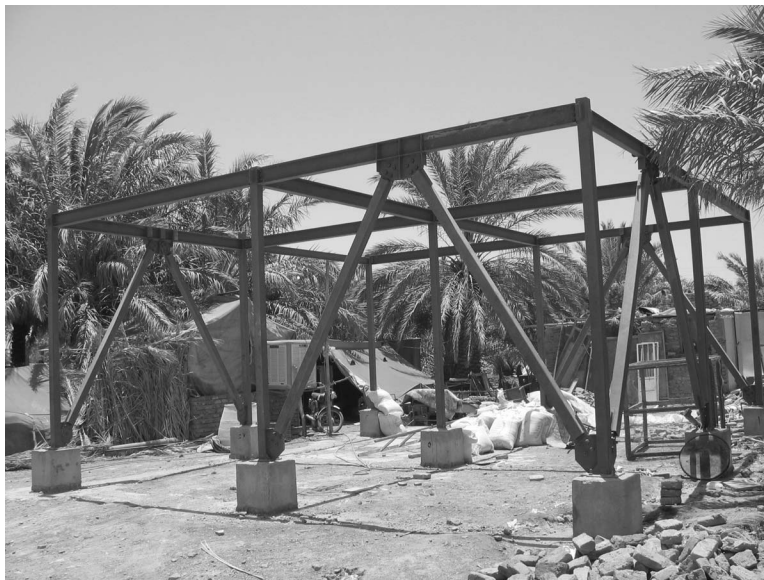
Figure 11. A 60 m² steel frame structure with inverted V-type Chevron bracing.

are available in Hawaii and Hosseini (2004). The steel columns in the superstructure are bolted to the RC column starter (Figure 16), and inverted V-type chevron braces, present in four of the eight bays, are bolted to gusset plates (Figure 11).

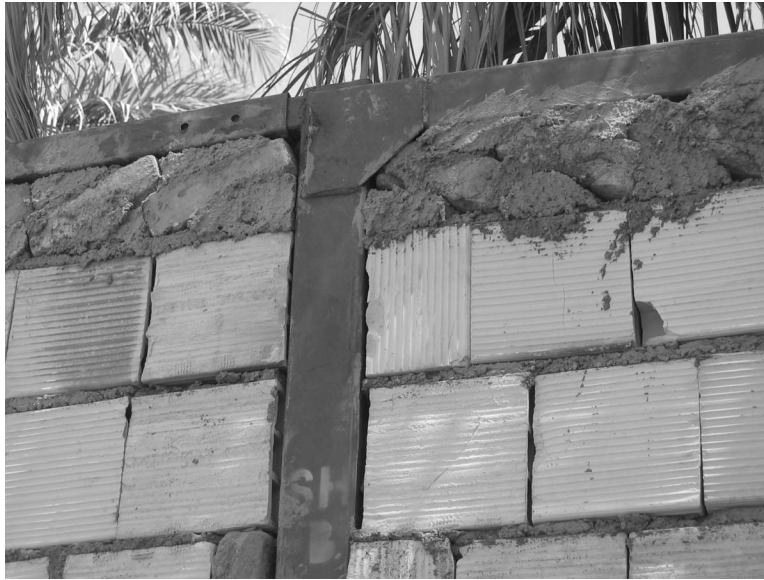
the superstructure are doveled into the strip footing, and the steel beam at the plinth level is encased in hand-mixed concrete. No bracing is present. Both welded and bolted connections were observed (Figure 12).

Figure 12. Air entrained ceramic hollow block infill in welded steel frame 18 m² structure.

Deficiencies were also noted in the hollow ceramic block masonry infill for a house in Poshtrood village. The bond is inconsistent, with the blocks laid flat on the short walls and on end in the long walls. No mortar is present in the head joints. Gaps are present between the masonry panel and the steel frame. The only effort to restrain the walls against out-of-plane failure is a spot-welded diagonal rod on the interior of one end panel (Figure 19). Two different masonry units are used ceramic hollow blocks for the majority of the wall and solid bricks at the top of the walls and around the window frames (Figure 12).

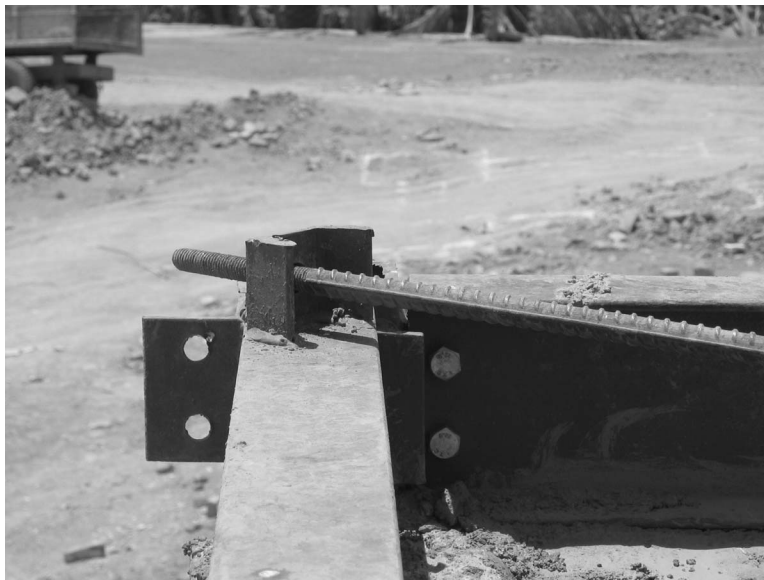
Figure 13. Bolted connections and tension rods on 43 m² structure.

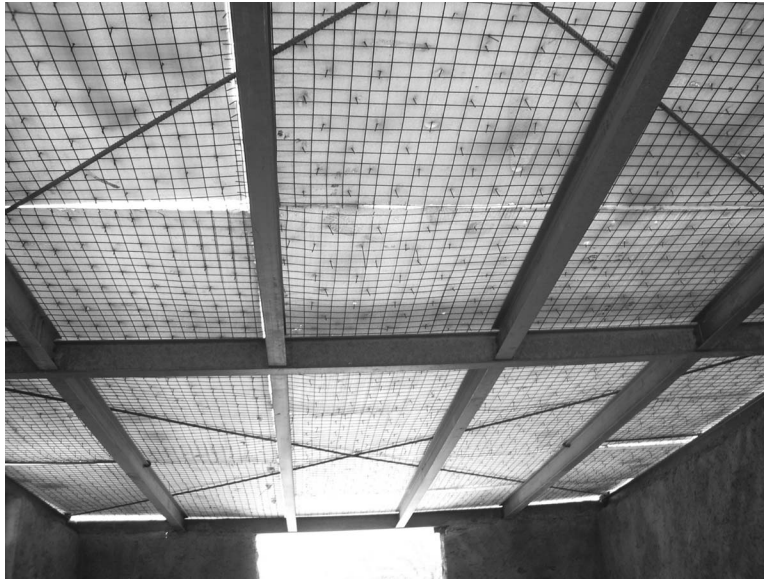
Figure 14. Styrofoam hooked to welded wire mesh covering roof of 43 m² structure.

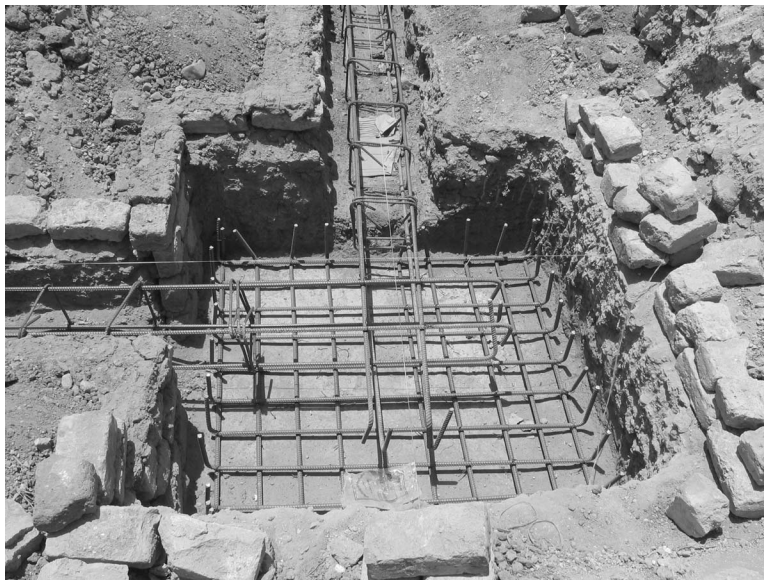
The 60m² structures are supported by reinforced concrete (RC) shallow spread footings with grade beams (Figure 15). The square footings are 55 cm deep and 130 cm wide at the base of the excavation (Hawaii and Hosseini 2004). The excavations for the grade beams are 35 cm deep and 40 cm wide. Design drawings for the 60m² structures

Figure 15. Steel reinforcement in spread footing, 60 m² structure.

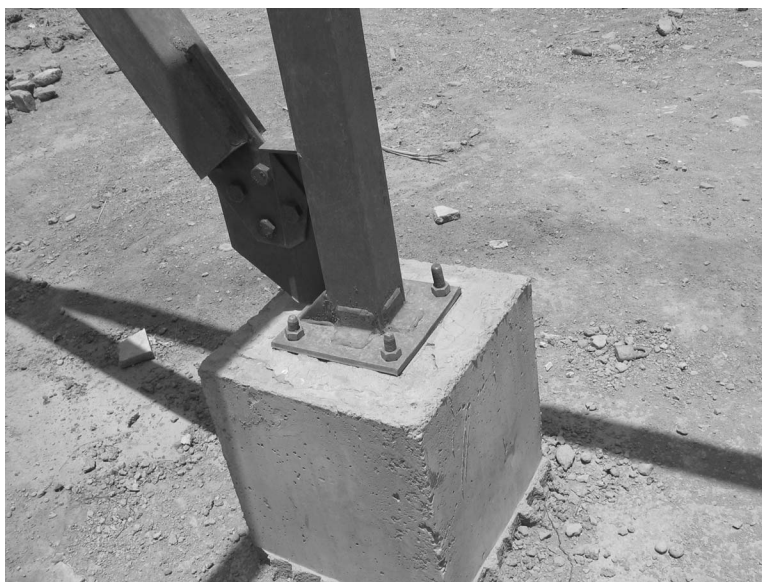
Figure 16. Steel columns bolted to reinforced concrete column starter, diagonal brace bolted to gusset plate.

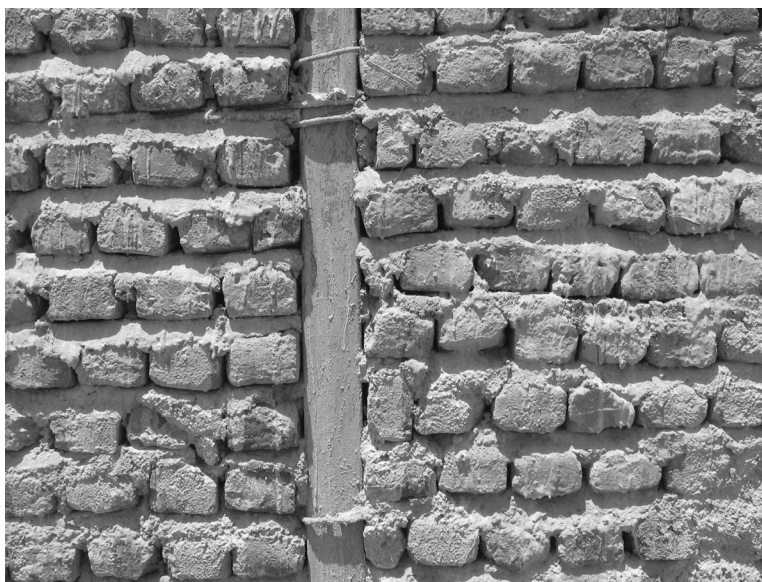
Figure 17. Solid fired-brick infill hooked to steel column, note orientation of bricks.

Several deficiencies were noted in the solid fired-brick masonry infill for a 43m² house in Esphekan village. As shown in Figure 17, all bricks are oriented perpendicular to the plane of the wall, while design drawings recommend English bond; the bond used

It should be noted that, following the field reconnaissance, the deficiencies in infill construction and the poor quality of the concrete in the foundation was brought to the attention of the Housing Foundation, which pledged to take immediate action to improve the quality of the construction.

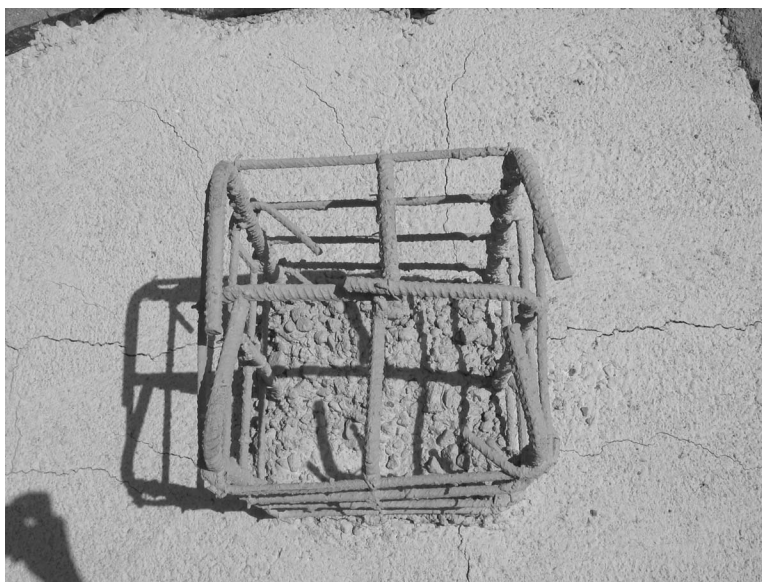
According to nonprofit organizations working in the villages, concrete testing is regularly done, and independent inspectors, as well as those from the Housing Foundation, periodically visit the building sites. However, one reinforced concrete foundation located in Poshrood village had cracks in the concrete at spacing consistent with the stir-rup intervals, indicating insufficient cover or improper curing of the concrete (Figure 18).

Figure 18. Cracks in reinforced concrete foundation for 60 m² structure.

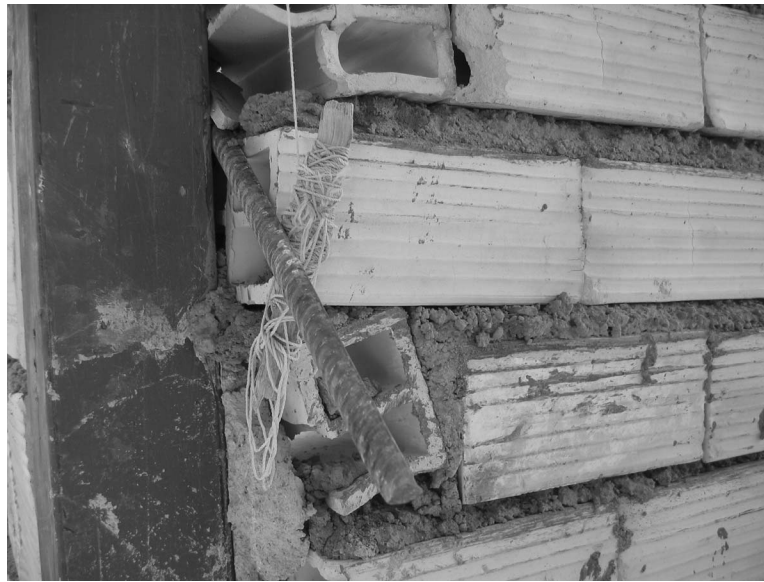
Figure 19. Diagonal restraint in 18 m² structure with hollow ceramic block infill.

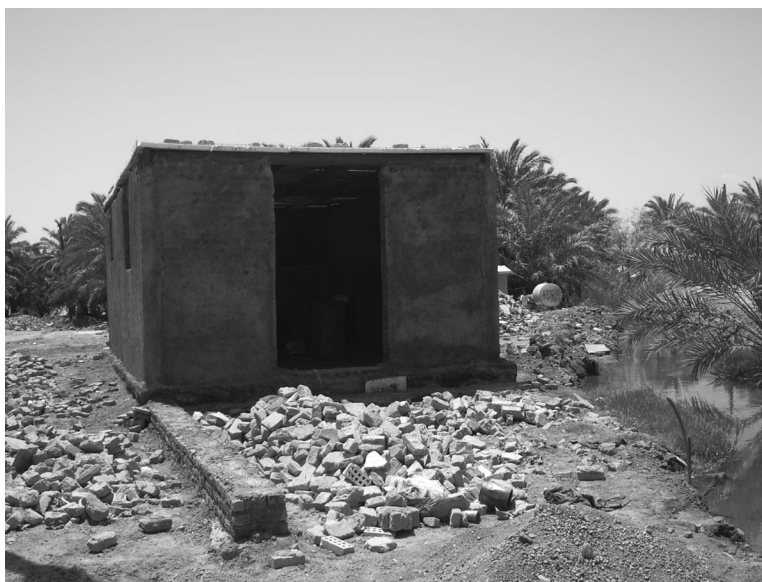
In selecting the design and materials for housing reconstruction in Bam and the surrounding villages, the Housing Foundation was proactive in attempting to satisfy a list of criteria, including earthquake resistance, environmental and architectural suitability, durability, and low cost. The 60m² braced steel frame structure, if built properly, will likely provide sufficient resistance to earthquakes. Likewise, exchanging the heavy earth and brick roofs used prior to the earthquake with lightweight Styrofoam and screed roofs is a positive change in terms of earthquake resistance. However, the lightweight building materials are less appropriate for the climate, which is one of intense heat in the summer and cold nights in the winter. Also, environmental suitability concerns, such as planning for flood zones or site characterization issues, were not always satisfied, as can be demonstrated by one house situated directly on the bank of a stream (Figure 20), which may present flooding and differential settlement hazards.

Figure 20. 43 m² house located on a stream bank.
