## Overview

Two devastating events occurred in the Philippines towards the end of 2013: a M7.1 earthquake on the island of Bohol on October 15, 2013, and typhoon Yolanda, which affected several islands on November 8, 2013.

### **Structural Damage Assessment**

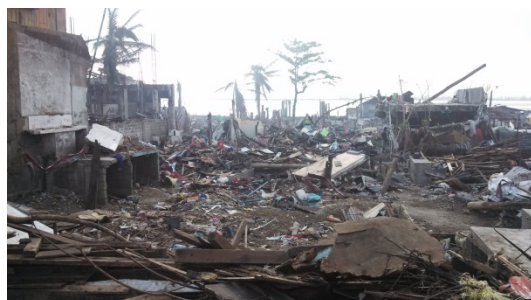
**Figure 3.** Typhoon damage on Leyte

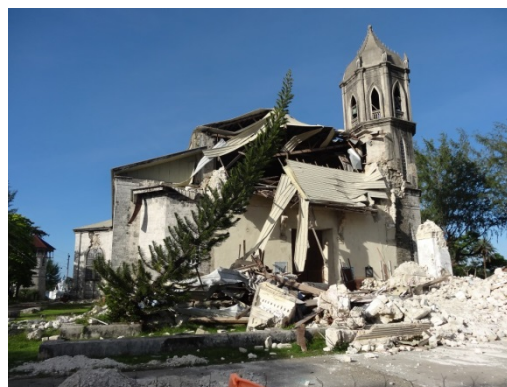
**Figure 4.** Earthquake damage on Bohol

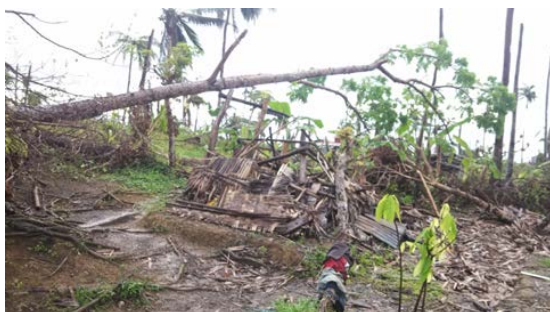
1. **Timber houses, both one- and two-story**, are almost all entirely destroyed, having performed very poorly in strong wind. The very light construction systems used by the poorest populations, such as nipa and other bamboo huts, were blown away completely, as these structures generally had no foundation at all. Most non-timber buildings used timber and CGI for their roofs, which are also almost all completely destroyed or blown away.

**Figure 21.** Destroyed timber house on Leyte

→ **Recommendation 14:** Connect all wood framing members to each other.

→ **Recommendation 17:** Ensure the foundation is deep and heavy enough to counteract the uplift force of wind.

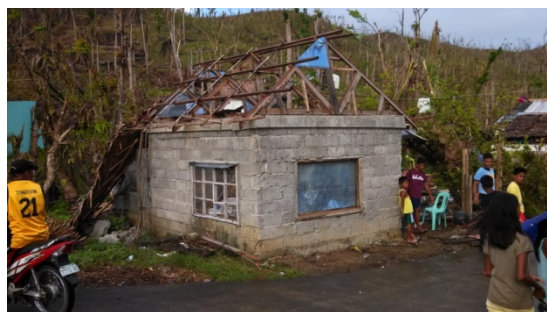
**Figure 22.** Intact masonry house on Leyte with destroyed timber roof

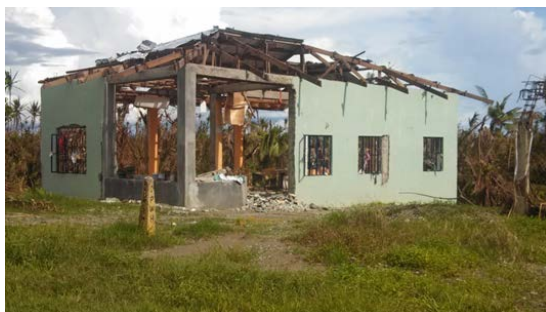
2. **Houses, both one- and two-story, relying on a reinforced concrete (RC) frame system with infill walls** performed poorly; in general only the frames are left, with the buildings unusable and often leaning hazardously. It should be noted that many larger RC frame structures, such as commercial and public structures, performed well in the typhoon, indicating that the permitting and code enforcement process in the Philippines can work quite well, but is not sufficiently applied to housing.

**Figure 23.** Damaged RC frame house on Leyte

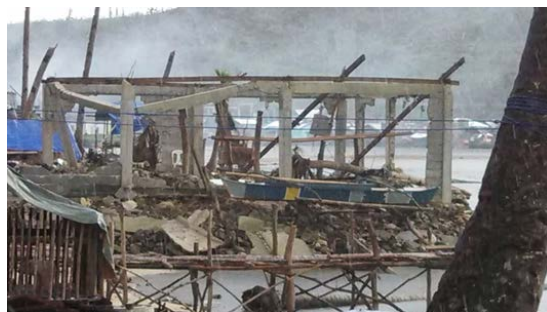
**Figure 24.** Destroyed RC frame structure on Leyte with only frame remaining

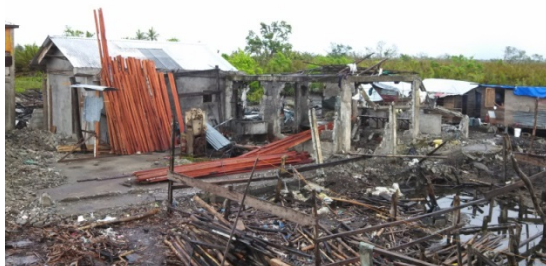
**Figure 29.** Destroyed masonry house on Leyte with only a few confining elements remaining

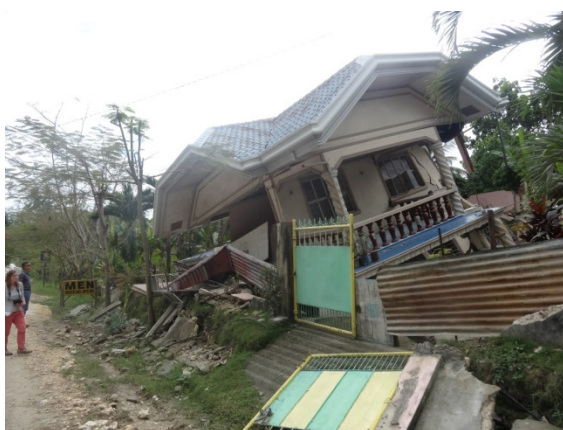
1. **Masonry houses, both one- and two-story**, are most commonly an inappropriate and dangerous mixture of URM, under-reinforced masonry, and poorly confined masonry. Rebar is commonly constructed with insufficient lap lengths. Column and beam connections are generally made with short hooks, which failed easily in the earthquake.

**Figure 30.** Masonry house destroyed by the earthquake on Bohol

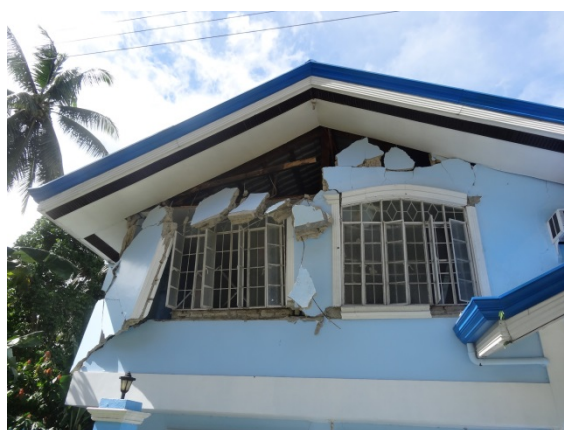
**Figure 31.** Collapsed masonry gable on Bohol

→ **Recommendation 1:** Don't use masonry in the gable wall. It's too heavy. Build a hipped roof or a lightweight gable instead.

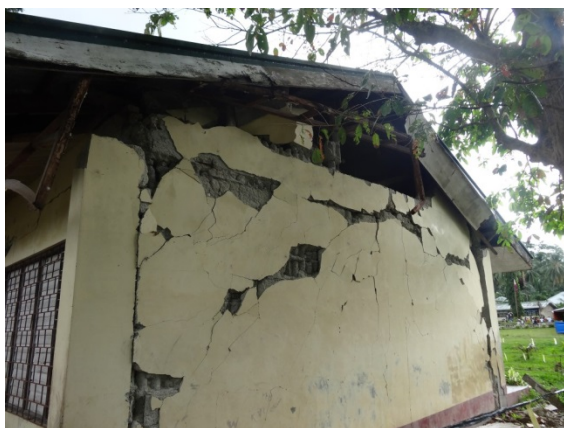
**Figure 32.** Earthquake damage, masonry house on Bohol

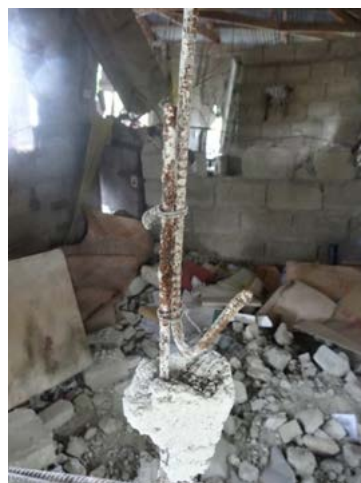
**Figure 33.** Inadequate rebar lap length on Bohol

→ **Recommendation 6:** Use 40cm overlaps to connect #3 rebar, not short laps or short hooks.

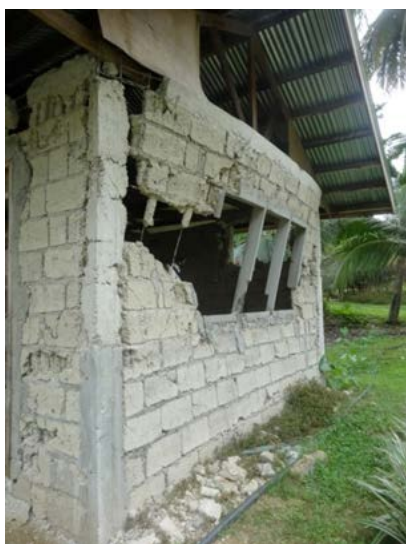
**Figure 34.** Out-of-plane ringbeam failure from earthquake on Bohol. The span of the ring beam is too great without a connected perpendicular wall to break it up, and the ring beam has failed at its corner joint. Note that some block walls are lightly reinforced vertically in the cell voids, which are then grouted. In many block houses all cells, even unreinforced ones, are grouted, which adds to seismic mass without adding strength.

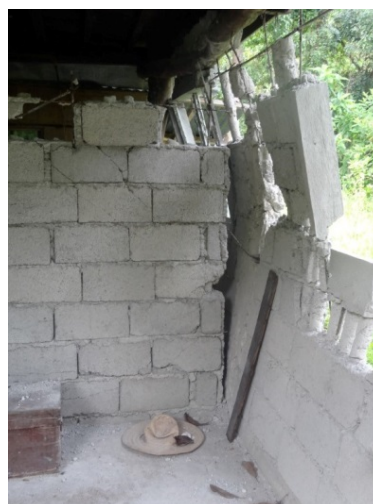
**Figure 35.** Masonry wall failure on Bohol. Note the lack of connection between perpendicular walls.

→ **Recommendation 5:** Connect the structure using a ring beam on top of walls, a plinth beam at the foundation, and tie columns between them.

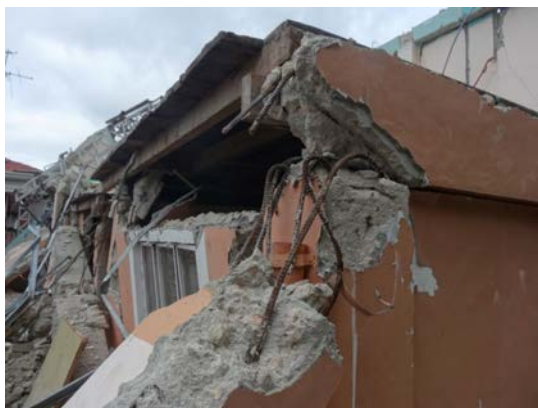
**Figure 36.** Earthquake damage on Bohol showing poor masonry construction.

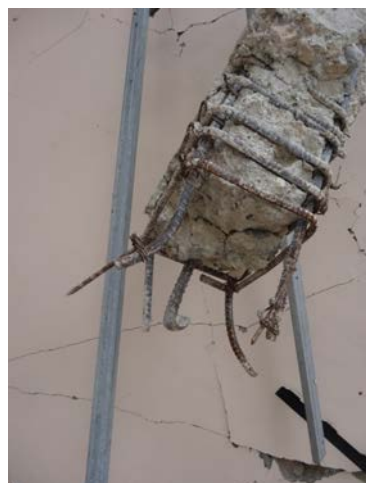
**Figure 37.** Stirrups kept this column on Bohol confined, but the short hooks were not enough to connect to the adjacent RC element.

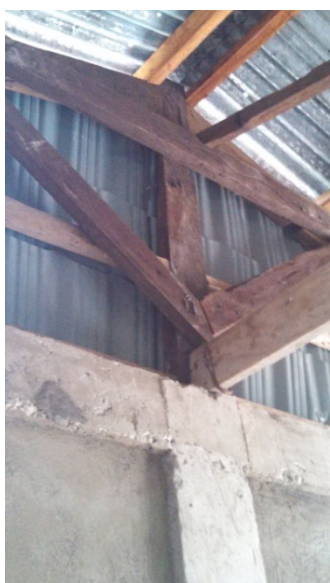
**Figure 38.** Inadequate roof connection on Bohol.

→ **Recommendation 4:** Connect the roof to the ring beam with straps or brackets.

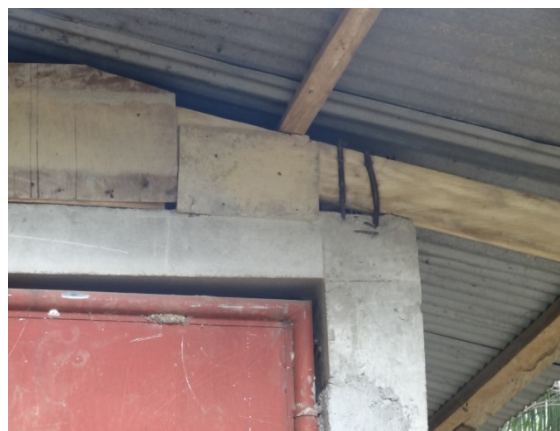
**Figure 39.** Roof framing must be firmly connected to the ring beam with brackets or straps that pass under the longitudinal ring beam reinforcement. Bending the vertical column bars over trusses or rafters is common but insufficient.

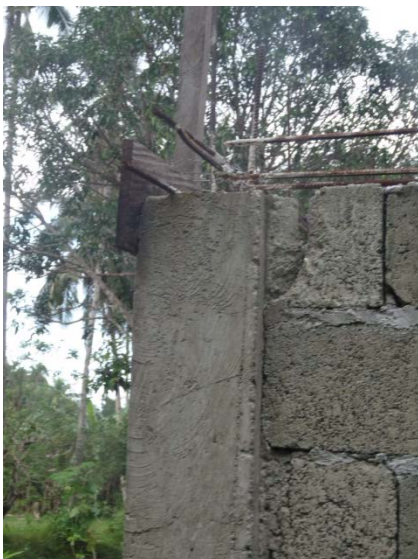
**Figure 40.** In this house under construction on Bohol, the longitudinal bars of intersecting ring beam segments are not connected at all. This extremely dangerous practice is common.

→ **Recommendation 7:** Connect beams and columns together by continuing rebar through the joints. Use rebar stirrups with rotated hooks around column and beam rebar.

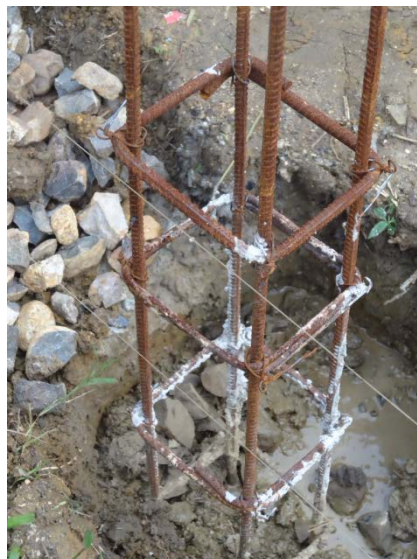
**Figure 41.** Rebar column under construction on Bohol. The ends of the stirrups are not hooked 135 degrees nor are they long enough nor are they rotated. These stirrups will blow apart under seismic load and allow the concrete core to crumble.

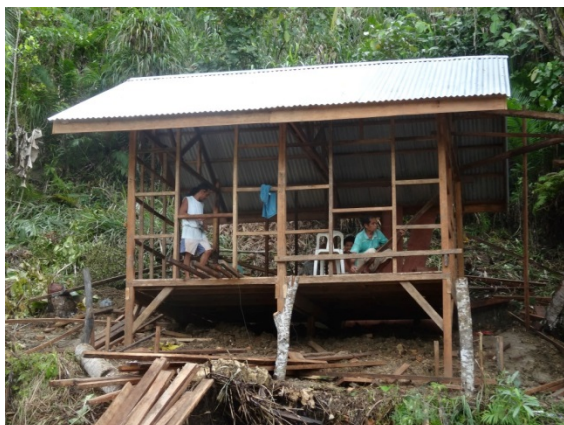
**Figure 43.** Timber-framed house under construction on Bohol. There is some diagonal bracing for the lower level, but not in the walls above.

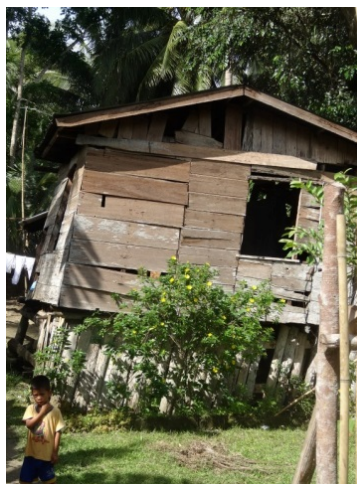
**Figure 44.** Timber house damaged by the Bohol earthquake. This is a typical “soft story” failure, where the open part below is not adequately braced to transfer the lateral seismic load from the story above.

→ **Recommendation 11:** Use diagonal wind bracing between trusses.

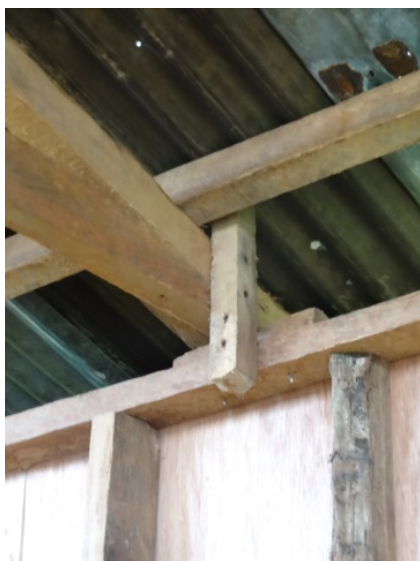
**Figure 45.** Insufficient nailing of a roof-to-wall connection on Bohol

→ **Recommendation 15:** Connect the roof to the walls with straps or brackets.

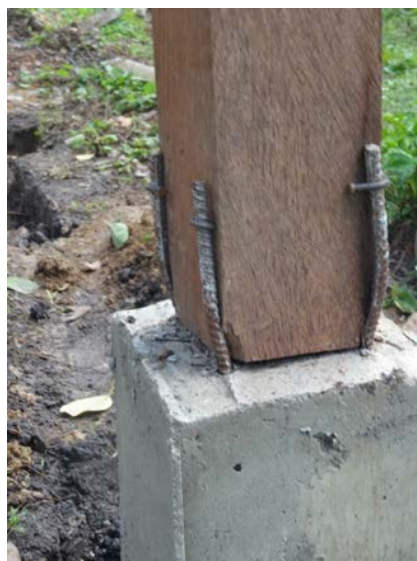
**Figure 46.** Inadequate connection of timber frame to concrete foundation on Bohol, for both uplift and lateral forces

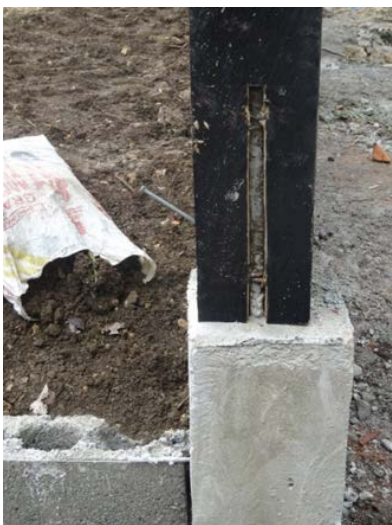
**Figure 47.** A more meticulous but still completely inadequate connection of timber frame to concrete foundation on Bohol. Brackets should be hooked to the column rebar and cast into the foundation pier, then bolted or heavily nailed to the wood column.

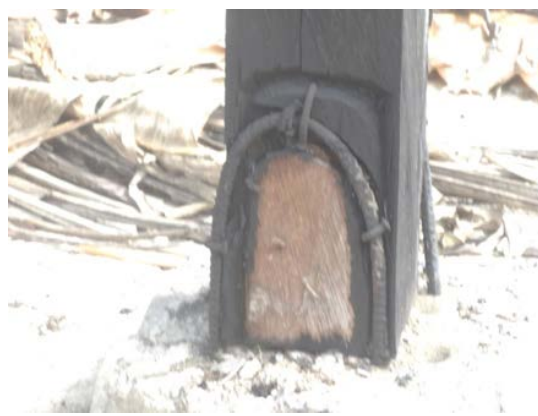
**Figure 48.** A better idea for the connection of timber frame to concrete foundation than in Figures 46 and 47, but insufficiently nailed to the wood column.

→ **Recommendation 16:** Anchor timber posts to the foundation with post brackets.

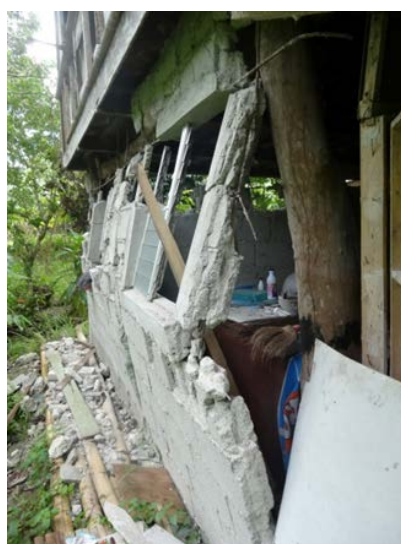
**Figure 50.** Wood post with masonry infill showing earthquake damage on Bohol

→ **Recommendation 12:** Use diagonal bracing to strengthen column-beam connections.

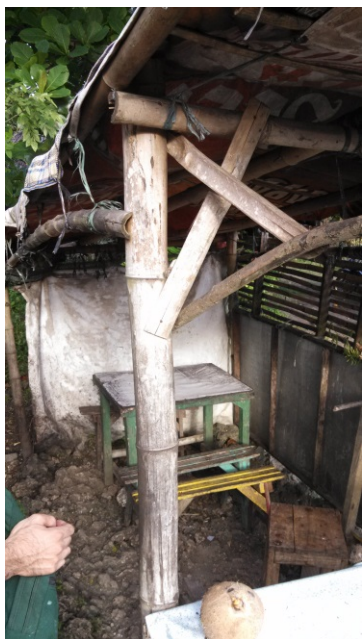
**Figure 51.** Bamboo and timber hut on Bohol with connections of single nails through braces made of bamboo split longitudinally

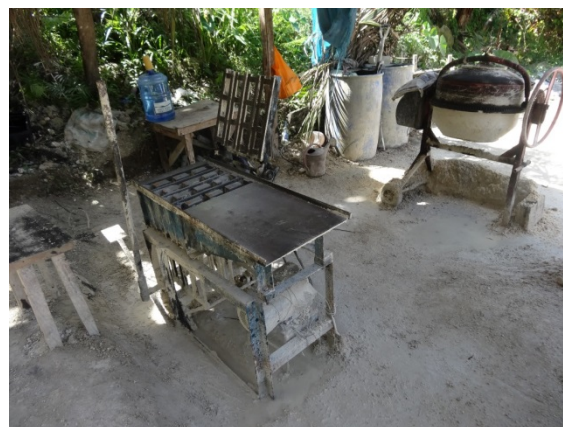
**Figure 58.** Concrete block mold on Bohol. Mechanical vibration of the blocks is common, but is not as important as proper materials and curing, which are not common.

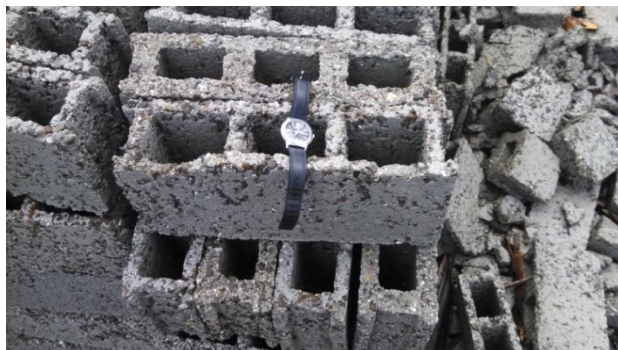
**Figure 61.** Poor quality concrete blocks on Samar. These tend to break when picked up.

→ **Recommendation 2:** Use strong concrete blocks. Don't use blocks that break when dropped on the flat side on hard earth from chest height. Find a seller that makes stronger blocks.

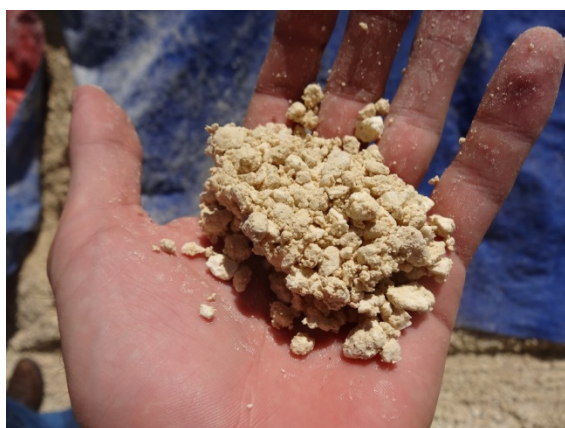
**Figure 65.** Bohol aggregates. Note the light limestone color – this is mostly seashells.

→ **Recommendation 10:** Don't use limestone, coral, or beach sand as aggregates to make concrete or concrete blocks.

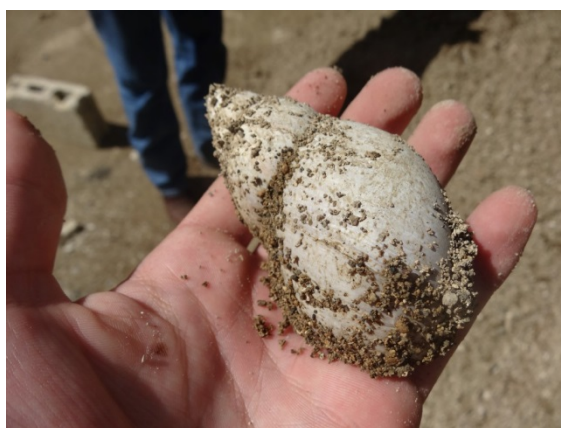
**Figure 66.** Seashell pulled from a pile of Bohol aggregate at a supplier's yard

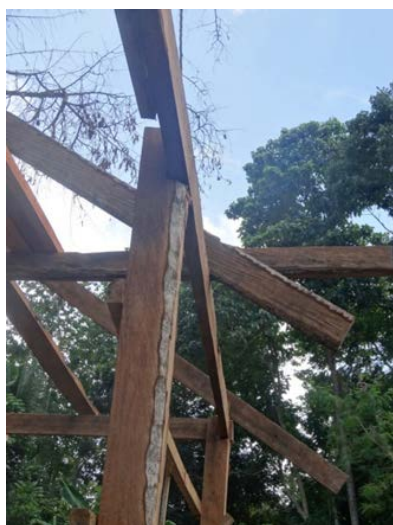
**Figure 73.** Timber connection on Bohol. Note that the connection is well notched for additional strength for gravity loads, but that this will not help for wind uplift. For uplift there is only one nail.

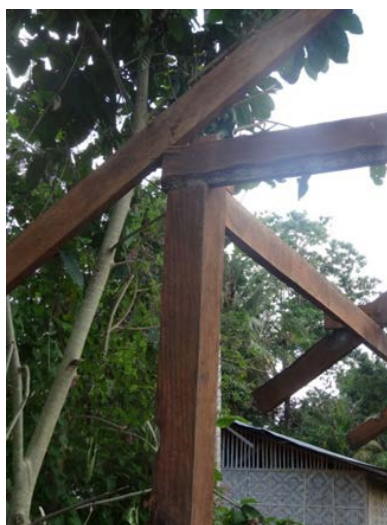
**Figure 74.** Timber connection on Bohol. This type of connection is typical, and is insufficient in every direction.

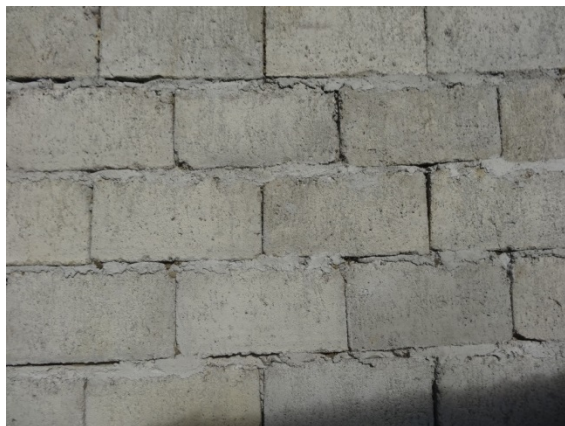
**Figure 75.** Poor masonry work on Bohol. Note the absence of mortar in the vertical joints.

→ **Recommendation 3:** Wet concrete blocks before adding them to walls, and plaster the house to make it stronger.

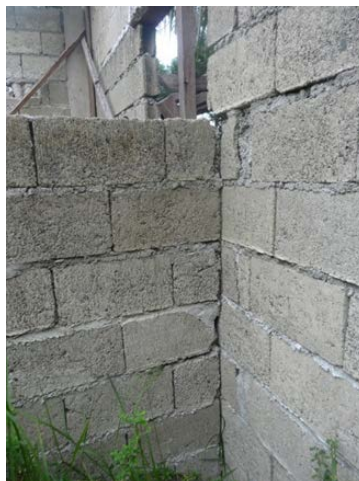
**Figure 76.** Inadequate masonry wall connections on Bohol. Each wall intersection should have a column with horizontal rebar dowels tying walls to the column.

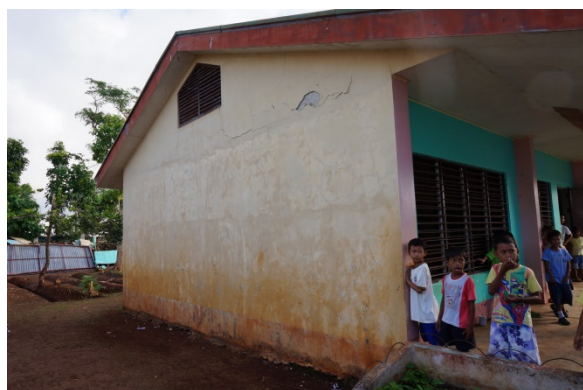
**Figure 77.** School building on Bantayan showing wind damage to the gable wall. This is unsafe and may result in failure and collapse in the next disaster event.

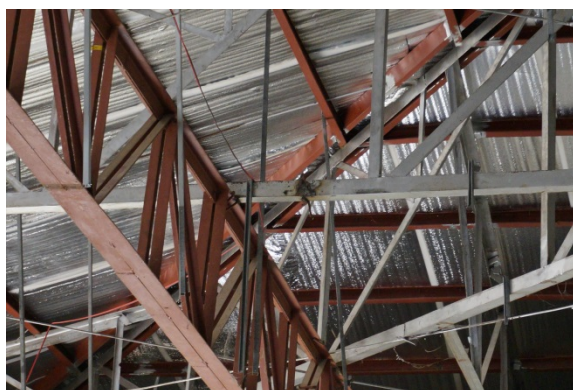
**Figure 78.** Example of poor welding techniques in the steel framing and CGI roof of a school building on Bantayan.
