APPENDIX I: UNDERSTANDING CAUSES OF COLLAPSE OF CONFINED MASONRY HOUSES IN INDONESIA

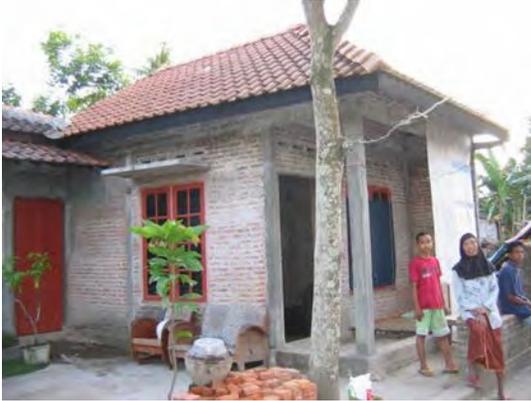
Figure 1. Well designed and built confined brick masonry house, edge of heavily damaged Pleret (Bantul), S7.83686° E110.41552°, IMG_6636

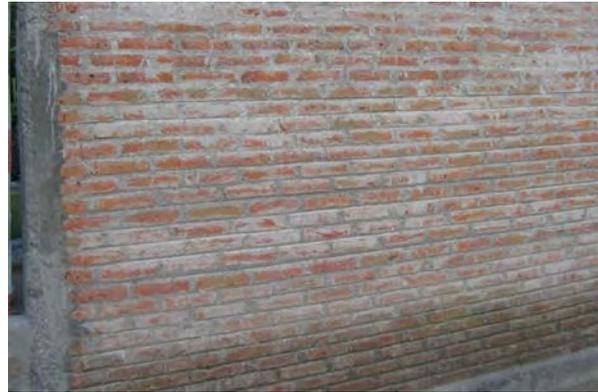
Figure 2. Well-built confined masonry wall, house on edge of heavily damaged Pleret (Bantul), S7.83686° E110.41552°, IMG_6640

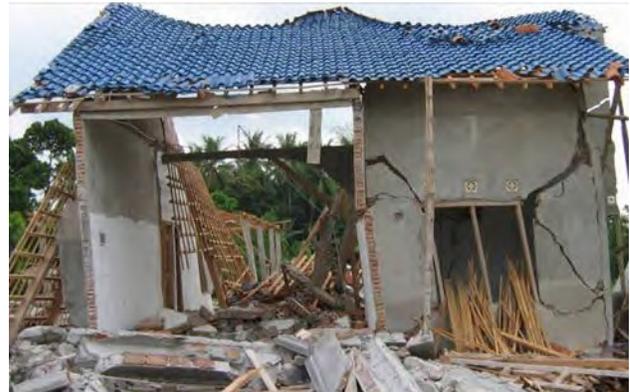
In contrast, the house shown in Figure 3 illustrates many of the shortcomings common to poorly designed and built confined masonry houses in Indonesia – tall slender wall with tendency to overturn, insufficient connections between confining elements, no reinforcement in the wall especially above openings. These flaws, and how the flaws can be addressed in design, are described in the following sections. The problems and solutions are grouped according to the three C's – configuration, connections, and construction quality.

Fig. 3. Confined masonry house under construction, insufficient connections, Pleret (Bantul). S7.87574°, E110.40703°, IMG_6575

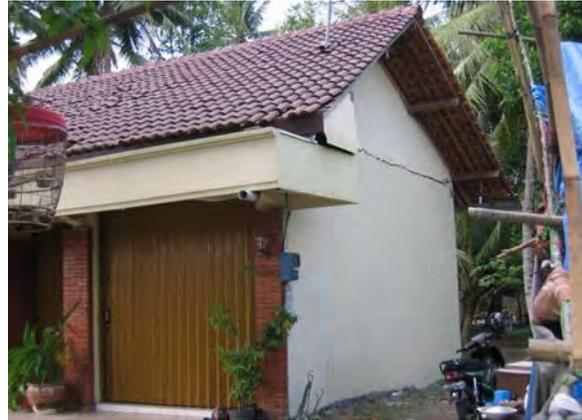
Problem: Masonry gables are notoriously poor performers in earthquakes (see Figures 4 and 5) and should be avoided. Damage and failure to masonry gable walls was widespread throughout all three earthquake-affected regions, and plagued both new and older houses with and without reinforced concrete ring beams. In most cases, gable masonry was neither properly confined nor properly connected to the roof. Cross-bracing between gables was not common.

Figure 5. Masonry gable wall out-of-plane failure in 27 May 2006 Central Java Earthquake, (Bantul) S7.89468°, E110.37341°, IMG_6542

Solution: REMOVE THE MASONRY ABOVE THE RING BEAM: Shift the truss over to rest on the wall and use a timber or other lightweight cover (Figure 6). Alternatively, use a hipped roof (Figure 7) which is the lowest cost alternative, and also performs better in high winds.

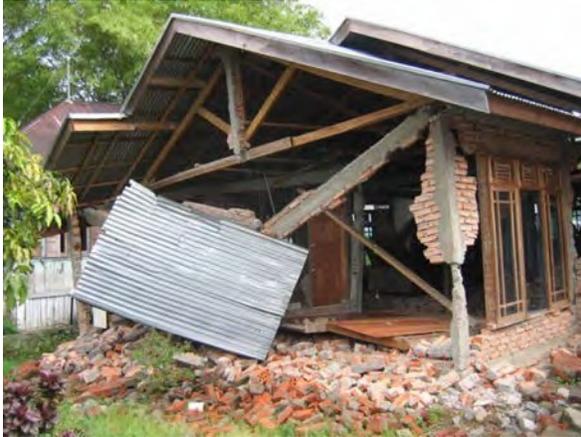
Problem: Large openings at the front of the house are common. There are many examples from all earthquakes in which the front of the house has collapsed, while the back of the house remained intact (see Figures 8 and 9). The problem associated with this lack of stiffness in the in-plane direction of walls with large openings and lack of confining elements to restrain masonry panels from failing outwards is exacerbated by the heavy mass of the masonry gable wall.

Figure 8. Collapse of front wall in confined masonry house , Padang Panjang, IMG_8831

- (1) Reduce the weight above the openings by following the previous recommendation about gable walls,
- (2) Reduce the number and area of windows, and consolidate them to provide longer, continuous shear walls,
- (3) Add vertical confining elements to all openings with area greater than 2.5m^2 . To reduce cost, shift openings from the middle of the panel to the corner, and
- (4) Add horizontal reinforcement to the wall every seven courses and above and below openings.

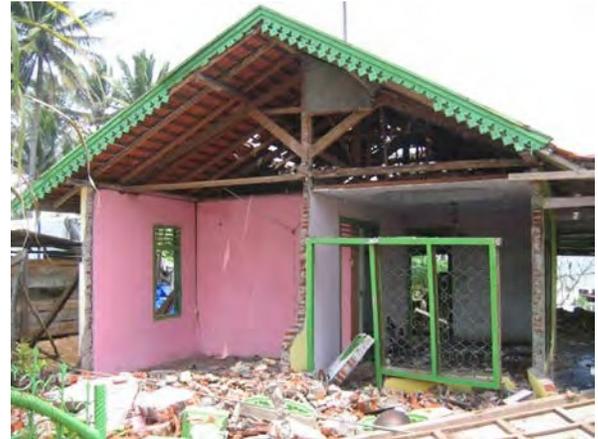
Figure 9. Partially collapsed brick masonry house with reinforced concrete (RC) tie columns and timber bond beams, note partial collapse of masonry gable wall, and lack of in-plane stiffness in front wall, Kec. Lais (North Bengkulu) S3.53217° E102.03771

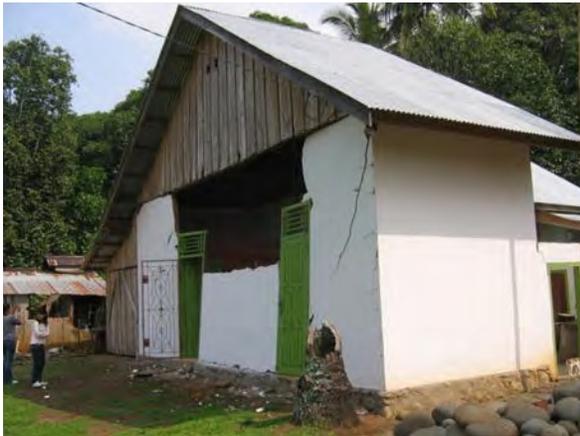
Problem: Walls upwards of 4m in height and longer than 6m without crosswalls and bracing are common and prone to out-of-plane failure, as illustrated in Figure 11 for a tall wall and Figure 12 for a long wall.

Figure 11. Confined masonry building with overturning failure of tall, unsupported wall, Kec. Airnapal (North Bengkulu)

Solution: Reduce the wall height to a maximum of 3m, and add crosswalls or bracing at the ring-beam level for spans longer than 4m. Tie the walls into the columns using horizontal reinforcement.

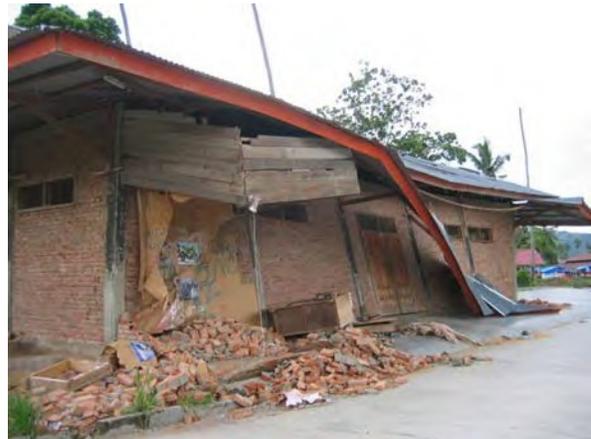
Figure 12. Confined masonry warehouse with out-of-plane failure of long walls without cross-bracing, , IMG 8891

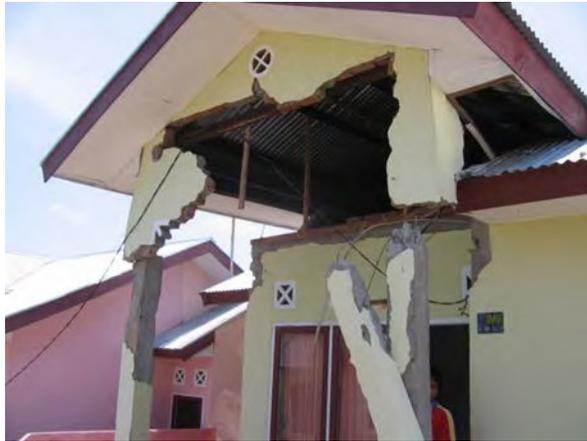
Problem: Covered terraces are en vogue in Indonesia. These open frame elements often have heavy, unreinforced and unconfined masonry gable walls above them. The frame elements are poorly detailed for connection to each other and to the main walls of the house. See Figures 13 and 14.

Figure 13. Subdivision of confined masonry houses, damage to covered terrace, Bengkulu. S3.83218° E102.29287

- (1) Avoid the covered terrace by using a simple extended overhang, as shown in Figure 10. Note that this requires good quality timber, or bracketing to support the overhang. Or,
- (2) Reduce the mass above the open frame by replacing the masonry, and ensure the connections are detailed properly (Figure 15).

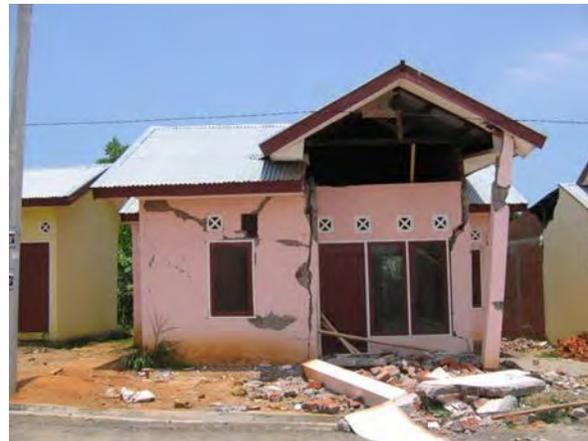
Figure 14. Subdivision of confined masonry houses, damage to covered terrace, Bengkulu. S3.83218° E102.29287

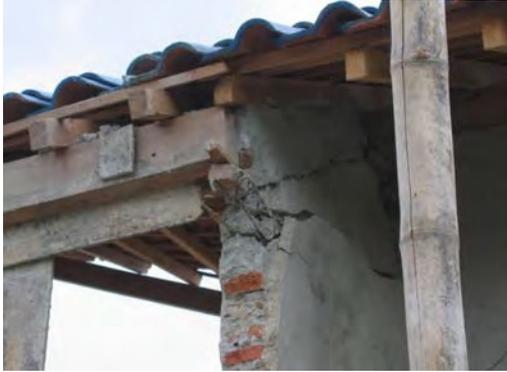
Insufficient connections between reinforced concrete tie columns and bond beams in confined masonry structures contributed to a majority of failures in all three events. The use of smooth rebar and the common practice of terminating the bond beam and tie column bars in the joint with a small hook does not provide sufficient rebar development or confinement. This problem was widespread in all earthquakes, and a dominant cause of failure for newly-built confined masonry houses in which both tie columns and bond beams were present. In Indonesia, insufficient connections are a problem that plagues both confined masonry and RC frame construction. See Figures 16 through 18 for examples.

Figure 16. Zoomed in view of ring beam column connection. IMG_6577

Solution: Use deformed bars. Bend the column reinforcement into the beams and overlap by 40 times the diameter of the bar. Similarly, bend the plinth and ring beam reinforcing around corners. Tie with double binding wire to maintain proper placement in the poured RC element.

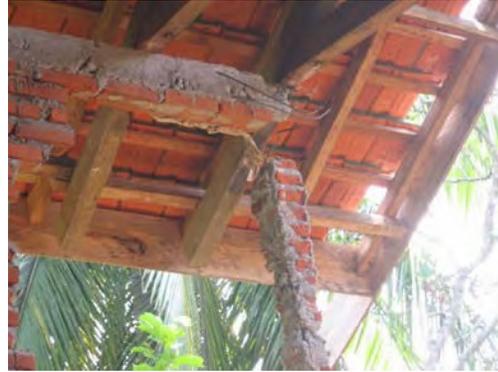
Figure 17. Confined masonry house with failure in masonry walls and connections between tie columns and bond beams, Kec. Airnapal (North Bengkulu)

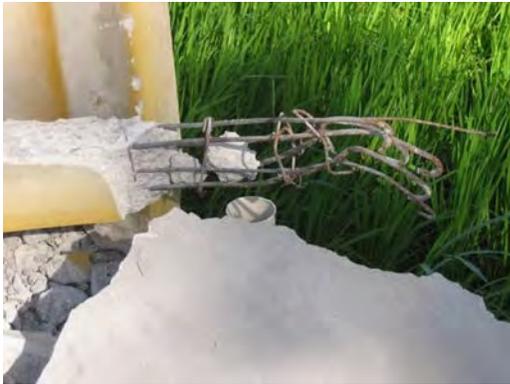
Figure 18. Connection failure, RC frame building, Central Java

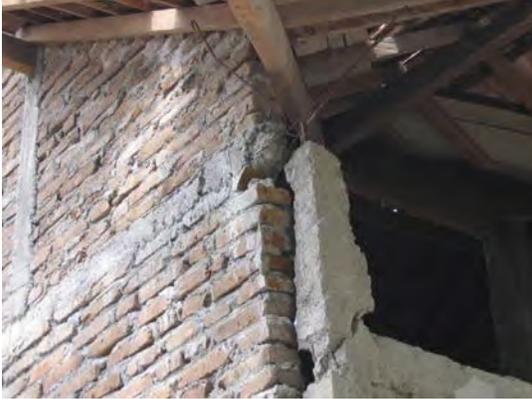
Problem: Critical to good performance of confined masonry buildings is the connection between the wall and tie columns. Separation between wall and confining elements occurred in many houses in all earthquakes and allowed the walls to fail out-of-plane. See Figures 19 and 20.

Figure 19. Insufficient connection between wall and tie column and between tie column and bond beam, Pleret (Bantul) S7.88174° E100.40869°, IMG_6746

Solution: Toothing, or staggering the bricks/blocks at the column interface so that the concrete pours into the wall every other course, is recommended for confined masonry buildings. The practice is not common in Indonesia. Homeowners and builders are unwilling to spend the extra money and time (respectively) on additional formwork required to accommodate a toothed wall or concrete to pour it. Further, our experience has been that it is difficult to get the concrete to flow completely into the toothed area. Instead, truss-type horizontal steel reinforcement can be used in the bed joint of the masonry, every seven courses of bricks and above and below openings, and tied into the columns and beams.

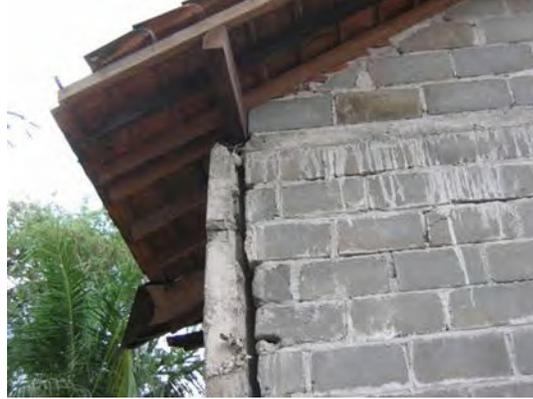
Figure 20. Insufficient connection between wall and tie column and between tie column and bond beam, Segoroyoso, Pleret (Bantul) S7.88174° E100.40869°, IMG_6749

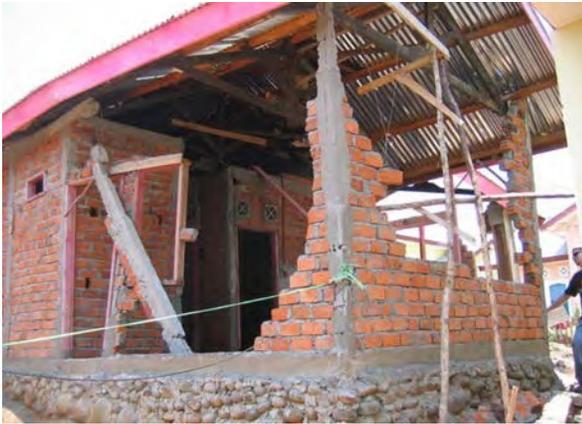
Figure 21. Subdivision of confined masonry houses, collapse of masonry wall exacerbated by insufficient connections, Bengkulu. S3.83218° E102.29287

Plaster is often ignored in structural engineering analysis; however, for a simple confined masonry building with a relatively weak wall, high quality cement-based plaster can add significant strength. The house in Figure 21 is the only house in which wall collapse occurred in a subdivision of similar houses affected by the 2007 earthquakes near Bengkulu. It is the only house that hadn't been plastered yet.

Solution: Insist on good construction quality, and finish the wall with cement-based plaster.

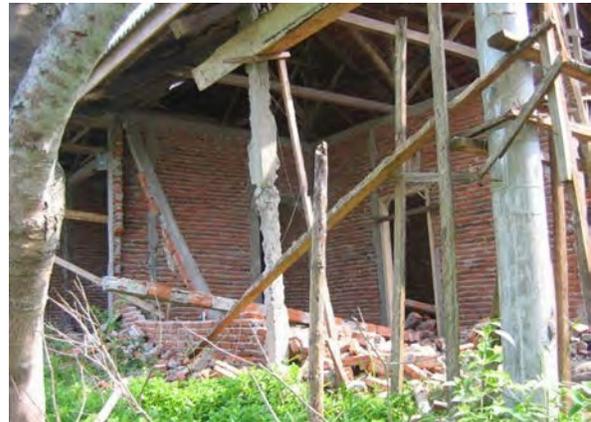
Figure 22. Confined masonry house with failure in masonry walls and connections between tie columns and bond beams, Kec. Airnapal (North Bengkulu)

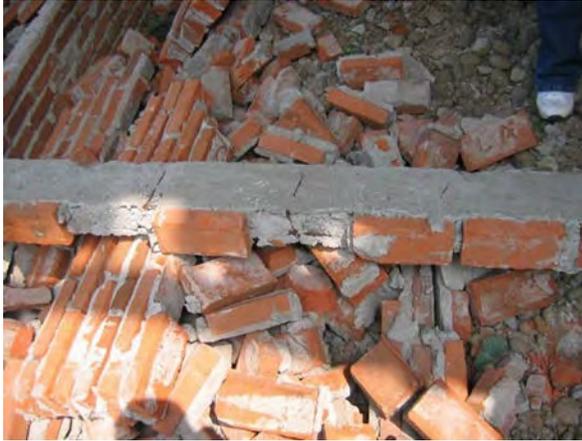
The first line of defense in a confined masonry structure in earthquake strong shaking is a well-built masonry wall. Typical single-story confined masonry houses in Indonesia have been shown to perform well in earthquakes, even when the tie columns are small in section and use bars of small diameter, provided the masonry wall is well constructed, with adequate bonding between bricks and mortar. See Figures 21 and 22 for examples of wall collapses with columns and roof intact. Weak bonding is clearly a contributor to failure (Figure 23); bricks were not soaked in water before building wall, and/or the mortar mix was too dry.

Figure 23. Close up view of collapsed ring beam and wall, same as Fig. 20. Failure plane between top of mortar bed and bottom of brick above it.

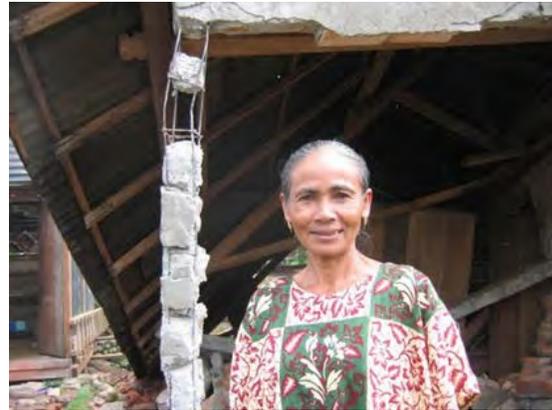
Figure 24. Homeowner standing in front of her collapsed wall, note quality of concrete, Padang Panjang, IMG_8840.

Problem. Poor quality concrete also contributed to failures. See Figure 24. Same solutions apply: ensure good quality materials and workmanship are used.

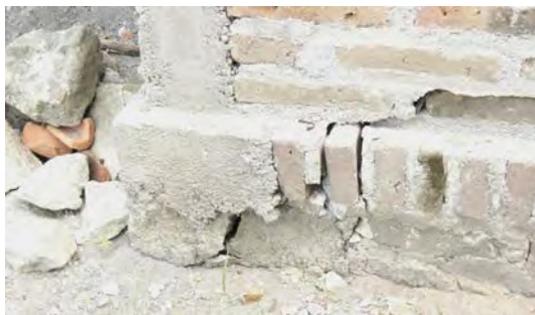
Very little earthquake-induced damage to confined masonry houses in Indonesia in recent earthquakes can be attributed to a soil or foundation problem. In the Central Java event, one example of sliding along the wall-foundation interface was found; in this case, there was no foundation beam. Effects of liquefaction were observed in one village in the Bengkulu event (Figure 26).

Figure 25. Displacement along wall/foundation interface, Tegal Kebong Agung, Imogir (Bantul) S7.93434° E110.36667°, CIMG1769

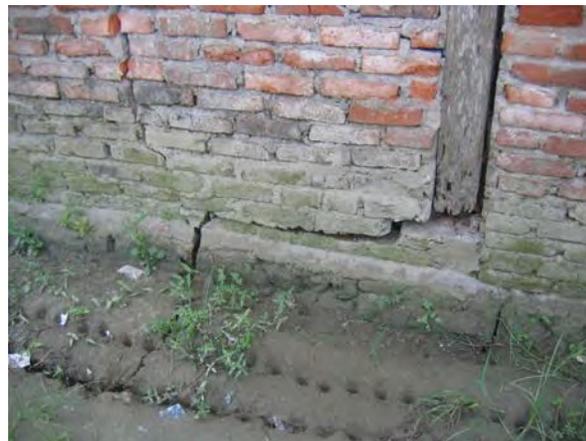
Figure 26. Cracks in foundation and walls associated with settlement and tilt on liquefiable soils, Lempuing (Bengkulu), S3.82799° E102.28473
