Overview

This reconnaissance report was compiled after site visits to Bengkulu province, West Sumatra province, and the Mentawai Islands. The focus is on the performance of houses, other low-rise buildings such as schools, multi-story RC frame buildings, and liquefaction effects on houses.

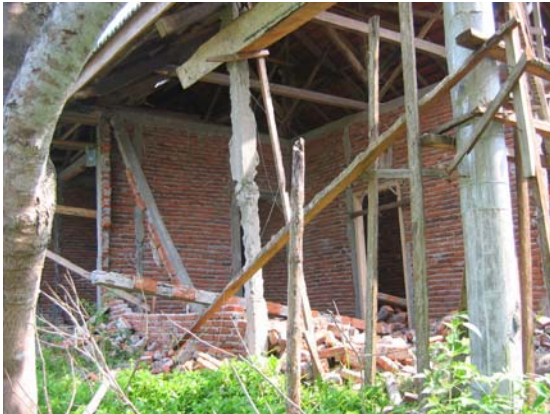
- (1) Insufficient connections between confining elements. Figures 2, 3 and 4 illustrate the importance of connections between confining elements. Note that the reinforced concrete columns and beams, despite their insufficient and inconsistent section and use of small diameter bars and stirrups or ties at large spacing, remain largely intact, with failure occurring in the masonry wall and at the connection between tie column and bond beam.

- (2) Poor quality workmanship in the masonry wall. Figures 2 and 3 also illustrate the importance of good quality masonry; in this case, partial collapse was initiated in the walls.

Figure 2. Confined masonry house with failure in masonry walls and connections between tie columns and bond beams, Kec. Airnapal (North Bengkulu)

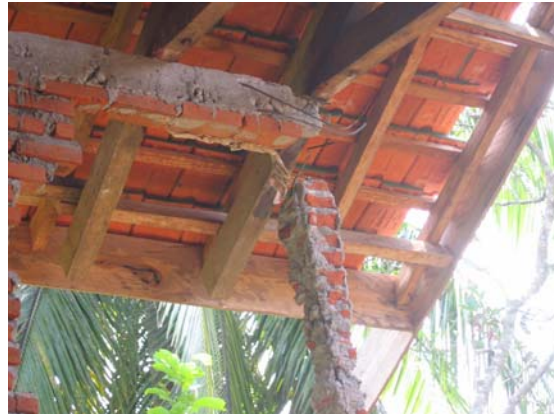
Figure 3. Confined masonry house with failure in masonry walls and connections between tie columns and bond beams, Kec. Airnapal (North Bengkulu)

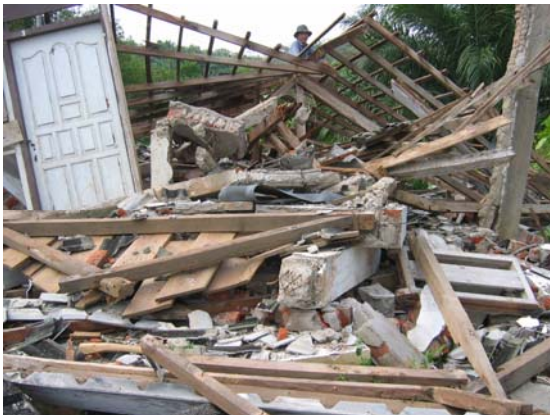
Figure 4. Collapsed confined masonry or RC frame with masonry infill house, note lack of sufficient connection (North Bengkulu)

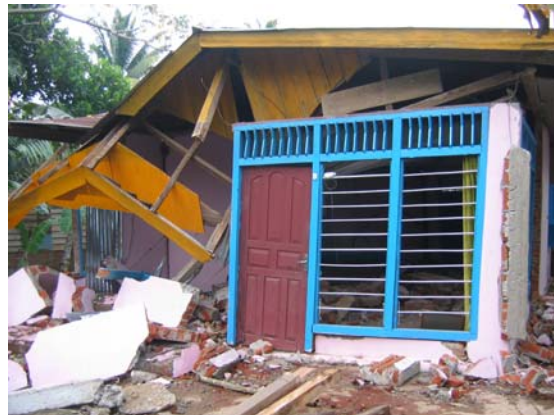
- (3) Lack of sufficient stiffness in the in-plane direction of the front wall. A common architectural preference in Indonesia is to have many large openings at the front of the house. This lack of stiffness in the in-plane direction contributed to several partial collapses (Figs. 5, 6 and 7).

Figure 5. Partially collapsed confined masonry house, (North Bengkulu)

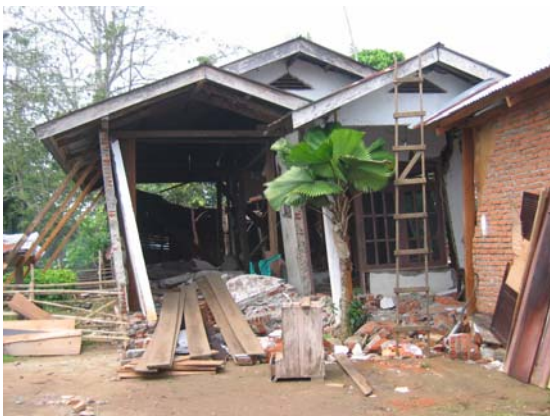
Figure 6. Partially collapsed unreinforced masonry house with timber bond beam, (North Bengkulu).

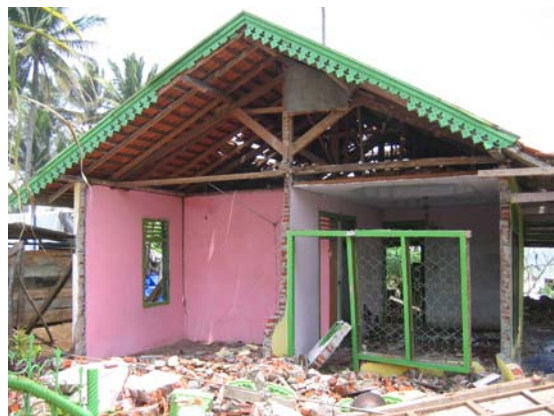
- (6) Use of timber for bond beams. Common practice was to use reinforced concrete for tie columns and timber for the bond beams. This construction practice was not sufficient to prevent collapse of walls of some houses. See Figures 7 and 10.
- (7) Unreinforced masonry without confinement. Figure 10 shows a partially collapsed house with unreinforced brick masonry walls, some timber tie columns at door frames, and a timber bond beam which is hooked to the wall.

Figure 7. Partially collapsed brick masonry house with RC tie columns and timber bond beams, note partial collapse of masonry gable wall, and lack of in-plane stiffness in front wall, Kec. Lais (North Bengkulu)
S3.53217° E102.03771°

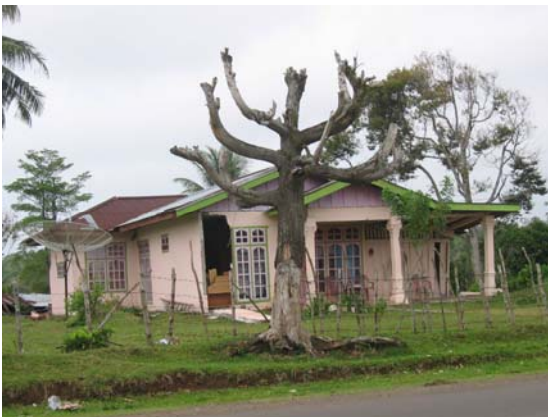
- (4) Insufficient connections between tie columns and masonry walls. Figure 8 shows the failure of a masonry panel without any connection to the column.

Figure 8. Confined masonry house with failure of masonry wall not connected to column, Kec. Lais (North Bengkulu)

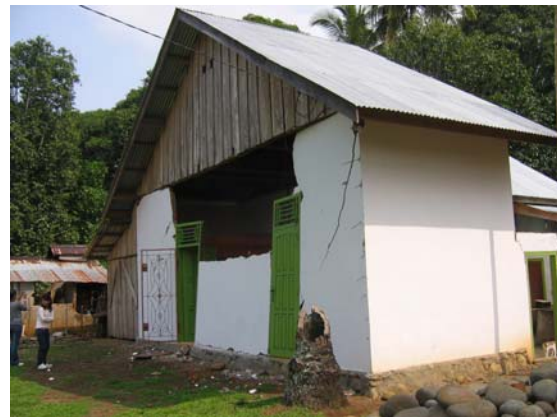
- (5) Tall, slender wall prone to out-of-plane failure. With plaster, the common wall is only 13 cm thick, and walls tend to be 3m in height. In the case shown in Figure 9, the wall was over 3.5m tall with a span over 5m without interior crosswalls or bracing.

Figure 9. Confined masonry house with failure in masonry walls and connections between tie columns and bond beams, Kec. Airnapal (North Bengkulu)

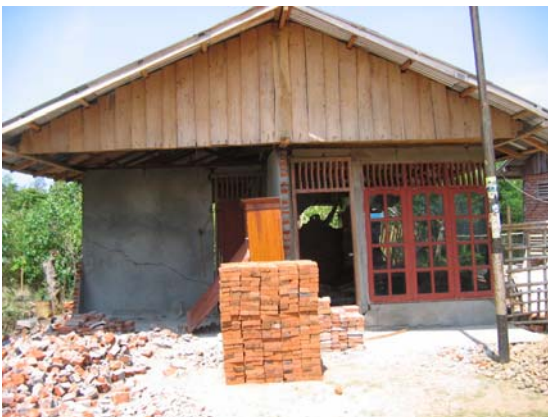
Figure 10. Partially collapsed unreinforced masonry house with timber bond beam, Lempuing (Bengkulu), S3.82799° E102.28473°

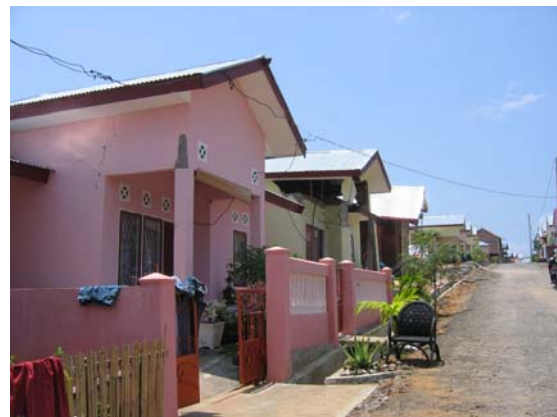
Damage was common at the upper column-beam connection in the open frame supporting the gable wall above the covered terrace (Figures 11, 12 and 13). The gable wall and the side walls collapsed completely in several cases. The most significantly damaged structure was the only one that was not yet plastered (Figures 15 and 16); in Indonesia, cement-based plaster adds significant strength to the masonry wall. That some houses were more damaged than others is probably because of (1) variations in construction quality and workmanship, and (2) location on the hillslope.

Figure 11. Subdivision of confined masonry houses, damage to covered terrace, Bengkulu. S3.83218° E102.29287°

These failures should be studied for the purpose of improving guidelines for new confined masonry construction. These causes of failures (particularly workmanship and poor connections) should be emphasized as key features in these guidelines.

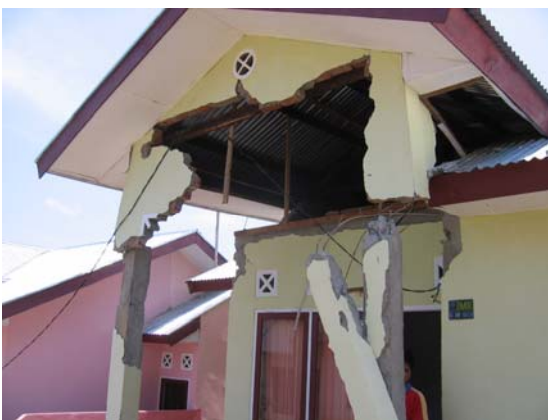
Figure 12. Subdivision of confined masonry houses, damage to covered terrace, Bengkulu. S3.83218° E102.29287°

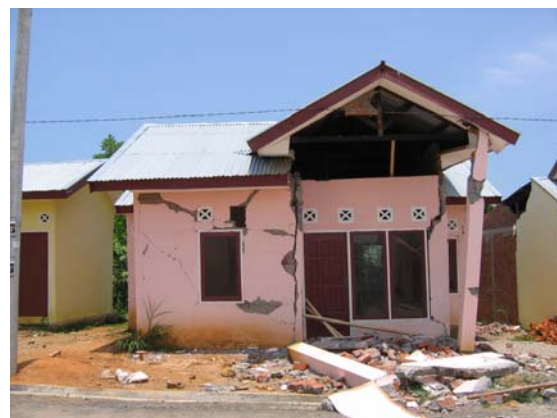
Figure 13. Subdivision of confined masonry houses, damage to covered terrace, Bengkulu. S3.83218° E102.29287°

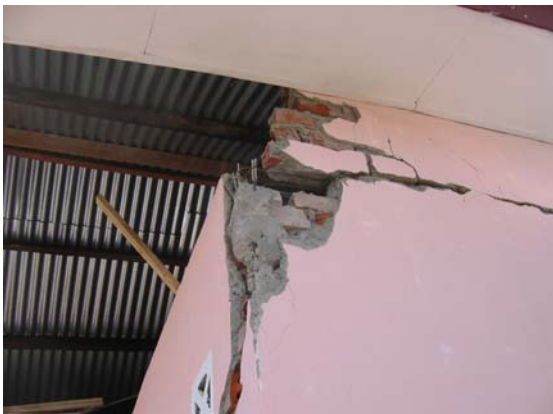
Several confined masonry houses located in a housing development in Bengkulu were damaged for similar reasons (Figures 11 through 16). This sloping subdivision of at least 60 houses was built by a developer, and the houses were subsequently purchased by owners. Although there were some variations in floor plans, most houses were identical, two bedroom with kitchen and indoor bathroom, single story, and approximately 40m².

Figure 14. Subdivision of confined masonry houses, separation and beam-column joint, Bengkulu. S3.83218° E102.29287°

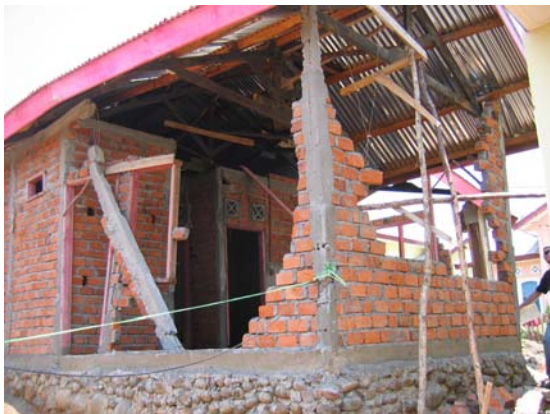
Figure 15. Subdivision of confined masonry houses, collapse of masonry wall exacerbated by insufficient connections, Bengkulu. S3.83218° E102.29287°

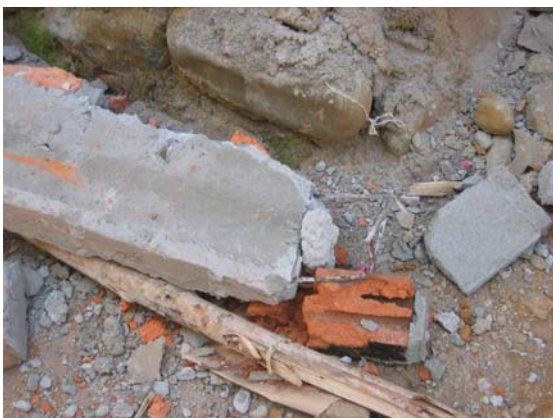
Figure 16. Subdivision of confined masonry houses, connection between beam and column, Bengkulu. S3.83218° E102.29287°

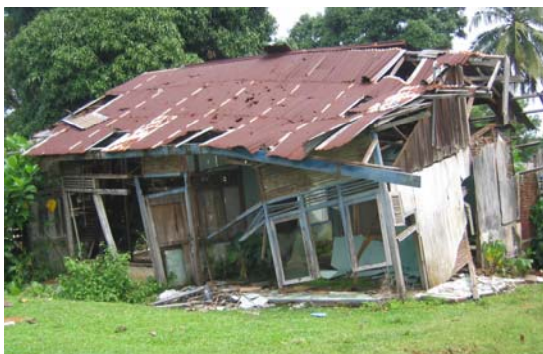
Timber Frame with Masonry Skirt. Many timber frame houses with 40 cm to 1m of masonry around the base of the wall performed well in the earthquake. Like confined masonry, this type of house is supported by a shallow stone masonry strip footing, however, there is rarely any connection between the timber posts and the footing, or the timber posts and the masonry panel. The damage to these structures, considered “semi-permanent” in Indonesia, consisted of cracking of the masonry panel, failure of the masonry panel as a rigid block, and shifting and damage to the timber frame (Figures 17 and 18).

Figure 17. Timber frame with masonry skirt, Kec. Lais (North Bengkulu)

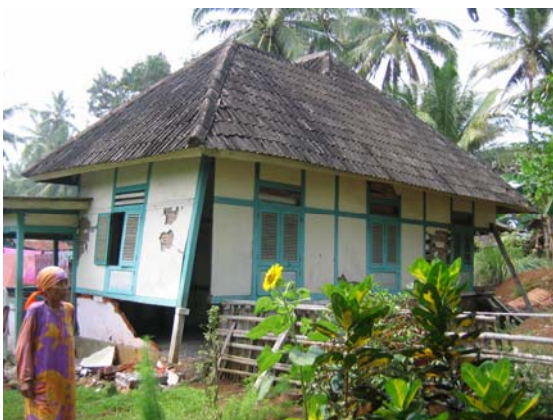
Figure 18. Timber frame with masonry skirt, superstructure has shifted off although the relatively heavy roof structure remains largely intact, and the masonry panel is partially collapsed, Kota Agung, Kec. Lais (North Bengkulu). S3.55841° E102.08951°

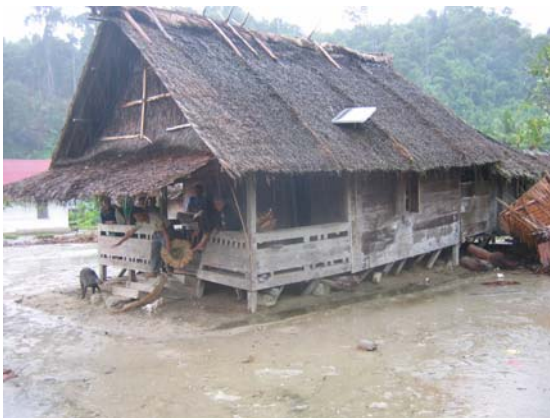
- (1) Timber posts rest directly on the ground, which caused the posts to sink in the ground at soft soil sites and sites inundated by tsunami; this foundation system to weathering of the timber due to the lack of isolation from water uptake from the ground (Figure 19)
- (2) Some houses with a stone or concrete stub foundation slid off the foundation
- (3) Superstructures lack bracing in the in-plane direction
- (4) Members are connected with nails only
- (5) Timber is not maintained or treated; newer houses with treated or painted timber performed better than those with older, weathered timber.

Figure 19. Timber frame with posts resting directly on soft ground, Barimanua, Pulau Sipora, Mentawai Islands.

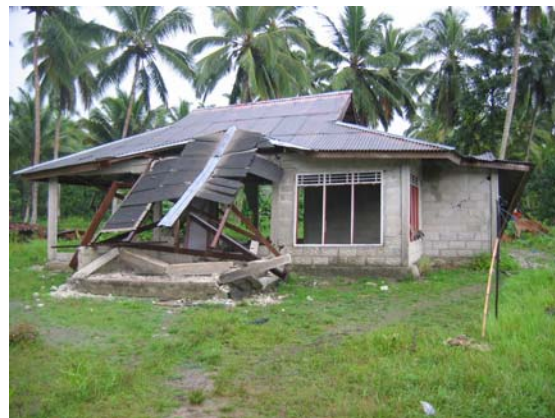
Confined Concrete Block Masonry. Confined Concrete Block Masonry structures have similar problems to the confined masonry structures described in the mainland Sumatra section, including lack of sufficient connections between confining elements, and poor quality block masonry (Figure 20). Most concrete blocks are cellular. There was a wide variation in the strength of the blocks used, some of them crushing easily under hand pressure. Low strength is a result of low cement content, use of beach sand, and production by hand (without mechanical vibration).

Figure 20. Confined concrete block masonry, partial collapse due to lack of sufficient connections between confining elements, Barimanua, Pulau Sipora, Mentawai Islands.

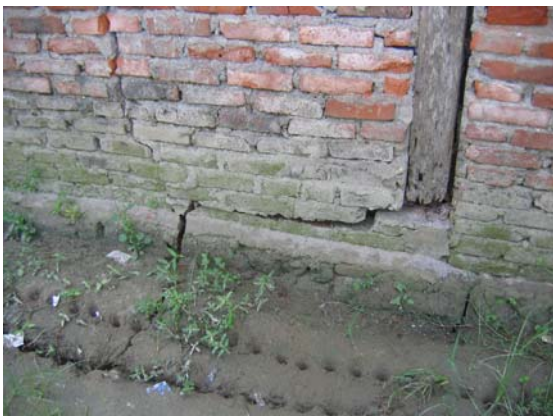
Effects of liquefaction, in the form of differential settlement and foundation cracking (Fig. 21), vertical cracks in masonry walls (Fig. 22), heave and cracking of interior floors (Figs 23 and 24), and reports of water and sand coming up through the cracks in the floors, were found in at least six houses in Lempuing, a village on the edge of Bengkulu city. This low elevation, high groundwater table site consists of clean, fine to medium sand near the surface. Floor slabs generally consist of thin (5 – 10 cm) unreinforced concrete.

Figure 21. Cracks in foundation and walls associated with settlement and tilt on liquefiable soils, Lempuing (Bengkulu), S3.82799° E102.28473°

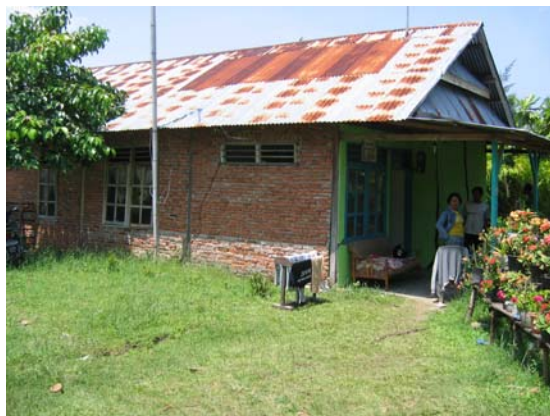
Figure 22. Ground cracking and vertical cracks in walls (behind owners), Lempuing (Bengkulu), S3.82799° E102.28473°

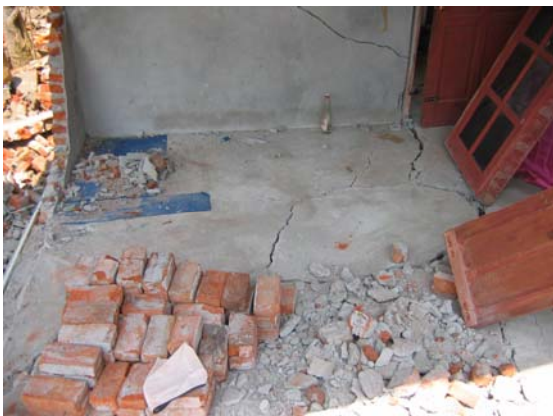
Figure 23. Floor heave and cracking, Lempuing (Bengkulu), S3.82799° E102.28473°

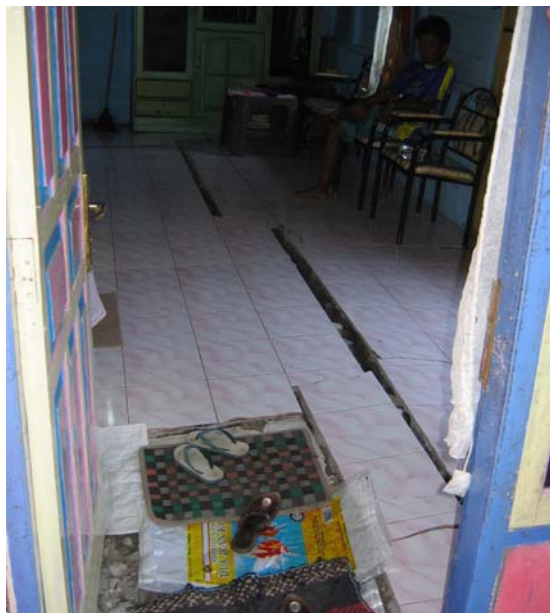
Figure 24. Floor heave and cracking, Lempuing (Bengkulu), S3.82799° E102.28473°

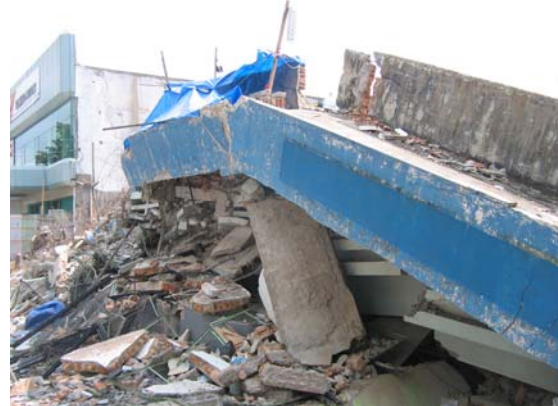
Figure 25. Hyundai Shop, Padang.

In the urban areas of Bengkulu and Padang, RC frame with masonry infill is still the most common structural type for multi-story commercial buildings and hospitals, although a handful of steel frame structures are under construction in Padang. In the cities, many multi-story RC frame with masonry infill buildings had cracks, however, little structural damage was observed. In Padang, two buildings collapsed completely, both RC frame buildings with RC slab roof and floors. The Mitsubishi showroom was already under demolition at the time of the site visit, and the Hyundai shop is shown in Figure 25.

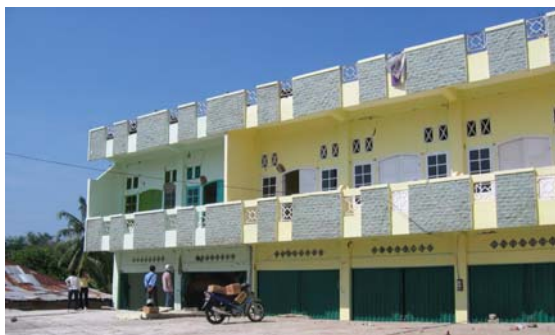
Figure 26. Two-story ruko, Bengkulu. S3.80362° E102.27617°

The ground floor of the five-bay, two story ruko shown in Figures 26 through 28 dropped by approximately one meter due to failure at the column-slab interface (Fig. 28). The structure is tilting back by approximately 4 degrees, and the first floor columns leaning to the left at 3 degrees. Ribbed, 14mm diameter steel was used in the columns and beams, with ties of 6mm diameter spaced at 4 cm near the joint. Similar failure at the column – ground floor beam interface occurred at a three-story, two bay ruko (Figures 29 through 31). In this case, the failure was clearly exacerbated by slope failure towards the building. The columns were 32 cm by 32 cm and used up to 8 smooth, 15mm diameter longitudinal bars.

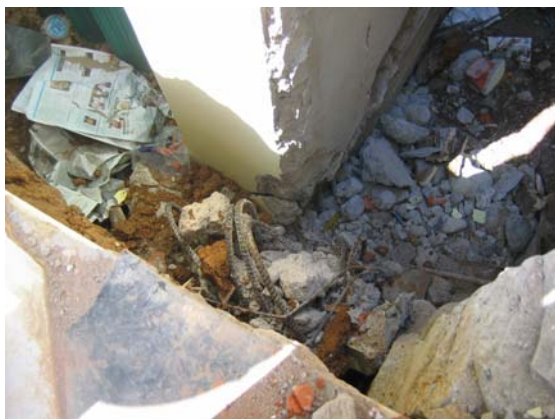
Figure 28. Two-story ruko, top of column below the ground floor slab, Bengkulu. S3.80362° E102.27617°

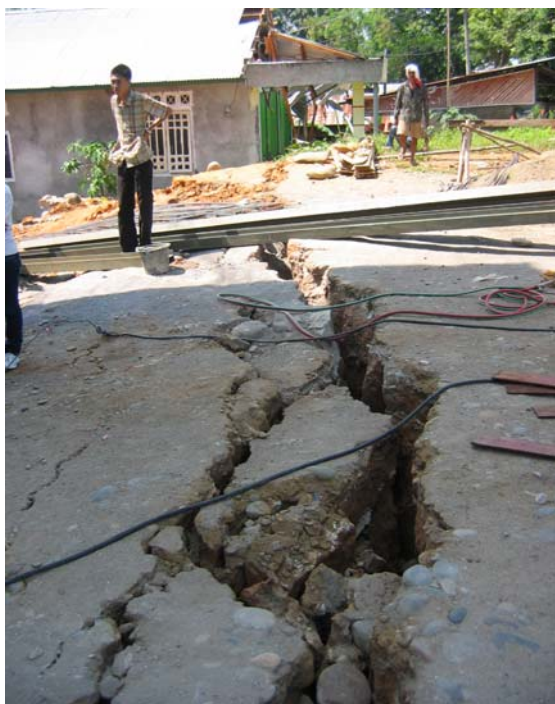
Figure 30. Ground settlement and lateral spreading toward three-story ruko, Bengkulu. S3.80581° E102.27953°

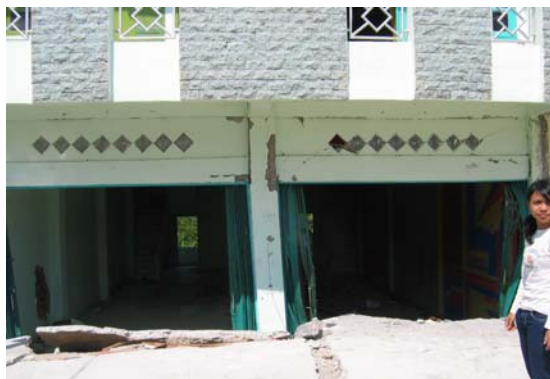
Figure 27. Two-story ruko, 3° tilt in first floor column, Bengkulu. S3.80362° E102.27617°

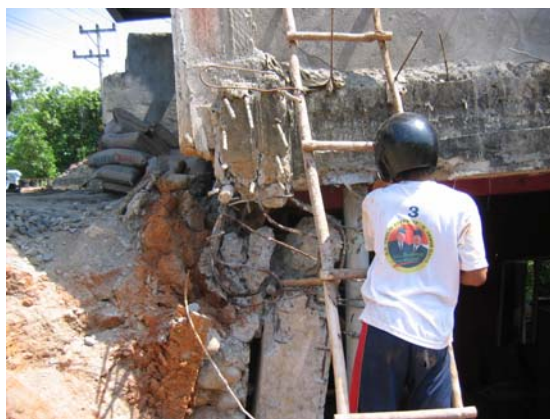
Figure 31. Three-story ruko, failure at the top of the column below ground floor beam, Bengkulu. S3.80581° E102.27953°

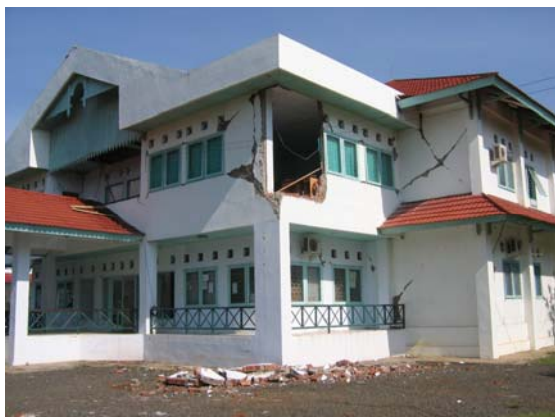
Non-structural damage, primarily in the form of cracks in masonry infill walls, was common in multistory commercial buildings (Figures 32 through 38), such as the Batang Arau Hotel, Bumi Minang Hotel, Pasar Raya, Plaza Andalas, Dr. MDJamil Medical Center, BPKP office, Governor’s office, BNI office, Bank Mandiri office, and Telkom office in Padang and at the Muhammad Yunus hospital in Bengkulu. Cracks and falling hazards existed at many frame structures in which the column was not located at the corner, and unreinforced masonry walls were used to extend the plan area (Figures 32 through 34).

Figure 32. University of Bengkulu, political science building, note failure of masonry wall extending out beyond main column, Bengkulu.

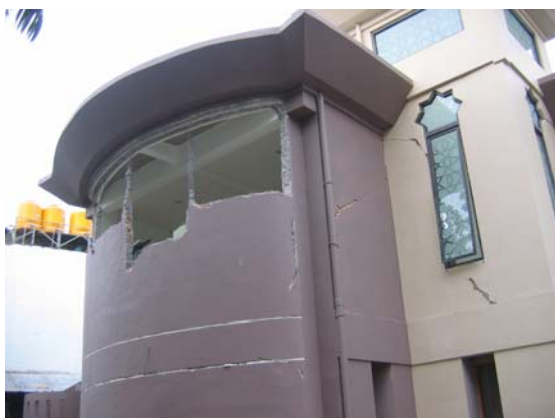
Figure 35. Two-story mosque near Bumi Minang Hotel, damage from earthquake consisted of vertical crack along wall-column interface; wall has been partially demolished since earthquake. Note minor columns are not connected to ring beam. Padang.

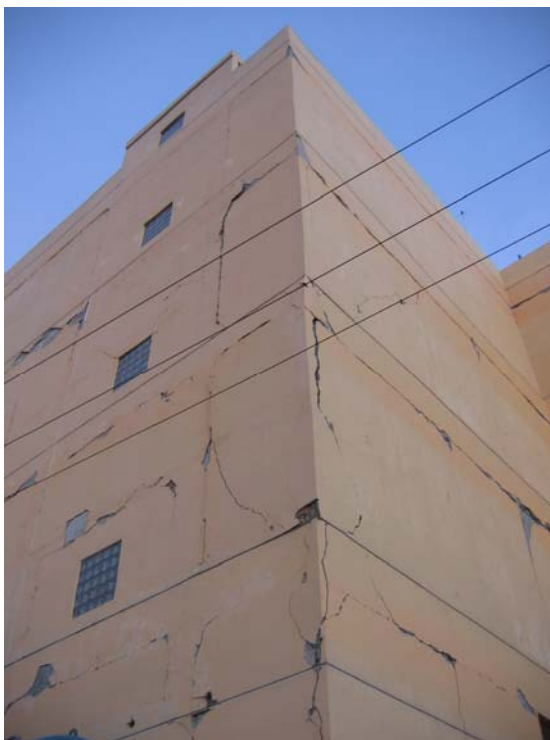
Figure 33. Plaza Andalas, 4-story shopping mall, damage to masonry walls, Padang.

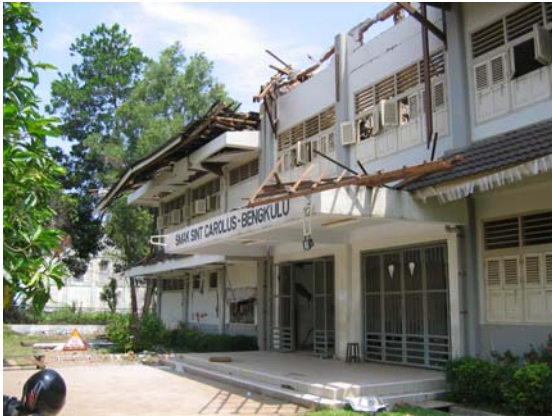
UN OCHA reports that 260 educational facilities were destroyed, and 450 severely damaged. The SMAK-SNT Carolus school in Bengkulu consists of two separate two-story RC frame buildings, one of which was a new building constructed after the previous building collapsed in an earthquake in 2000. The other building was repaired after the 2000 earthquake. Only hairline cracks were found at the edges of masonry infill walls in the new building, however, the timber truss roof collapsed where it was joined to or impacted by the older building. The repaired building had new, hairline cracks in the same pattern as those that were plastered and painted after the last earthquake. The tops of the first floor columns were also cracked. It appeared that they had been previously repaired by a sealant or adhesive. Some masonry interior walls were partially collapsed.

Figure 37. SMAK SNT Carolus School, pre-2000 earthquake building on left, post-2000 earthquake building starting with verandah and going right, Bengkulu. S3.82846° E102.29587°

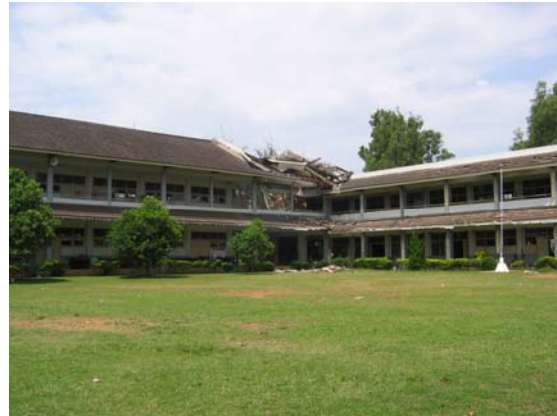
Figure 38. SMAK SNT Carolus School, pre-2000 earthquake building on right, post-2000 earthquake building on left, Bengkulu. S3.82846° E102.29587°

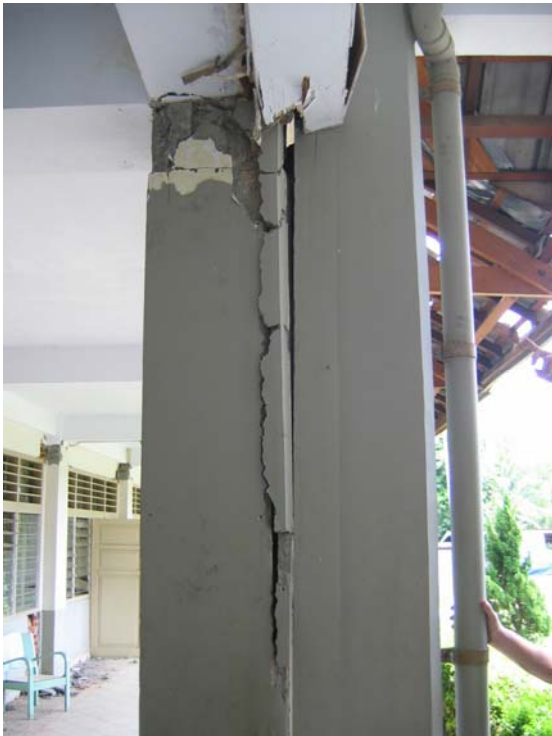
Figure 39. SMAK SNT Carolus School, pre-2000 earthquake building column on left, post-2000 earthquake building on right, Bengkulu. S3.82846° E102.29587°

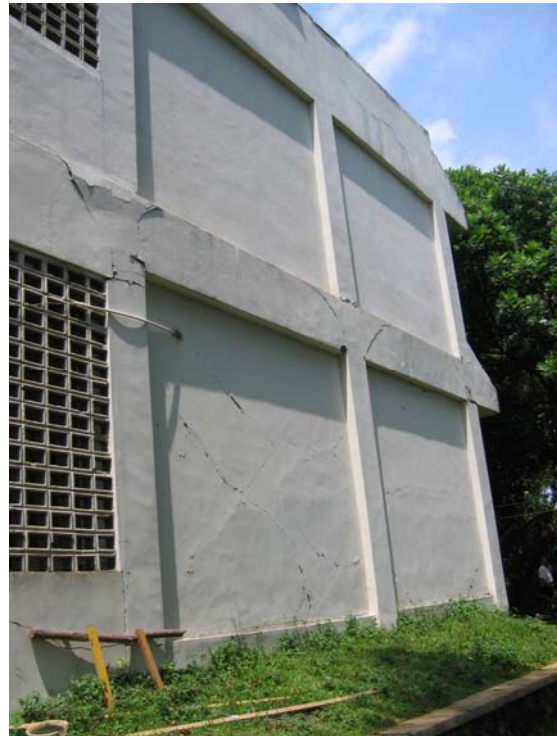
Figure 40. SMAK SNT Carolus School, pre-2000 earthquake building, new cracks in same pattern as those plastered over after 2000 earthquake, Bengkulu. S3.82846° E102.29587°

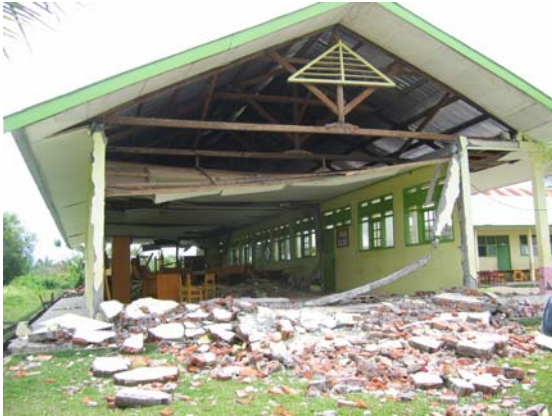
Confined masonry interior and end walls collapsed at a rural single story school complex in Lais Subdistrict (Sekolah Dasar Negeri No. 04) (Fig 41 through 44), leaving the long walls standing and supported against out-of-plane failure primarily through column steel tied around the roof trusses. Without strong-motion recordings, it is difficult to say how much directionality contributed to the end and interior wall collapses. The ring beams were not capable of spanning these wide classrooms. Ring beams were approximately 15 cm by 11 cm in section, used four 8mm diameter longitudinal bars with 4-5mm diameter stirrups spaced at distances of 20 to 30 cm (Fig. 43). Similar to the problems observed for confined masonry houses, connections between tie columns and bond beams were insufficient (Figures 43 and 44). Coarse gravel to cobble-size aggregate was used in the concrete; concrete was broken easily by hand pressure.

Figure 41. Sekolah Dasar Negeri No. 04, end and interior masonry walls collapsed, Kec. Lais (Bengkulu). S3.52958° E102.04525°

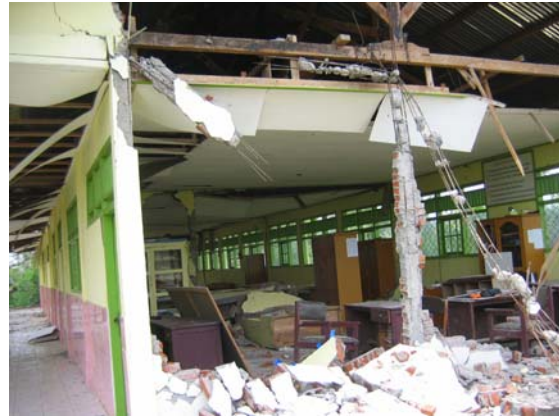
Figure 42. Sekolah Dasar Negeri No. 04, note steel splice location, use of rounded cobbles in concrete, Kec. Lais (Bengkulu). S3.52958° E102.04525°

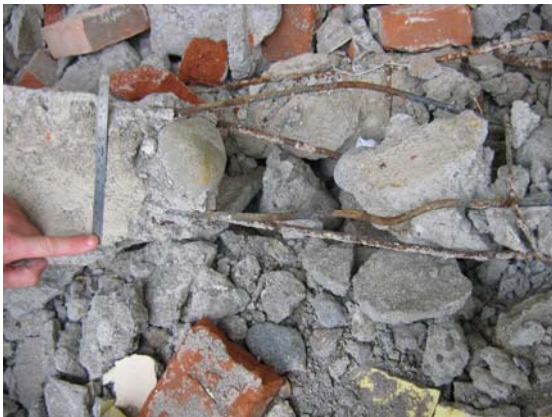
Figure 43. Sekolah Dasar Negeri No. 04, collapsed ring beam over end wall, note use of cobble size aggregate, Kec. Lais (Bengkulu). S3.52958° E102.04525°

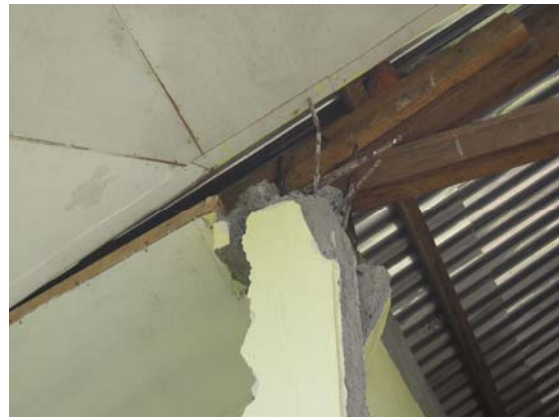
Figure 44. Sekolah Dasar Negeri No. 04, column-beam and column-truss connection, Kec. Lais (Bengkulu). S3.52958° E102.04525°

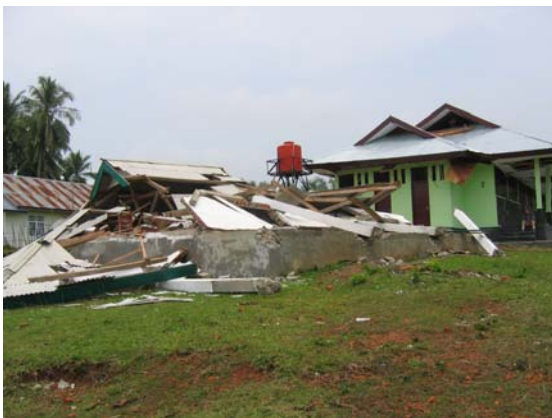
A second school compound with significant damage in Lais Subdistrict consisted of two buildings. A single story confined masonry building collapsed. The plinth was built of rounded river stone masonry, without a plinth beam for the columns to tie into. Failure at these and the upper column-beam joints likely led to collapse. The columns themselves appeared to be largely intact. A newer single story building, rectangular in plan with a covered terrace on one side, experienced cracking and tilt of the columns on the terrace. Cracking from deformation in the out-of-plane direction (perpendicular to the long axis of the building) was observed.

Figure 45. Collapsed confined masonry building, Pal 30, Kec. Lais, (North Bengkulu). S3.53490° E102.05996°

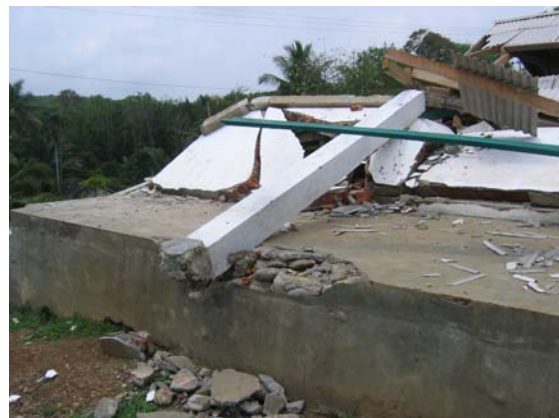
Figure 46. Collapsed confined masonry building, note lack of plinth beam and connection between column and plinth, Pal 30, Kec. Lais, (North Bengkulu). S3.53490° E102.05996°

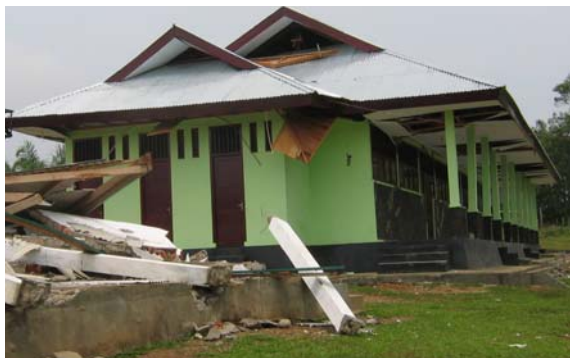
Figure 47. Rectangular plan school, note several columns out of plumb, Pal 30, Kec. Lais, (North Bengkulu). S3.53490° E102.05996°

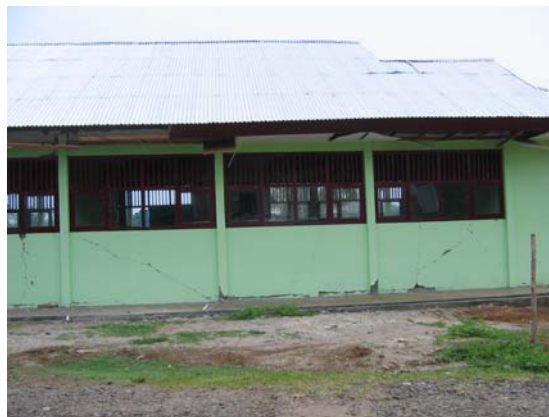
Figure 48. Rectangular plan school, cracks due to out-of-plane deformation, Pal 30, Kec. Lais, (North Bengkulu). S3.53490° E102.05996°

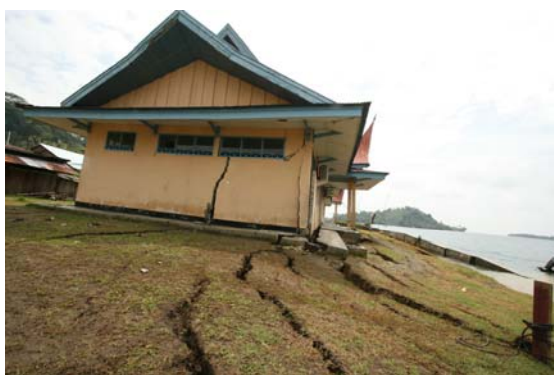
Figure 49. Lateral spreading toward river, Sikakap (Sikakap, Mentawai Islands) photo courtesy SurfAid International
