## **OVERVIEW**

The  $M_w$ 7.9 earthquake in Wenchuan, China on 12 May 2008 was catastrophic in terms of lives lost and buildings destroyed or damaged: 69,185 people killed, 374,171 injured, 18,467 still listed as missing. More than 7.79 million houses were destroyed, and 24.5 million damaged. Some villages have few to no buildings that remain standing.

Observations were made by Dr. Elizabeth Hausler during a field reconnaissance to the earthquake-affected area between 15 and 24 June 2008. Dr. Hausler's visit to Sichuan was coordinated through the 10 + 10 Strategic Partnership between the University of California system and 10 universities in China. This report includes a short list of opportunities for collaboration identified during the field visit, in single family housing and other areas.

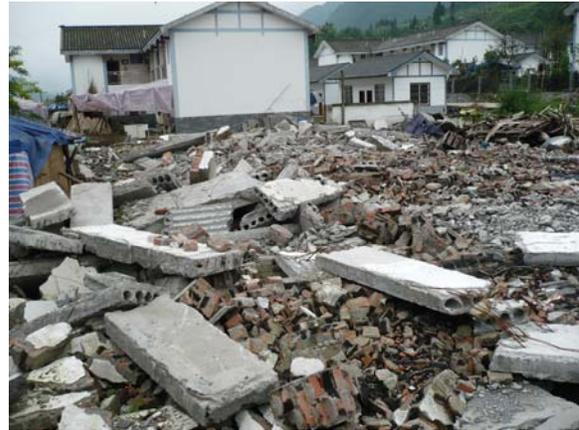
*Fig. 1. CAUSE OF SO MUCH LOSS...and the case for confined masonry. Debris from collapse of unreinforced masonry buildings with precast concrete roof/floor planks (foreground), and 2-story confined masonry buildings with no damage (background) built in 2006 reportedly according to the Chinese Seismic Code. Gao Yuan Village, Wenchuan County, within 500m of evidence of permanent ground displacement (See Fig. 2)*

→ CAUSE OF FAILURE: For the rural areas I have visited so far, the biggest killer was unreinforced masonry wall with precast concrete plank roof and floor (see Figs 1 and 3 Table 1). There is no (or weak) connection between the planks and the walls, and no ring beam to confine the planks.

→ PROMISING SOLUTION: I visited one village in which some 2-story buildings were built by a private company in 2006 using confined masonry reportedly per the Chinese Seismic Code (see Figs. 1 and 4 and the summary table). Flawless performance. Other unreinforced masonry buildings in the same village with the precast concrete planks collapsed (Fig. 1). Some homeowners built single story unreinforced masonry kitchens with timber roofs, and they performed well overall (a few gable wall cracks; only one building damaged beyond repair).

- UNREINFORCED MASONRY with precast concrete planks – should be prohibited, not an option. For permanent, rural homes, introducing other structural systems which use precast concrete components should be strongly discouraged.

- CONFINED MASONRY – in absence of timber, maybe the best solution for single family rural house, but may be expensive, and although it is codified and becoming more common in China, rural homeowners are not yet familiar with this technology.

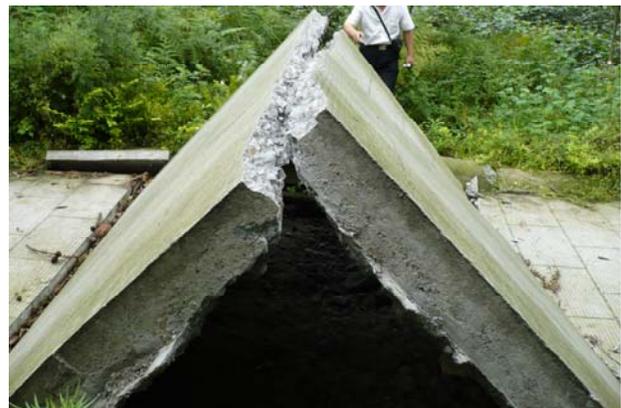
*Fig. 2. Permanent ground displacement, Gao Yuan*

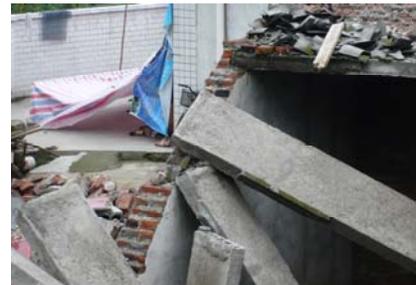
*Fig. 3. Collapse of precast concrete plank on masonry wall, near Xiao Yu Dong bridge.*

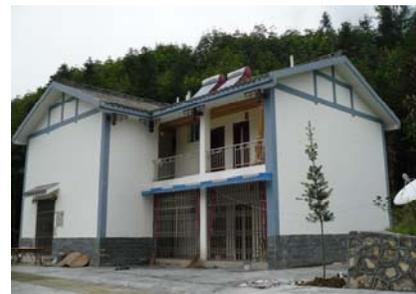
*Fig. 4. Confined masonry two-story house, no damage, Gao Yuan.*

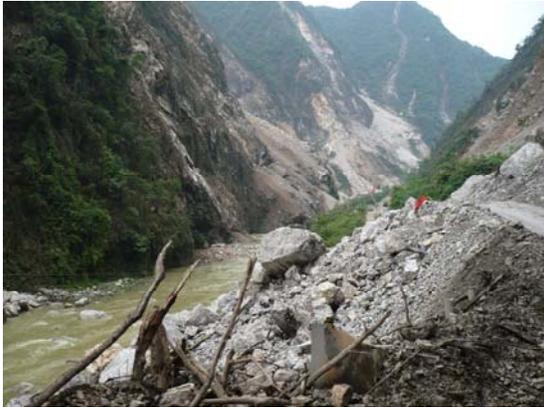
Again, in the Joint Chinese-US Reconnaissance Meeting, “method to evaluate and/or mitigate hazards from rock (boulder) falls/slides in steep canyons” is listed under request for technical assistance. I am not a landslide expert but I’m not afraid of heights, and I can say that traveling on the road leading out of Dujiangyan toward Gao Yuan was by far the scariest part of this trip. The road is reduced to one lane in areas over fresh slides. It wasn’t safe to get out of the car and take a close look, but some slides consisted of topsoil with river cobbles, others were rock/boulders larger than cars (Fig. 5). There was some work going on to contain soil from spilling onto the roadway with unreinforced stone masonry retaining walls (Fig. 6).

*Fig. 5. Landslides near Gao Yuan.*

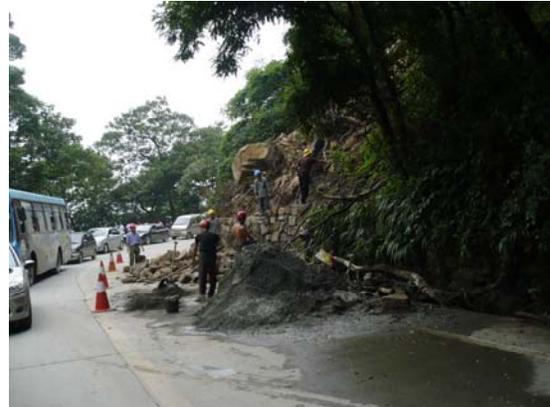
*Fig. 6. Stone masonry retaining wall construction near Gao Yuan.*

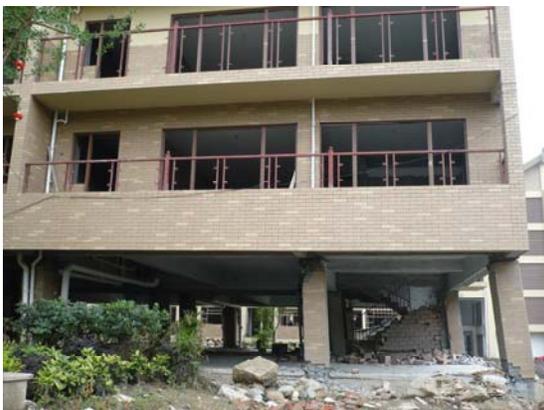
Two types of multi-story buildings were responsible for most of the casualties and loss in urban areas: (1) reinforced concrete frame with masonry infill (Figs. 7 and 8), and (2) unreinforced, load-bearing masonry with precast concrete plank roof/floors (Figs. 9 and 10). The latter may have had some confining ring beams and tie columns, and often had an open frame ground floor.

*Fig. 7. Damaged soft story columns in new, six-story reinforced concrete frame apartment building (Dujiangyan IMG0721).*

- Tagging/inspecting buildings
- Developing and implementing retrofit solutions – maybe this fits in to the NEES Grand Challenge on non-ductile concrete frame buildings?

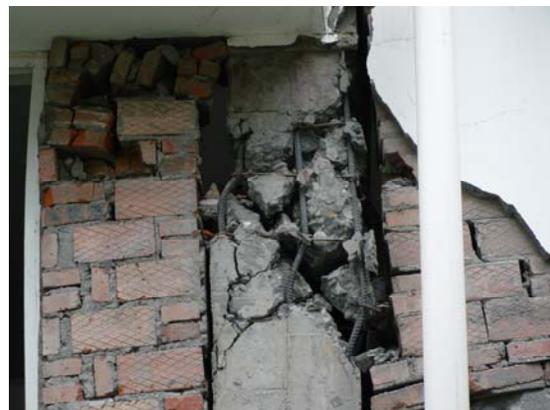
*Fig. 8. Shear failure in top of ground floor column, six-story reinforced concrete frame with masonry infill (Dujiangyan IMG0705)*

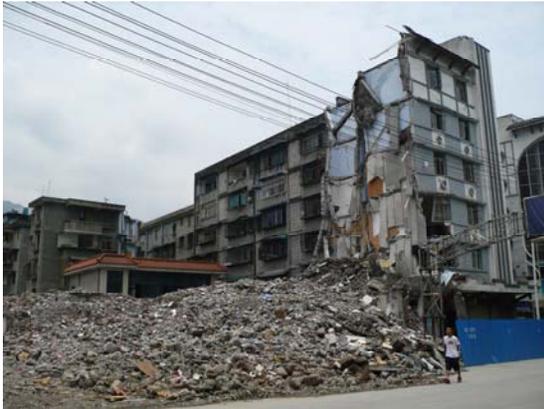
*Fig. 9.* Partial collapse of masonry with precast concrete plank floor, six-story (Dujiangyan IMG0335).

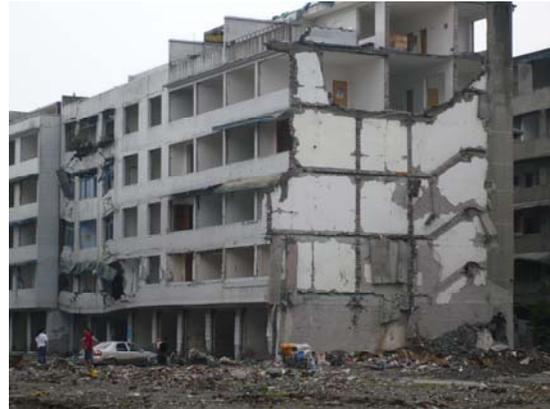
*Fig. 10.* Damage to masonry building with open frame ground floor (Dujiangyan IMG0286)

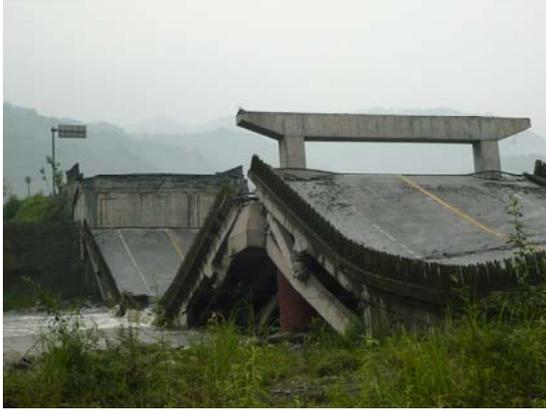
I observed two bridge collapses first-hand and saw a third on local TV news. Both collapses were exacerbated by permanent ground displacement. See Figs 11 through 14 and the Bridge reports for more information.

*Fig. 11.* Collapse of two spans of four-span reinforced concrete arch bridge, (Xiao Yu Dong IMG0038).

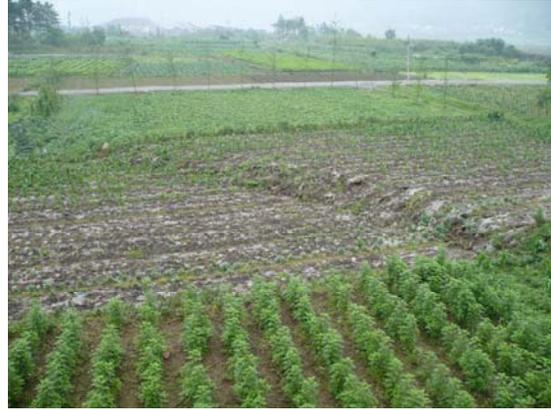
*Fig. 12.* Permanent ground displacement near Xiao Yu Dong Bridge. Note bridge is to the right of the photograph. (IMG0393)

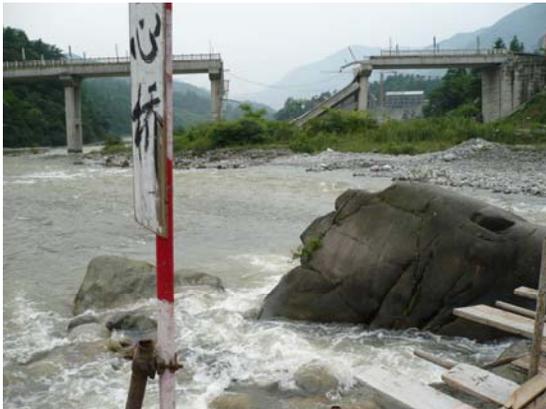
*Fig. 13.* Collapse of one span of Gao Yuan bridge. (IMG0458)

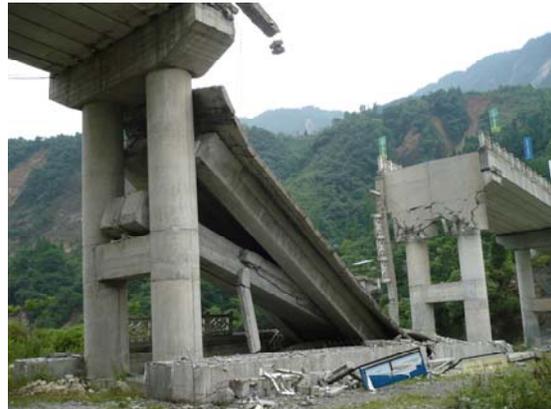
*Fig. 14.* Collapsed span of Gao Yuan bridge. (IMG0472)
