OVERVIEW

RURAL RESIDENTIAL BUILDINGS
12 May 2008 Wenchuan, China Earthquake
Dr. Elizabeth Hausler
30 June 2008

(1) Unreinforced Masonry with Timber Roof

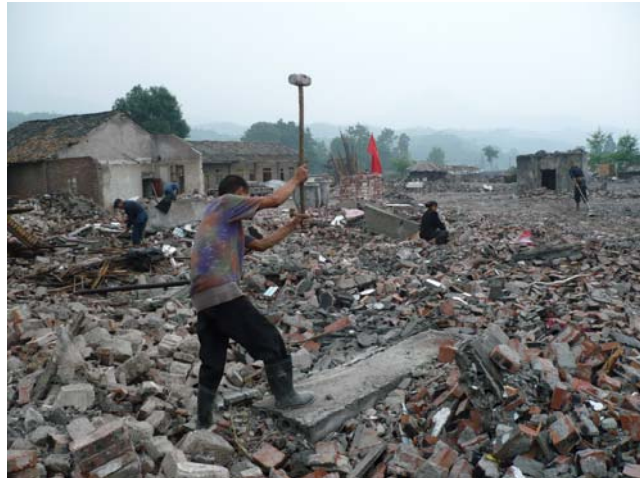
The overwhelming losses in this earthquake in both urban (multi-story) and rural buildings can be attributed in large part to use of unreinforced masonry with precast concrete plank roofs and floors (Figs. 1 and 2). There is, however, at least one compelling example of excellent performance of confined masonry houses reportedly built according to the Chinese Seismic Code (Fig. 2).

Fig 1. Debris removal and recycling in heavily damaged Danan Village. A few unreinforced masonry buildings with timber roofs remain standing. Collapse of unreinforced masonry buildings with precast concrete roof/floor planks (shown under the worker's right foot) contributed to the majority of casualties in both urban and rural areas visited during the reconnaissance.

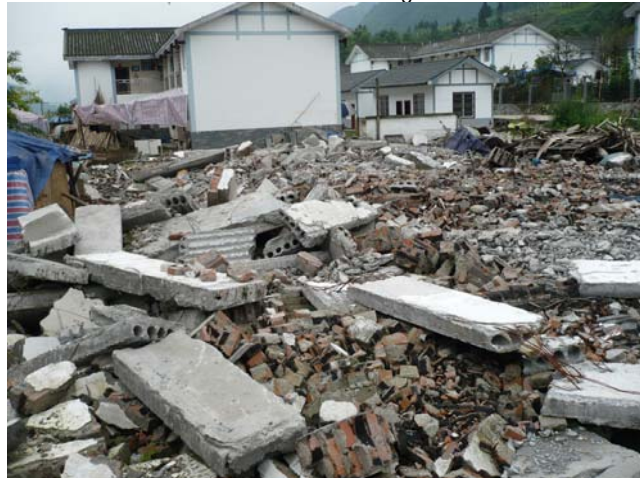
Fig. 2. Debris from collapse of unreinforced masonry buildings with precast concrete roof/floor planks (foreground), and 2-story confined masonry buildings with no damage (background) built in 2006 reportedly according to the Chinese Seismic Code. Gao Yuan Village, Wenchuan County

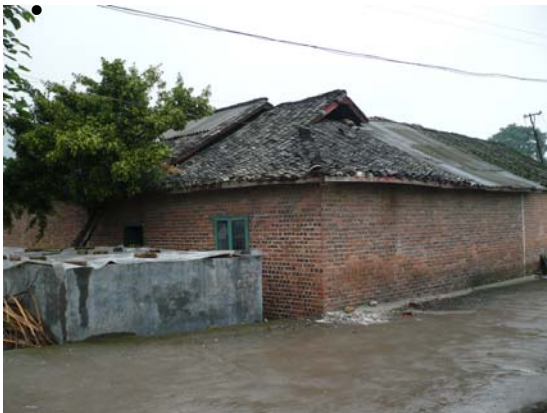
Fig 3. Unreinforced masonry house with pitched timber roof, no damage, Danan Village. IMG0104

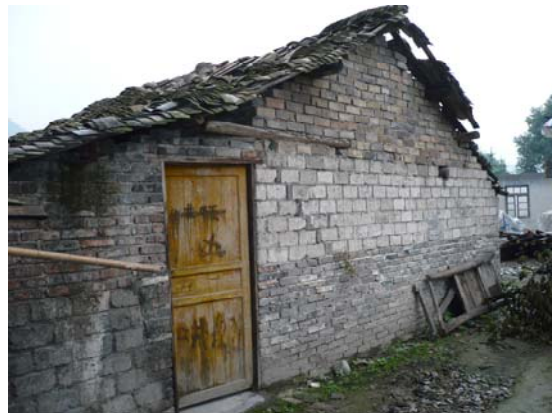
Fig 4. Unreinforced masonry house with brick and solid concrete block, displacement of clay tiles on roof, Danan Village. IMG0129

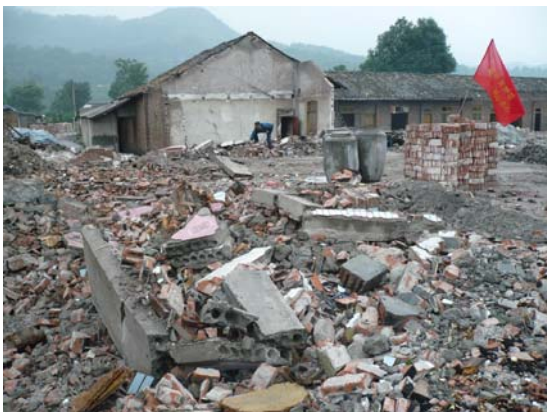
Fig 5. Partially collapsed unreinforced masonry with timber roofs in background, collapsed URM with concrete plank in foreground. Rural Pengzhou. IMG0122

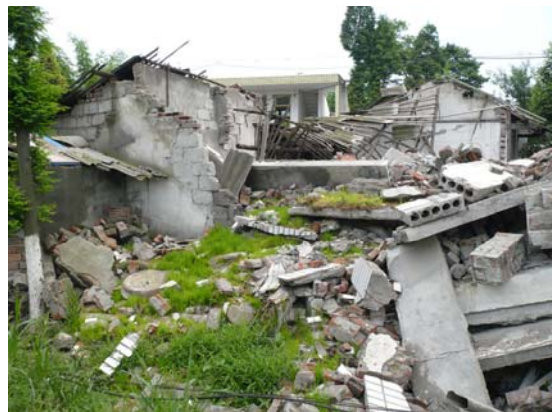
Fig 6. Partially collapsed unreinforced masonry with timber roofs in background, collapsed URM with concrete plank in foreground. Rural Pengzhou. IMG0351

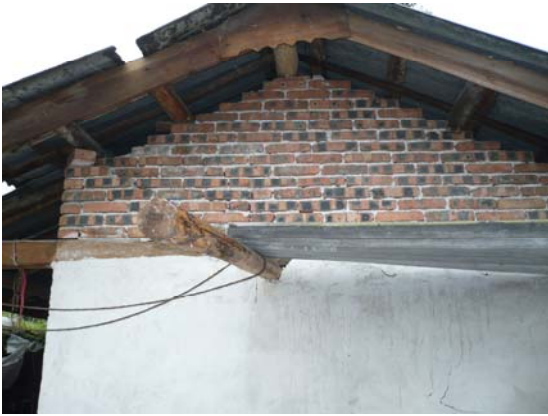
Single story unreinforced masonry buildings with pitched or hipped timber roofs experienced light to heavy damage. Compared to their counterparts with precast concrete plank roofs discussed in the next section, these simple URMs with lightweight roofs performed better. See Figs 3 through 18 for examples. As is typical for unreinforced masonry, gable wall cracks and failures were common. Materials used are as follows:

Fig 7. Crack in masonry gable wall, Danan Village.
IMG0116

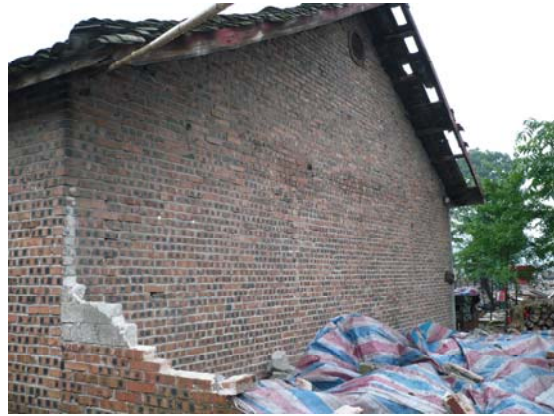
Fig 8. Undamaged masonry gable wall, Danan Village
IMG0118

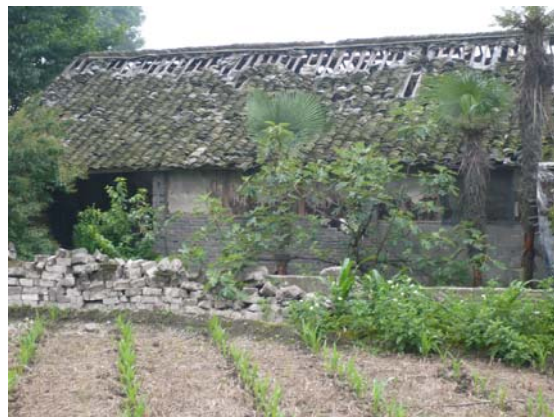
Fig 12. Typical traditional roofing system with simple
clay tiles, free to slide during shaking. IMG0094

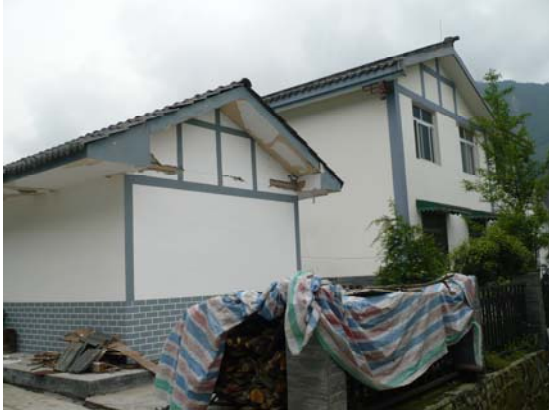
New (2006) unreinforced masonry buildings with pitched timber roofs were observed in Gao Yuan village (Figs. 13 and 14). Damage was limited to the gable walls, except for the only building that wasn't finished (Figs 15 through 18). This building was more heavily damaged, perhaps because the interior and exterior wall tiling had not been completed.

Fig 13. Single story URM with timber roof, cracked gable wall (two story building is confined masonry, described later) Gao Yuan village. IMG0559

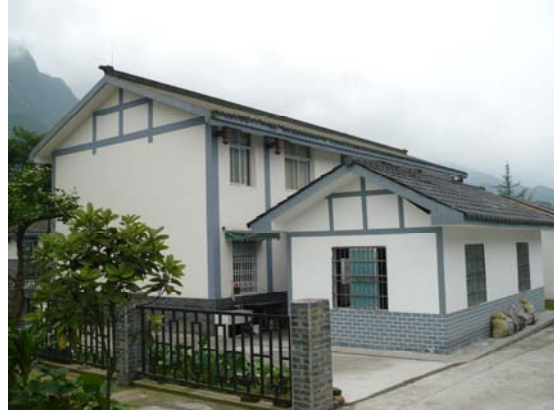
Fig 14. Single story URM with timber roof, no damage (two story building is confined masonry, described later), Gao Yuan village. IMG0560

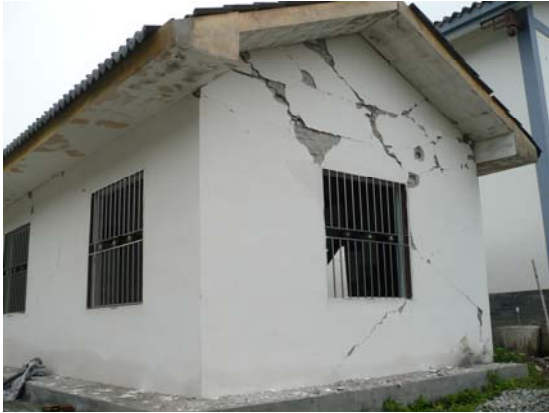
Fig 15. In-plane damage to unreinforced masonry building, Gao Yuan Village. IMG0569

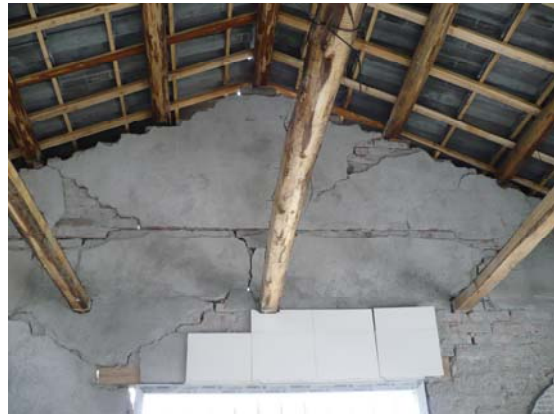
Fig 16. Interior unfinished gable wall, Gao Yuan Village. IMG0573

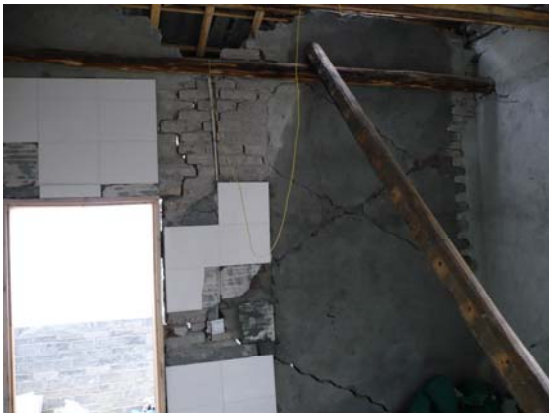
Fig 17. Damaged masonry wall not yet finished with ceramic tiles. Note cracks occur at the interface between brick and mortar. IMG0574

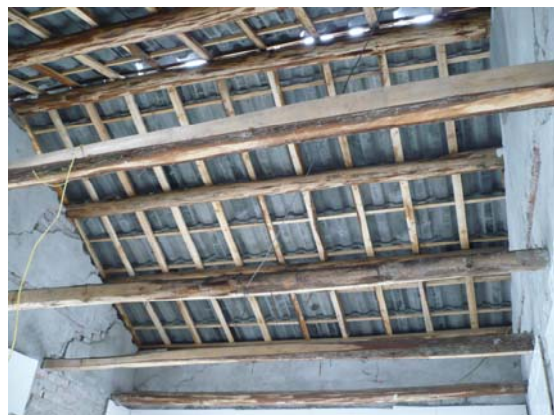
Fig 18. Use of more modern roofing tiles with ridges to prevent displacement. IMG0031

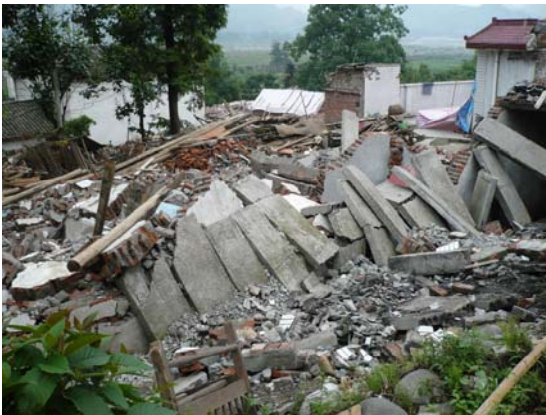
These buildings collapsed in massive numbers. Nearly every pile of rubble observed during the reconnaissance in the rural areas included these precast planks. They were responsible for building collapses in peri-urban areas as well; this structural system is the first collapsed encountered when traveling on local roads out of Chengdu towards Dujiangyan.

Fig 19. Collapsed URM with precast concrete plank, near Xiao Yu Dong Bridge. IMG0433

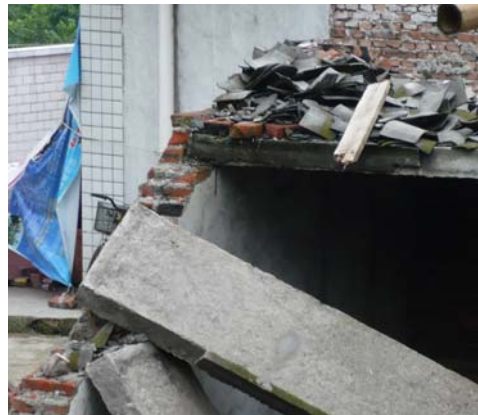
These buildings differ from their URM with timber roof counterparts in that the masonry bonding is usually full-brick wide for the first story, and a second story is common. The second story may use half-brick wide bonding. The precast concrete planks are not connected to the walls, nor were they confined by a ring beam, as is required in the Chinese Seismic code. Some of the planks have very short steel reinforcement available for a connection, but this steel appears to have been bent out of the way and plastered over. The planks are prefabricated by small businesses and sold for around US\$13 per plank, depending on the vendor and the size.

Fig 20. Lack of connection or confinement of precast concrete plank with URM wall, near Xiao Yu Dong Bridge. IMG0431

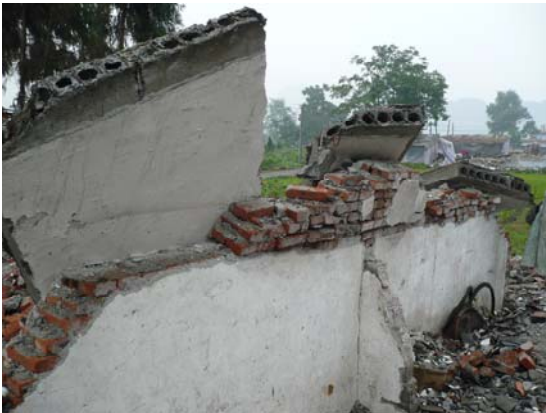
Fig 21. Collapsed two-story, rural unreinforced masonry with precast concrete plank floor and roof, Danan Village. IMG0085

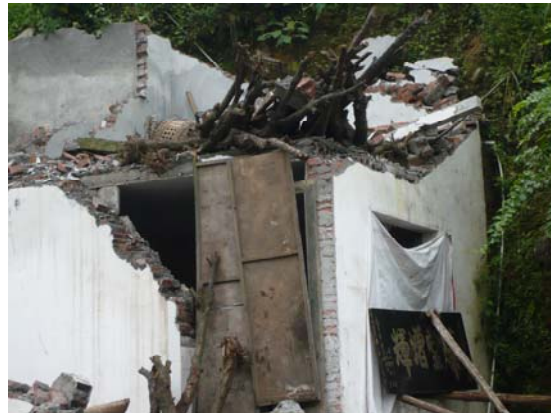
Fig 22. Partially collapsed two-story, rural unreinforced masonry with precast concrete plank floor and roof, near Xiao Yu Dong Bridge. IMG0436

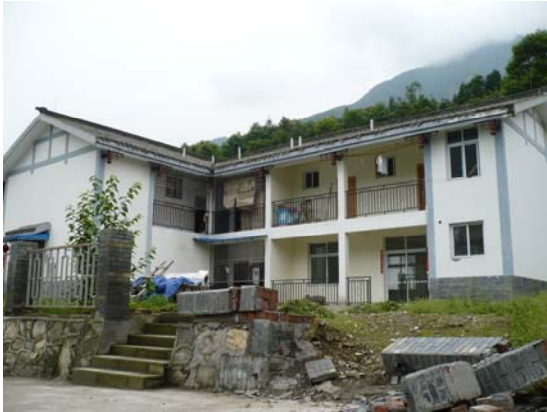
Two-story confined masonry residential buildings built in 2006 reportedly according to the Chinese Seismic Code performed well in this earthquake. Located in Gao Yuan Village, within 500m of evidence of permanent ground displacement and a bridge collapse, no cracks or other damage was observed during a quick survey. These buildings were designed and built by a private company. Efforts to obtain detailed design drawings are currently being made. The walls are full-brick wide, the columns are cast after the wall is built as is typical practice for confined masonry (see an example of the tothing used at another building site near Pengzhou in Fig. 26), and the floors are cast-in-place reinforced concrete slab.

Fig 23. Two-story confined masonry, no damage, Gao Yuan village. IMG0552

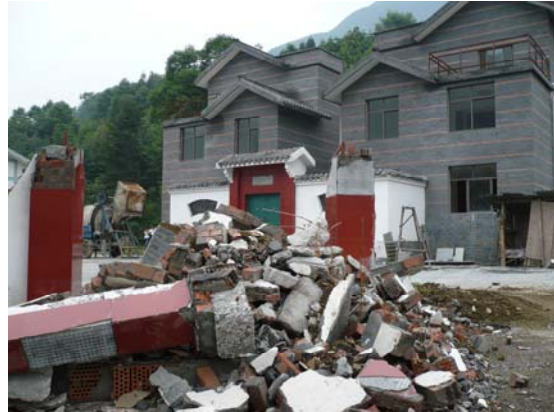
Fig 24. Two-story confined masonry, no damage, tiled exterior, collapsed URM gate in foreground, Gao Yuan village. IMG0545

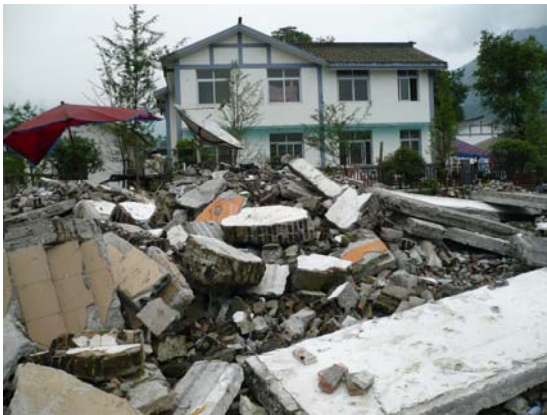
Fig 25. Two-story confined masonry, no damage, collapsed URM with precast plank in foreground, Gao Yuan village. IMG0586

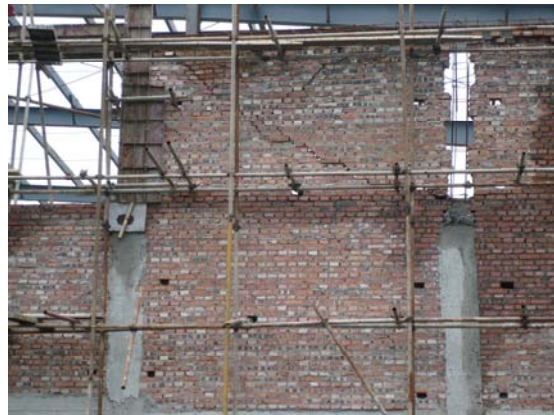
Fig 26. Confined masonry exterior wall for industrial building under construction, note tothing and steel connection between column and wall, near Pengzhou. IMG0347
