## **OVERVIEW**

## Permanent ground displacement and strong shaking appear to have contributed to heavy damage and partial collapse of the bridge near Gao Yuan.

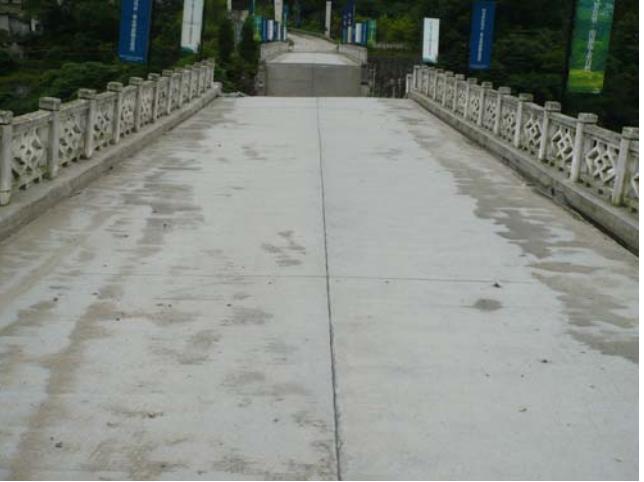
*Fig 1.* Collapsed middle span of reinforced concrete bridge at Gao Yuan, looking south. IMG0490.

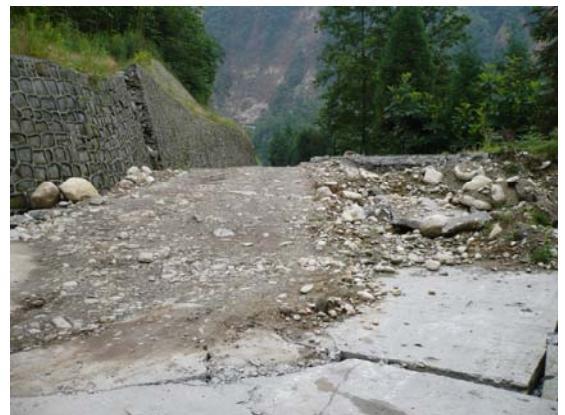
Permanent ground displacement, in the form of extension of a stone masonry retaining wall, heave in the adjacent road, and buckling in pathway, were located near Gao Yuan Bridge. It is possible that these features line up along an E-W trending line. More detailed surveying is needed. The compression of the pathway shown in Fig. X was in a N-S direction.

*Fig 3.* Extension of retaining wall along Chengxiang Road, Gao Yuan Village, looking roughly southeast. Note road has been filled in. IMG0502

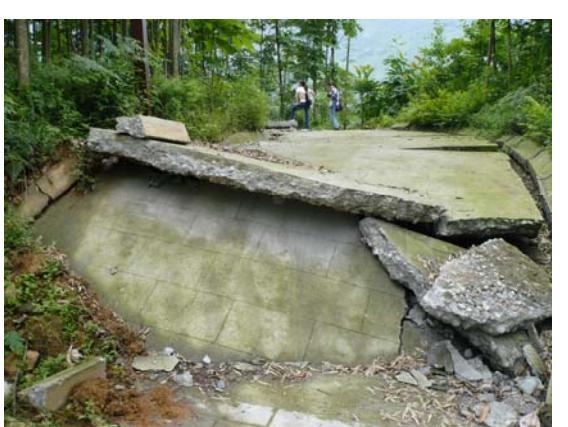
*Fig 5.* Permanent ground displacement along pathway. IMG0511

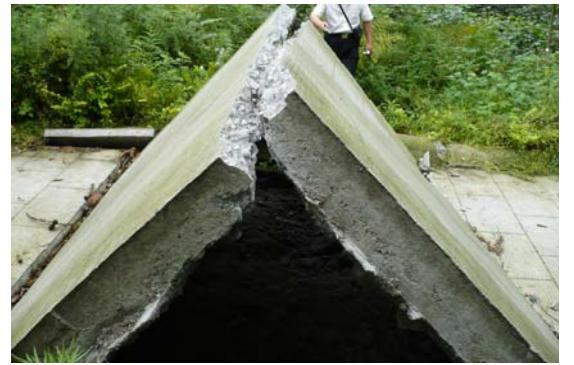
*Fig 7.* Buckling pathway pavement due to compression, of roughly 1m. Looking west. IMG0520

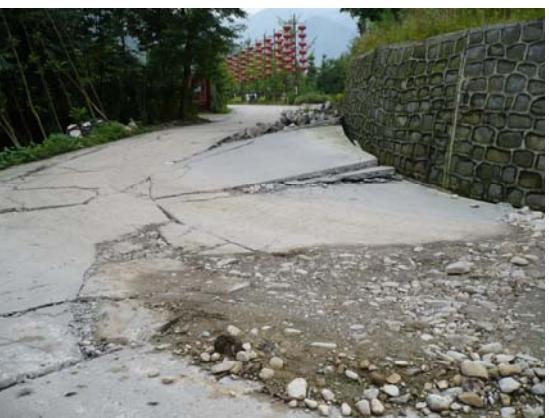
*Fig 4.* Heave along Chengxiang Road, Gao Yuan Village, looking roughly northeast. IMG0503

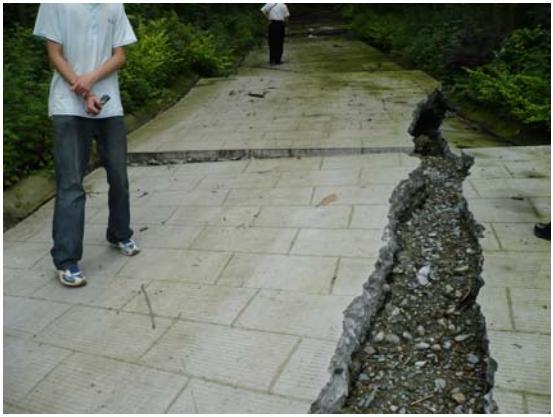
*Fig 6.* Permanent ground displacement along pathway IMG0514

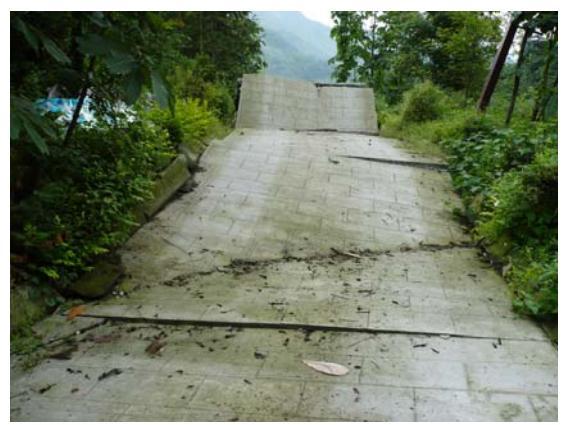
*Fig 8.* Permanent ground displacement along pathway, looking south IMG0525

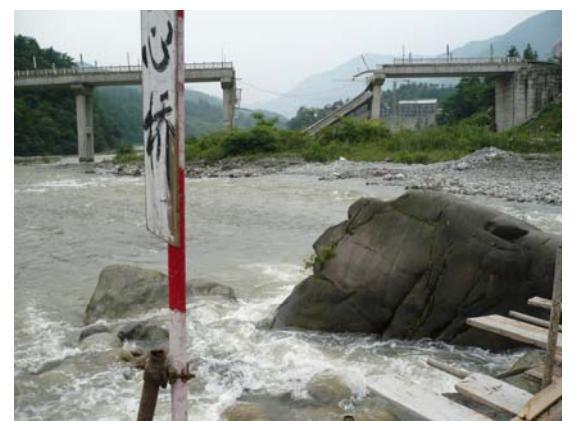
<u>Gao Yuan Bridge</u> This roughly north-south spanning concrete bridge had one collapsed section. The northmost deck shifted into the north abutment and to the west. This extension appears to have contributed to the collapse.

Fig 9. Gao Yuan bridge looking west from temporary footbridge. IMG0458

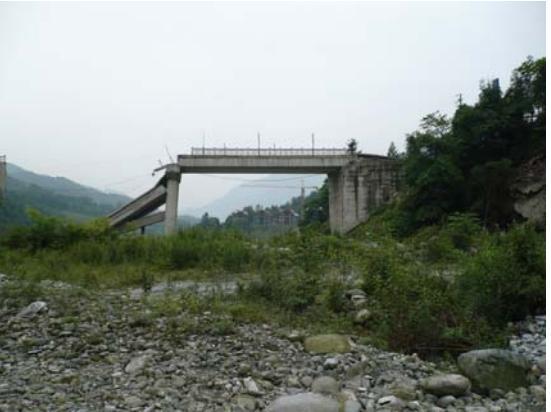
Fig 10. Gao Yuan bridge looking west, note displacement of north deck to the north. IMG0461

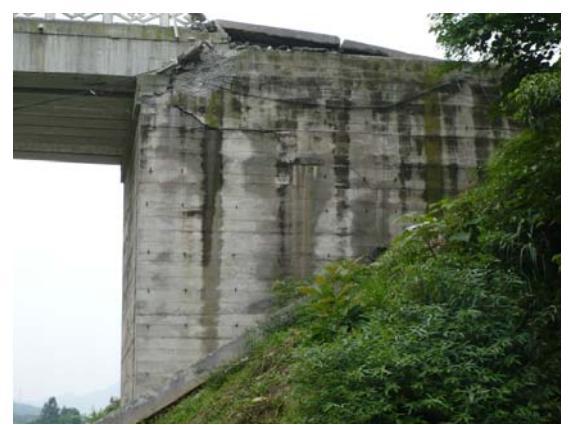
Fig 11. North abutment from the east. Note deck has moved north (or abutment moved south). IMG0463

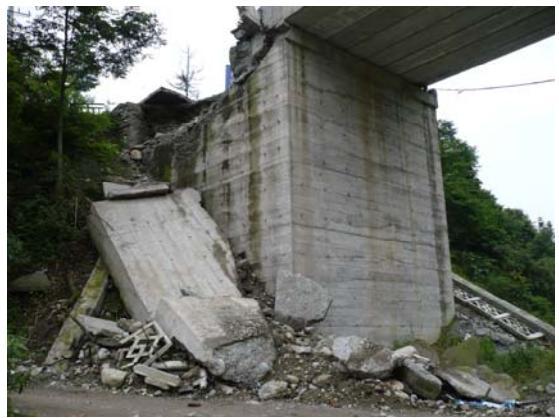
Fig 12. North abutment from the west. Note deck has moved west (or abutment moved east). IMG0476

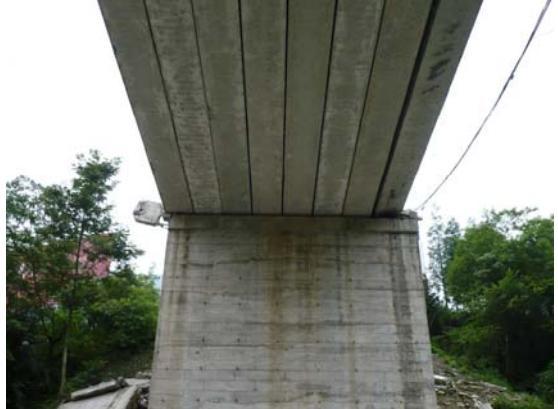
*Fig 13.* North deck, north end. Note displacement to the north and west. IMG0478

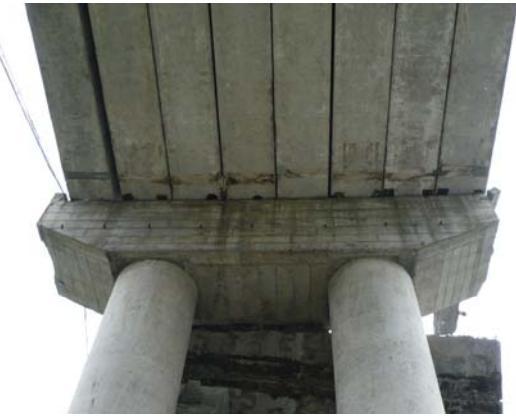
*Fig 14.* North deck, south end. Note deck has displaced to the north. IMG0479

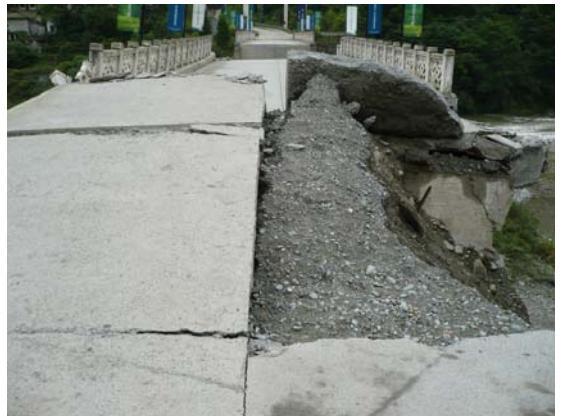
*Fig 15.* Heave and buckling of road on north abutment., looking south. IMG0483

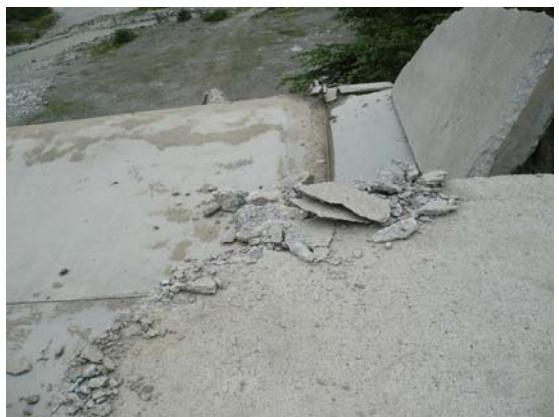
*Fig 16.* Displacement of north roadway over north deck, looking west. IMG0488
