# APPENDIX 2: HOUSING SUBSECTOR STUDY AND DESIGN OF CONFINED MASONRY HOUSES IN INDONESIA

## HOUSING SUBSECTOR STUDY

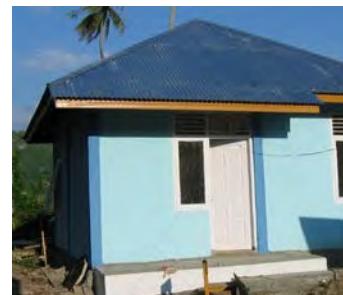
Figure 1. Build Change Pilot Project House, Hipped Roof (Owner: Rusdi Razali).

**Roof.** Roof was made of timber trusses covered by corrugated galvanized sheeting. Both hipped (Figure 1) and pitched (Figure 7) roofs covers with CGI sheets were already

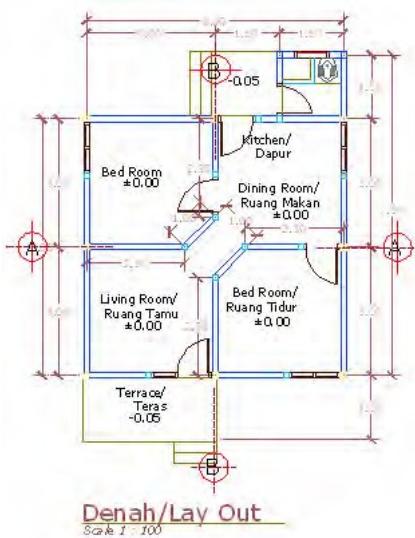
Figure 2. Build Change Pilot Project House, 2 bedroom, living room, dining room, with toilet outside.

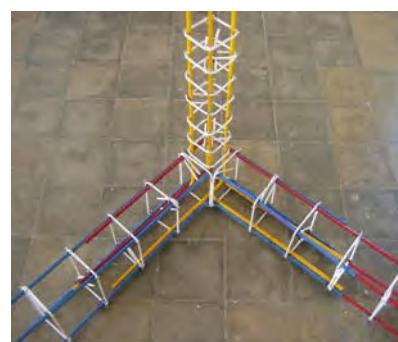
Figure 3. Bond Beam-Tie Column Connection Model. Note it has been suggested that to strengthen the interior corner, the interior long bars should pass through the joint and tie to the external long bars.

- Reduced longitudinal bar diameter and used ribbed instead of smooth: 12mm long bars and 8mm bars for stirrups and ties were too difficult for builders to cut and bend properly.
- Reduced the stirrup and tie bar diameter and reduced the spacing of stirrups at the top and bottom of the columns: again for workability reasons, and to provide increased strength in shear at connections of columns and beams.
- Considered increasing the spacing of stirrups in the bond beams, all of which were resting on a masonry wall or foundation. Our design calculations indicated that greater stirrup spacing was allowed.
- Specified hook length, hook rotation, and joint detailing on the drawings. It was not common practice to call out these details on engineering drawings used in Aceh. See Figs. 3 and 4.

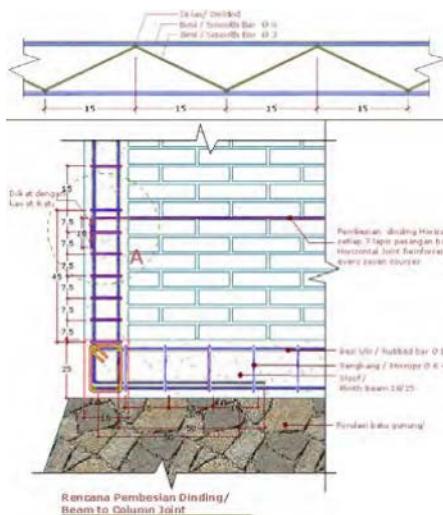
Figure 5. Horizontal Wall Reinforcement.

We opted for the combined solution of additional vertical confining elements adjacent to all large openings, and horizontal steel reinforcement in the wall (Figure 5 and 6). We shifted the openings to the corner locations of major columns so that only one additional tie column would be needed (rather than two, if the openings remained centered). All walls were finished with cement-based plaster and painted.

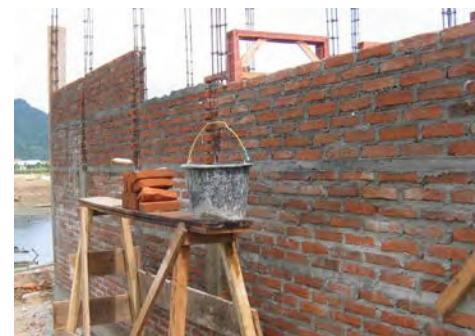
Figure 6. Wall with Horizontal Reinforcement.

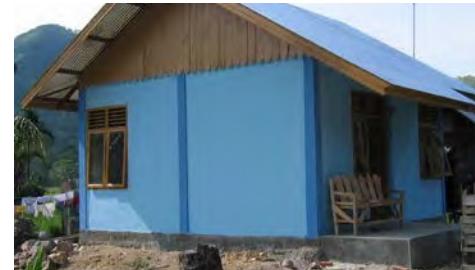
Figure 7. Build Change Pilot Project House, Pitched Roof. Owner: Ruslan AB.

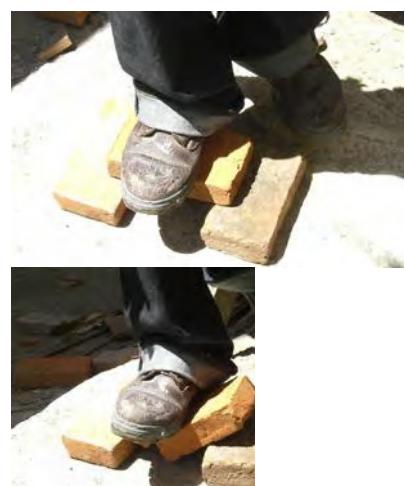
Figure 8. Three point bending test for brick strength, use average size Indonesian male, no bouncing

at several kilns to determine which vendors to purchase from. The type of clay and the firing process had the biggest impact on brick quality. Many brick producers had access only to a source of clay that was prone to warping and shrinking during firing. The length of burn, fuel used in burning, and the location of the brick in the kiln also strongly influenced its properties. Bricks at the top of the kiln were rarely completely fired, and would erode or crumble in the rain. We used simple three-point bending tests (see Figure 8) and the following checks to evaluate brick strength in the field.

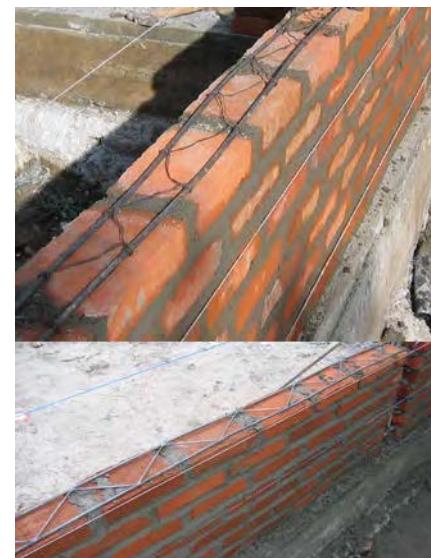
Figure 9. Horizontal reinforcement fabricated on-site with binding wire (top) and prefabricated at welding shop (bottom).

**Durowall-Type Reinforcement.** This truss type reinforcement was initially assembled on-site by the builders using two 6mm diameter bars tied together with binding wire in a truss pattern (Figure 9, top). This process was time consuming, and consistent separation between the long bars was difficult to

maintain due to flexibility of the binding wire. We switched to a welding school to prefabricate the reinforcement using 3mm bars as the diagonals (Figure 9 bottom). When the welding school could not meet our demand, we used private sector local welding shops.

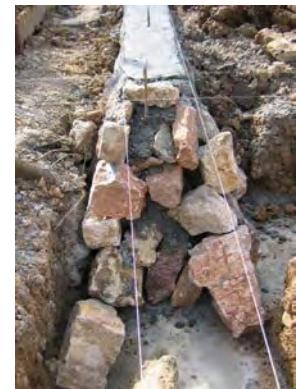
Figure 11. Poorly built stone masonry foundation. Note gaps between stones, stones standing on end.

**Stone Masonry Foundation Wall Construction:** At the base of the excavation, we used a weak screed layer instead of the more common layer of loose cobbles. The challenge with the stone masonry foundation was to ensure the builders filled all the gaps between the stones with mortar, laid the stones down rather than standing them up, and used long stones at corners and T-junctions. See Figure 11 for an example of a poorly built strip foundation.

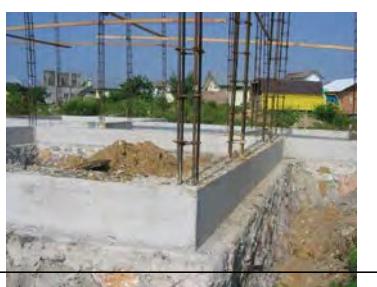
Figure 12. Typical Build Change foundation (plinth) beam, Build Change-designed house for CRS

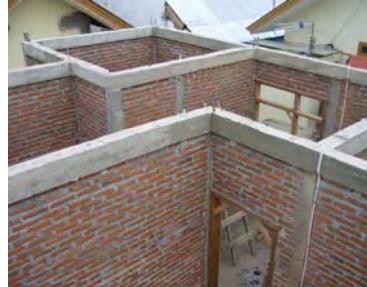
Figure 13. Typical Build Change ring beam, Build Change-designed house for CRS

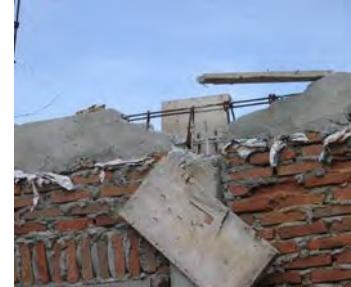
Figure 14. Bad practice, connections and concrete quality, other organizations

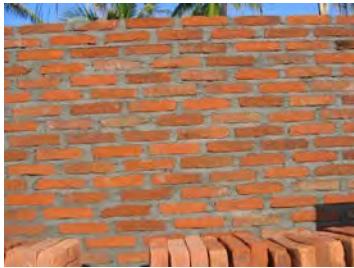
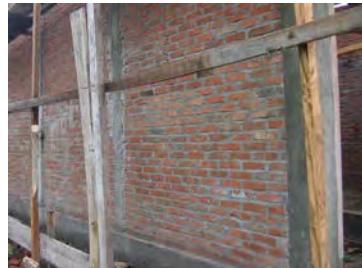
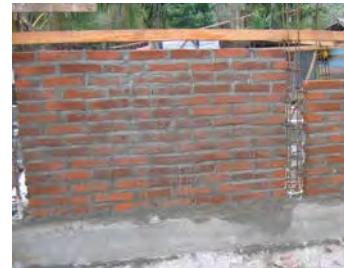
Figure 15. Typical wall built by Build Change-trained mason

Figure 16. Typical wall built by Build Change-trained mason

Figure 17. Typical wall built by Build Change-trained mason

strong bond. We promoted wetting or soaking the bricks prior to building the wall.<sup>11</sup> In addition, we stressed uniform joint thickness no greater than 15mm, filling the joints completely with mortar, staggering the vertical joints, and ensuring the wall remained plumb. Some examples of masonry produced by Build Change-trained masons vs. that produced by other organizations, are shown in Figs. 15 through 20.

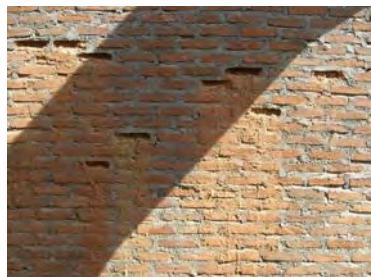
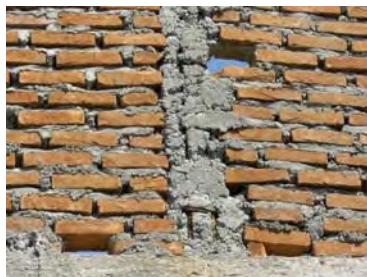
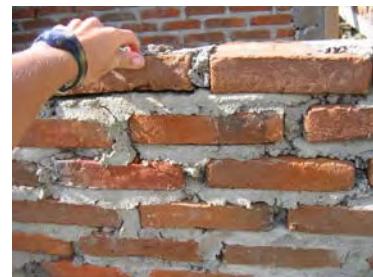
Figure 18. Typical wall built by other mason

Figure 19. Typical wall built by other mason

Figure 20. Typical wall built by other mason

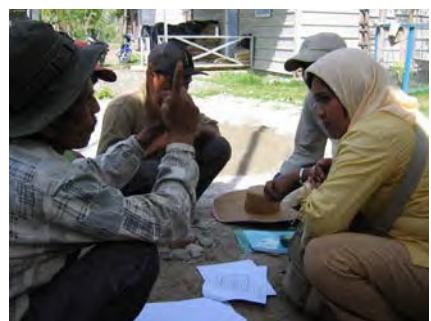
Figure 21. Builder, homeowner, Build Change architect, and Build Change engineer discuss ring beam-truss detail

**Carpentry:** Carpentry was the least challenging aspect of the construction process; we found many skilled carpenters, some of whom suggested changes to our truss details that made them simpler to build (Figure 21). The primary challenge with the timber elements was that some of the window and door frames were produced with timber that wasn't totally dry. The frames would look straight and square when we accepted the order from the vendor, but a few days in the tropical sun, and some of them would warp or split.
