APPENDIX IV: CASE STUDIES: NEPAL AND PERU

SEISMIC RETROFITTING OF NON-ENGINEERED MASONRY IN RURAL NEPAL

Proceedings of the Institution of Civil Engineers: Structures and Buildings, Vol. 64, Issue 6, May 2012.

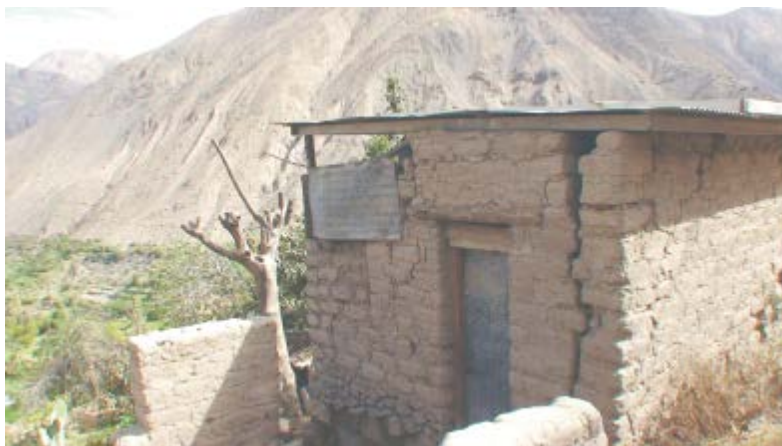
Figure 1. Non-engineered adobe house in Peru showing vertical crack and separation of orthogonal walls owing to out-of plane forces

Structural collapse under seismic loading displays many possible failure mechanisms often related to the interaction between structural components (e.g. separation of walls or floor–wall connections). When considering individual walls, earthquake loading can have components both within the plane of the wall (in-plane, Figure 5) and orthogonal to the plane of the wall (out-of-plane, Figure 1).

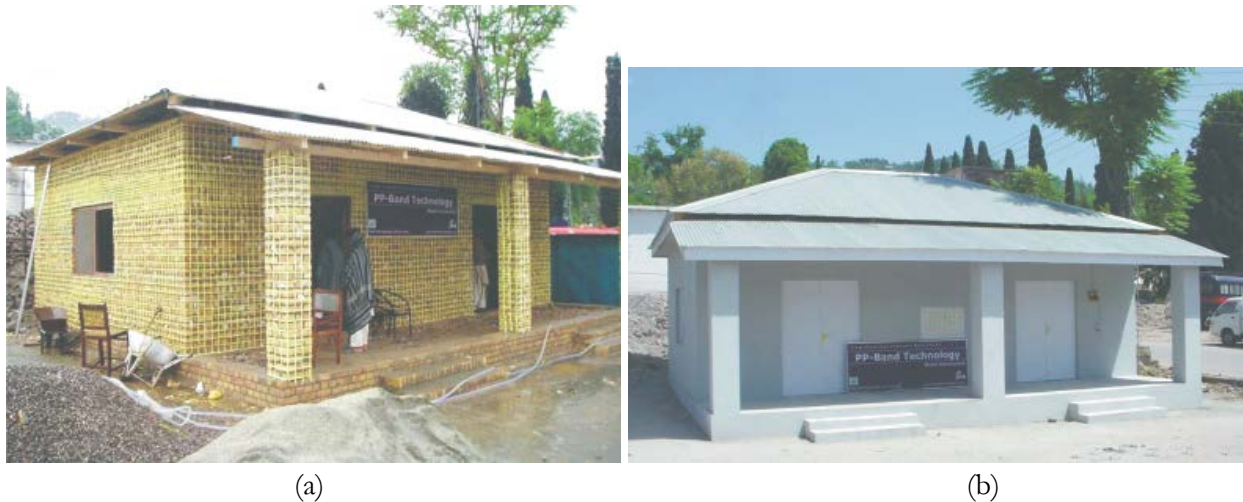
Figure 4. Retrofitted house in Pakistan before and after application of covering mortar layer. Note that the mesh is also applied to the inner face of the walls, with inner and outer meshes connected with through-wall ties. Photograph: Meguro Lab, Tokyo University

The mesh is formed by arranging the individual bands into a grid and electrically ‘welding’ at intersecting points (using a plastic welder such as that shown later in Figure 15(c)). Each wall to be retrofitted is stripped of existing render or covering, holes are drilled through the wall at regular spacing, anchor beams are installed at ground level (Figure 15(a), see later) and a ring beam at top of wall level if lacking. The mesh is connected to both faces of the wall, fixing to the anchor beams and ring beam and passing through openings and around corners with sufficient overlap. Meshes are connected together through the wall by wires passing through the previously drilled holes. Finally the mesh is rendered over protecting the mesh from sunlight, improving fixity to the wall and making the retrofit invisible (Figure 4).

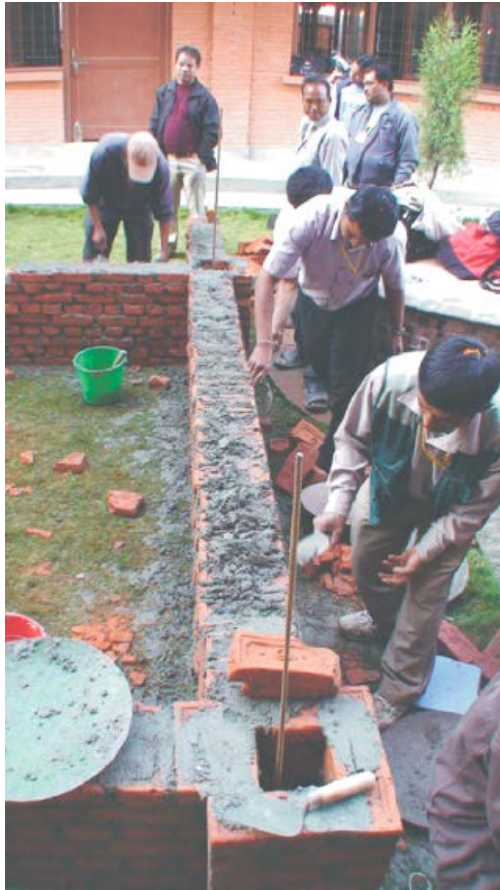
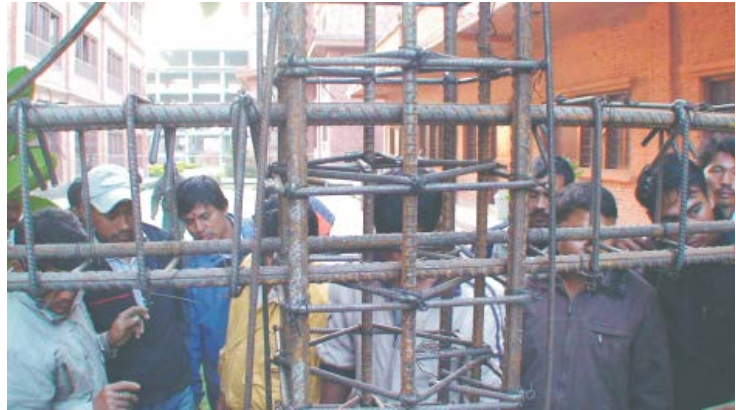
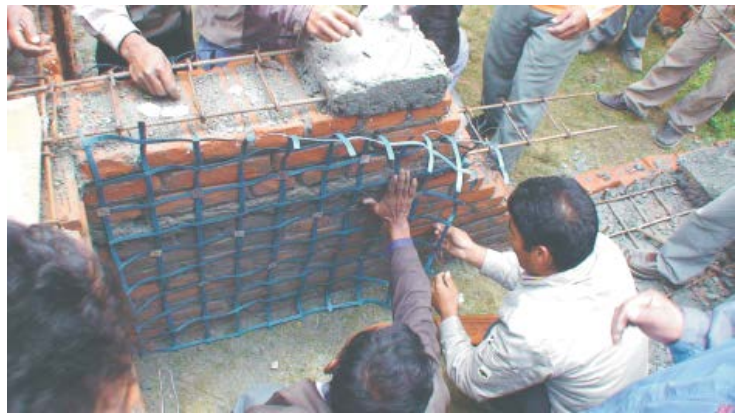
Figure 13. Six-day training programme for rural masons, Bhaktapur, Nepal 2008

Figure 13(c) shows a simplified introduction to applying the PP mesh to a masonry wall. Note that the PP mesh would not usually be applied in conjunction with internal reinforcement but was applied to the reinforced masonry model (Figure 13(a)) purely as a simple tool for demonstrating the basics of applying the mesh. During the course it was stressed that PP retrofitting is intended for use with adobe where holes can be drilled through bricks as well as mortar, allowing more accurate spacing of through-wall connectors, giving a tighter mesh. The real retrofit is also continued and overlapped around corners and through openings and connected to the foundations and ring-beam (Figure 15, see below).

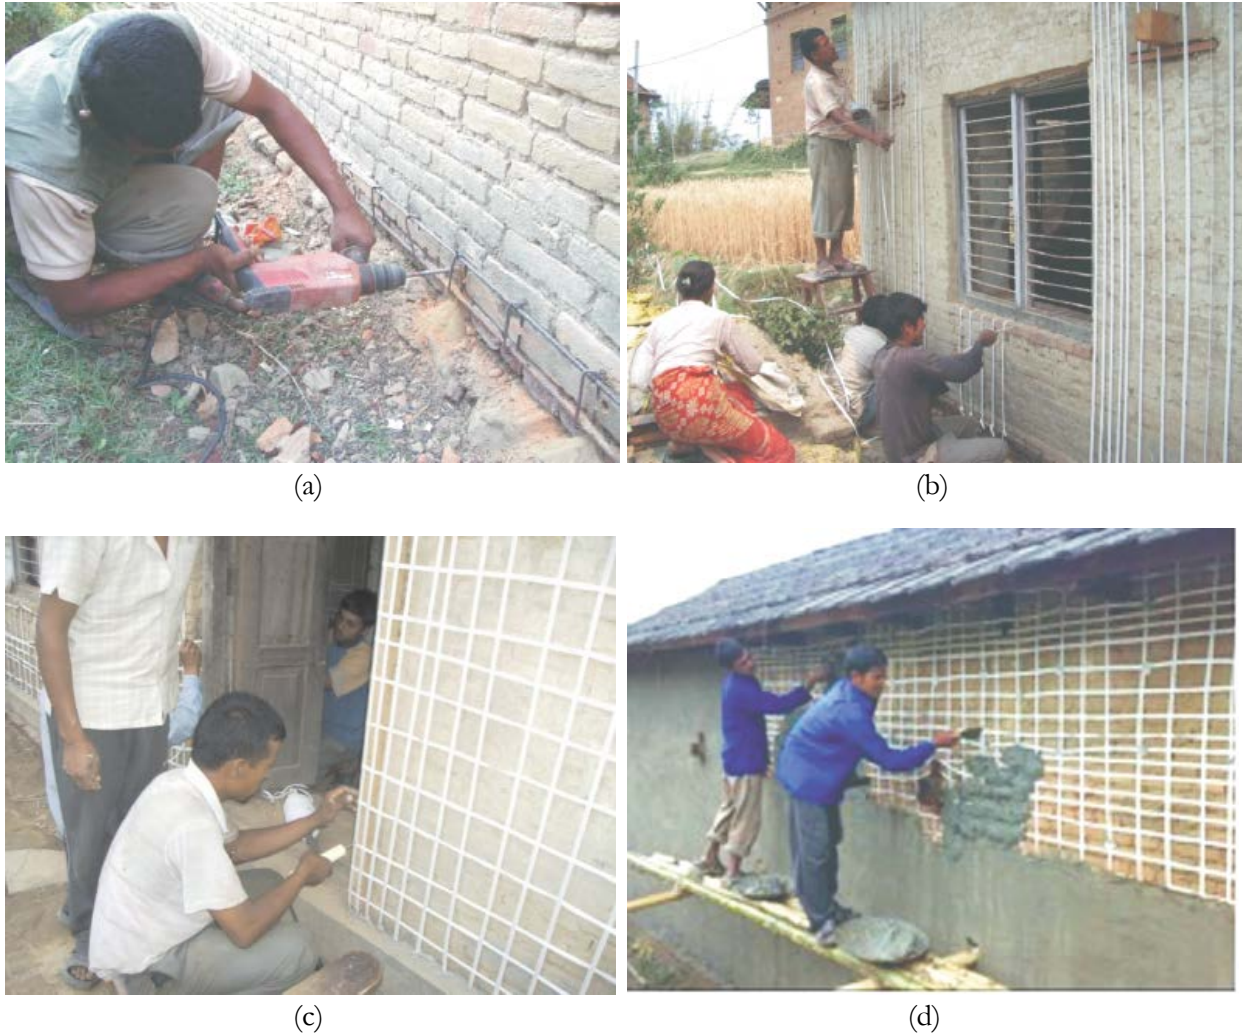
Figure 15. Retrofit of a real adobe dwelling, Nangkhel, Nepal 2009. Photographs: NSET

The general process of the retrofit can be seen in Figure 15. An anchor beam was first fixed to the base of the wall inside and out; vertical PP bands were fixed between the internal and external base anchor beams; horizontal bands were then woven between and welded to the vertical bands; meshes on opposite faces of each wall were connected to each other through the wall by steel wires passing through drilled holes; finally a render was applied to cover the mesh. Note that this house also required additional refurbishment work in replacing rotten floor and roof beams and infilling unnecessary openings.

The work was carried out by one NSET technician, two masons and two unskilled labourers over 4 weeks. The material costs associated with the PP retrofit came to \$250. Details on full-scale retrofitting and the process described here are given in the final report of the implementation work (NSET, 2009).

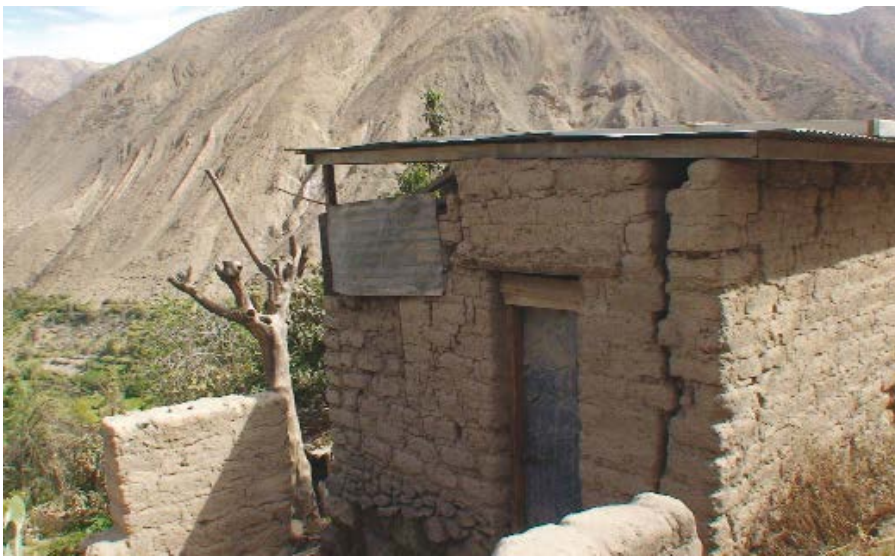
Fig 1. Non-engineered adobe in Condesuyos, Peru. Vertical crack typical of poorly bonded orthogonal walls. Walls are adobe blocks laid in mud mortar. Roof consists of timber planks covered with corrugated sheeting

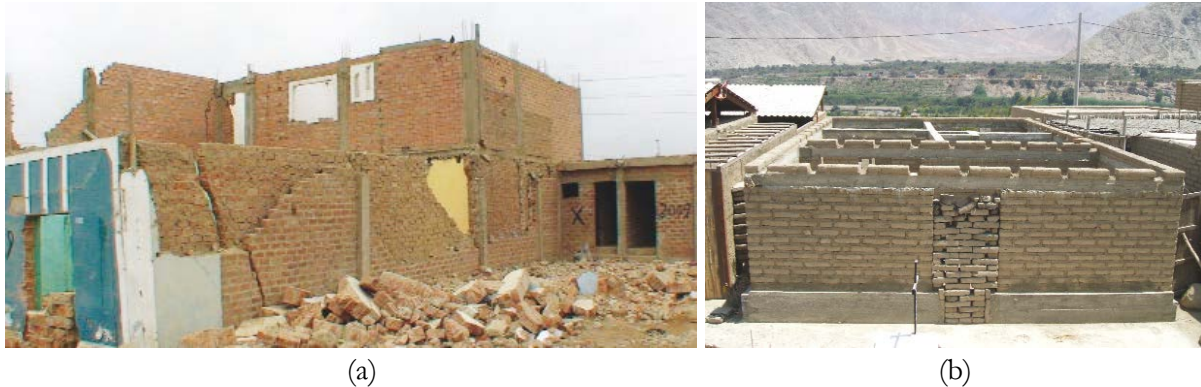
Fig 3. Non-engineered structures using modern construction methods resulting from the negative perception of adobe but limited means of the homeowner: a) Non-engineered confined masonry dwellings in Chíncha that performed badly in the 2007 Peru earthquake b) Non-engineered hybrid structure in Lunahuaná displaying slender adobe walls with long clear spans supporting a heavy concrete ring beam with no vertical tie members

More modern construction methods are beyond the means of a large proportion of the population in remote rural areas. However, adobe is often associated with poverty meaning that those with limited means are opting for non-engineered masonry or confined masonry leading to poor quality construction (Fig 3a) or vulnerable hybrid structures, combining materials inappropriately (Fig 3b).

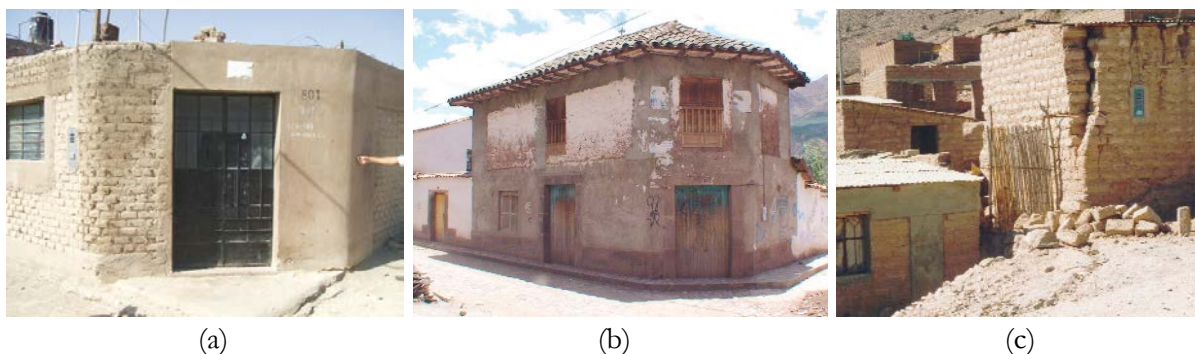
Fig 4. Existing adobe houses retrofitted with steel mesh reinforcement: a) Partially reinforced wall in La Tinguiña. Performed well in the 2001 earthquake b) Two-storey reinforced house in Andahuayllillas, Cuzco c) Reinforced house in Moquegua without damage after 2001 earthquake and neighbouring unreinforced house with severe damage (Quiun)

20 existing houses in six towns across Peru were retrofitted with the steel mesh as pilot projects, with five of these being two-storey accommodations. Six retrofitted houses were affected by a major earthquake in 2001 (South Peru, $M_w = 8.4$) and five retrofitted houses by an earthquake in 2007 (central Peru, $M_w = 8$). These houses demonstrated no visible damage, while neighbouring houses of traditional adobe without reinforcement showed heavy damage or complete collapse (Fig 4c).

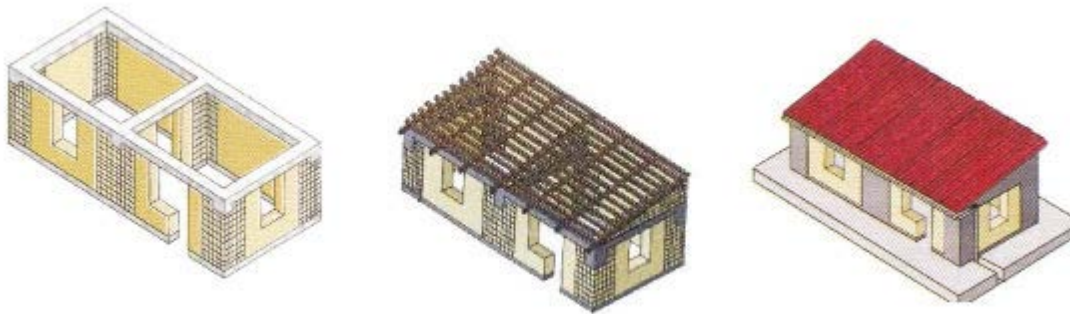
Fig 6. House design for reconstruction programme. Incorporates steel wire mesh at intersection of orthogonal walls, RC ring-beam and raft foundation (San Bartolome)

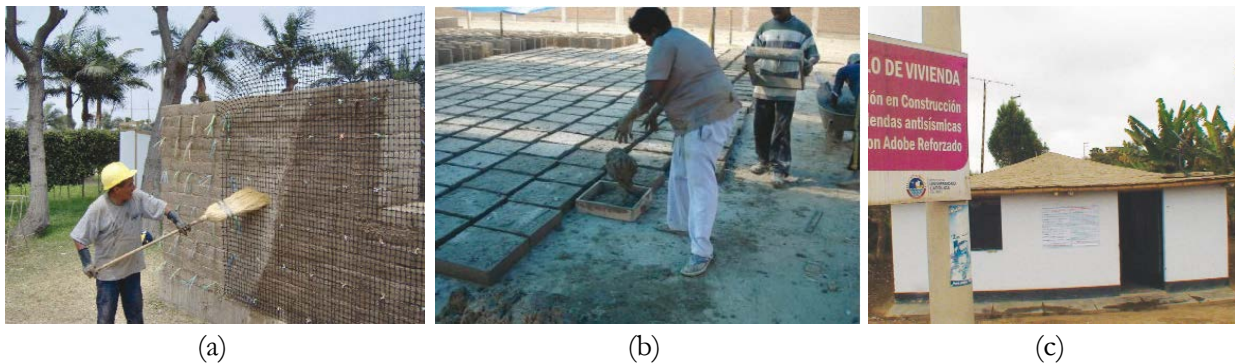
Fig 7. Various stages of the post-2007 reconstruction and capacitation programme: a) Example house reinforced with the plastic mesh, used during the initial training of masons, engineers and NGO personnel (Rubiños) b) Fabrication of adobe blocks in Cañete, carried out by hired masons (Rubiños) c) Completed house in Chinchá Baja, constructed by the public under supervision (after theoretical workshops and practical exercises). Nine houses were completed throughout Cañete, Chinchá and Pisco

Key stages of the project are shown in Fig 7. The community capacitation programme incorporated literature and videos and taught 883 in theoretical workshops and 276 in practical exercises and live construction. The construction of each four-roomed, 50m² house cost \$3155 (\$65/m²).

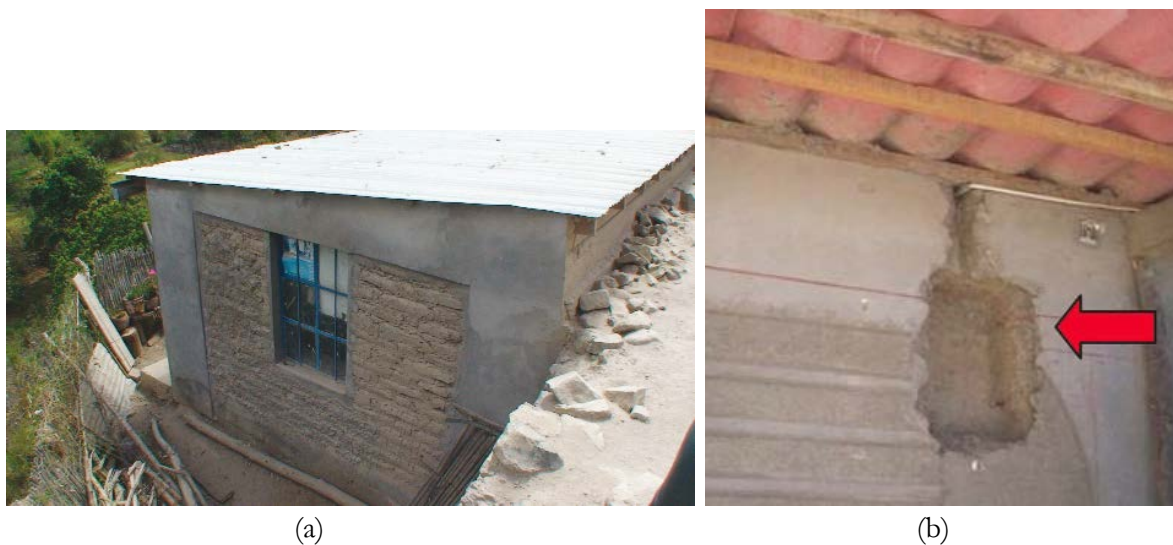
Fig 9. 2001 reconstruction project in Arequipa: Errors in construction or subsequent modifications: a) Rear wall being used as retaining wall to a public road b) Holes cut into wall for electrical and mechanical services, undermining the wall connection and forming a hole in the reinforcing mesh [photo: Chuquimia]

All of the houses built during the programmes described were performing well but several non-reinforced adobe structures built by communities after the programmes showed errors (Fig 9), showing that many lessons had been lost because of no further training input after the initial programmes.
