## Overview

Two devastating events occurred in the Philippines towards the end of 2013: a M7.1 earthquake on the island of Bohol on October 15, 2013, and typhoon Yolanda, which affected several islands on November 8, 2013.

### **Structural Damage Assessment**

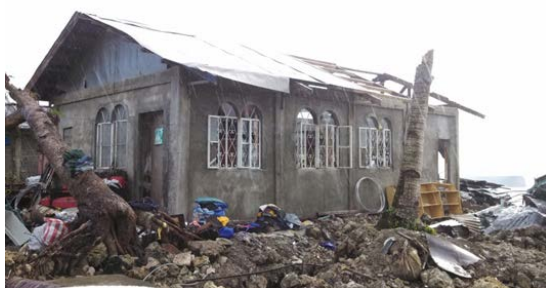
door openings are typically unconfined. Out-of-plane failure was found in almost all buildings without a ring beam. Buildings with a ring beam exhibited much greater capacity and first failed out-of-plane at the unconfined openings. Failure did not typically occur at the wall-column joint, which is common in many other countries, because builders in the Philippines tend to use mortar bed dowels to connect walls to columns. Most connections between reinforced concrete elements are made with hooks that are too short, and have therefore failed. Global wall overturning due to a lack of foundation connections was frequently observed. Deformed rebar is much more common than smooth rebar in the Philippines, but unfortunately many failures of RC confining elements were observed as a result of insufficient bar lap lengths, often only 2" or 3". RC slab roofs also fared well. It is not common to see concrete slab roofs on these houses, although on nicer, more expensive houses they are more common, especially in sloped configurations. Because the majority of the wind force on roofs is uplift, the heavier concrete roofs would be expected to perform better. (As will be seen in the earthquake section below, however, houses with these heavy roofs did not perform well under seismic load, where the roof force is sideways and must be transferred to the walls below.)

**Figure 25.** One-story confined masonry house on Leyte that survived the typhoon

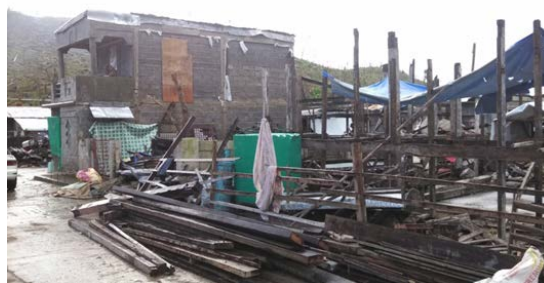
**Figure 26.** Two-story confined masonry house on Leyte that survived the typhoon (although it lost its wood framed roof)

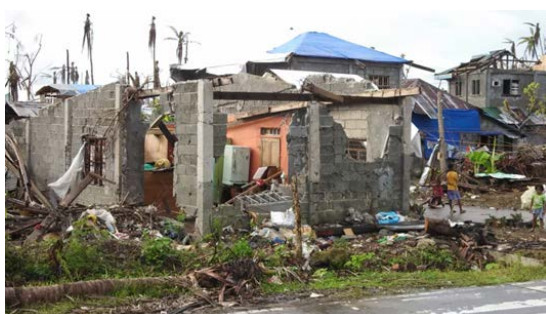
**Figure 27.** Destroyed masonry house on Leyte (example 1)

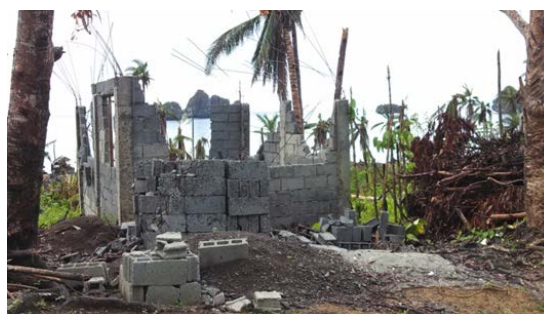
**Figure 28.** Destroyed masonry house on Leyte (example 2)

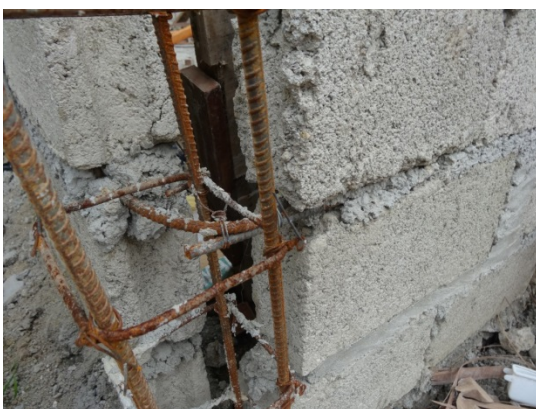
**Figure 42.** Confined masonry building under construction on Bohol using earthquake-resistant construction technique of wall dowel extending into column joint.

→ **Recommendation 8:** Use rebar dowels or masonry tothing to connect masonry walls to columns. Build the walls before pouring the columns and ring beam.

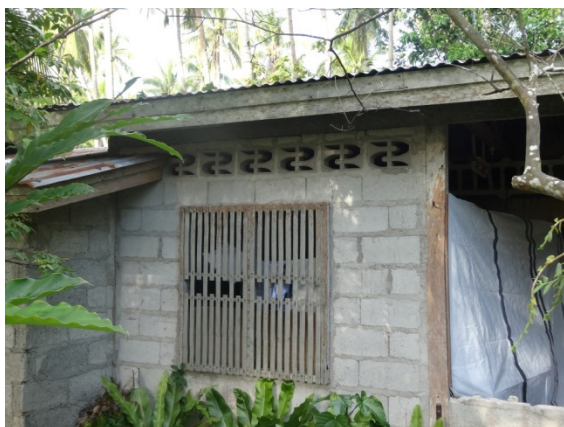
3. Other houses had a **hybrid system of timber and masonry**, such as timber frames with six-to-eight inch diameter log columns and ring beam with concrete block masonry infill walls. Because of the incompatibility in ductility between masonry and wood (wood can accommodate a lot more movement in an earthquake, whereas URM is brittle), in most of these structures the infill walls failed while the post and beam structure remained supporting the roof or often even a second floor. Infill URM panels will not give lateral strength to a timber frame. Under seismic load they will explode and fail well before the timber frame reaches its deflection limit. The timber frame should be well-braced with diagonal wood bracing in all directions.

**Figure 49.** Wood post with masonry infill on Bohol

→ **Recommendation 12:** Use diagonal bracing to strengthen column-beam connections.

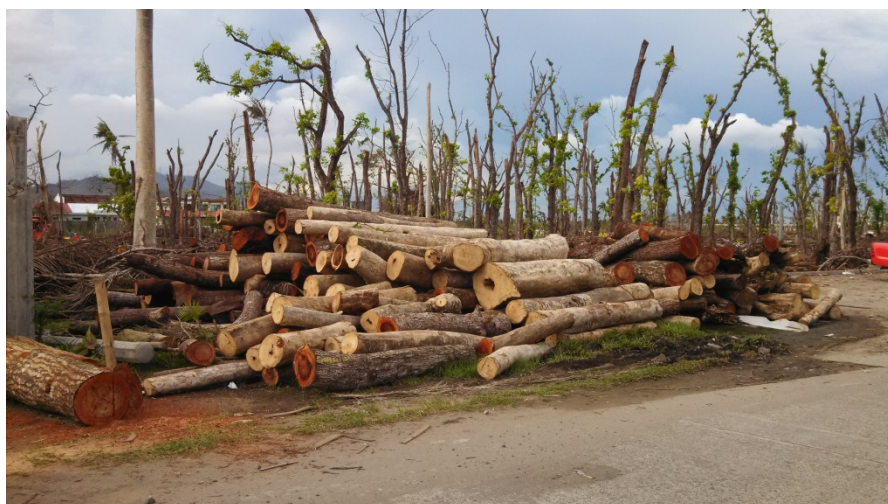
**Figure 54.** Fresh timber from coconut trees downed by Yolanda is available for construction on Leyte. This is all that is left of what was a forest. Collection, milling, and reuse of this downed timber should be encouraged and supported. The typhoon zone should be trading coconut lumber for mahogany from Bohol.

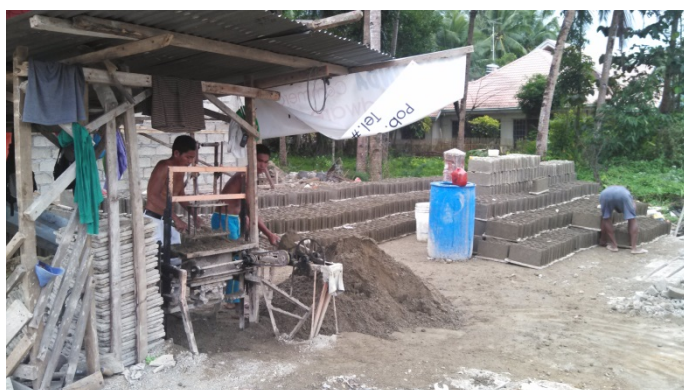
Masonry materials quality, however, is substandard. Concrete blocks are locally made in hand-filled four-inch-wide molds with aggregates of limestone, coral, and seashells, and are weak and unsuitable for structural use. Although good quality deformed Grade 40 rebar is almost universally used, concrete and concrete blocks suffer from a lack of sufficient cement, poor aggregates, and inadequate curing. For larger projects where building codes are enforced, quality aggregates are imported from neighboring volcanic islands, but for poorer populations the cost of these housing materials is prohibitive.

**Figure 57.** Workers making concrete blocks on Bohol. Note that the blocks are curing in the sun. They will be sold the next day.

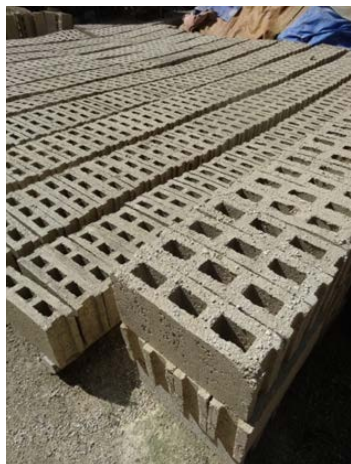
**Figure 59.** Concrete blocks on Bohol. Note the tan color, a combination of poor quality aggregates and insufficient cement ratio.

→ **Recommendation 2:** Use strong concrete blocks. Don't use blocks that break when dropped on the flat side on hard earth from chest height. Find a seller that makes stronger blocks.

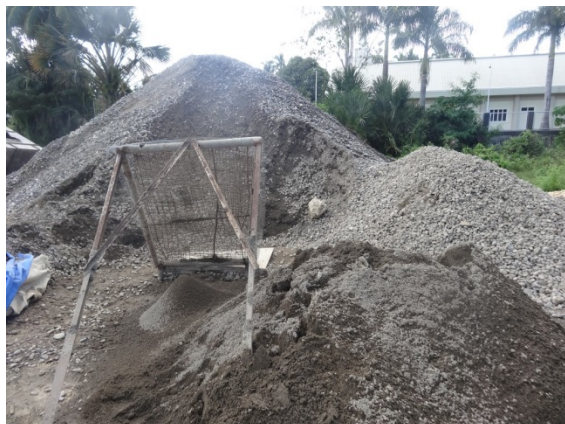
**Figure 63.** Local aggregates on Bohol

→ **Recommendation 10:** Don't use limestone, coral, or beach sand as aggregates to make concrete or concrete blocks.

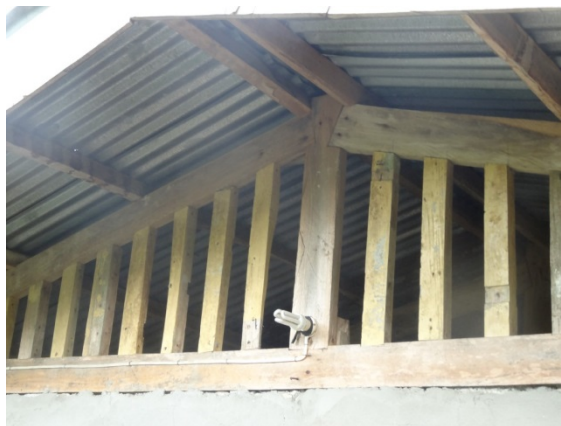
Aside from structural connections, carpentry skills in Bohol are generally excellent, with joinery commonly notched and housed. On the other hand, masonry skills are poor on Bohol as in the rest of the Philippines, with consistent examples of high-quality, safe masonry or concrete construction found only in commercial and public buildings or higher-end residential construction.

**Figure 72.** Timber roof connections on Bohol
