APPENDIX I: UNDERSTANDING CAUSES OF COLLAPSE OF CONFINED MASONRY HOUSES IN INDONESIA

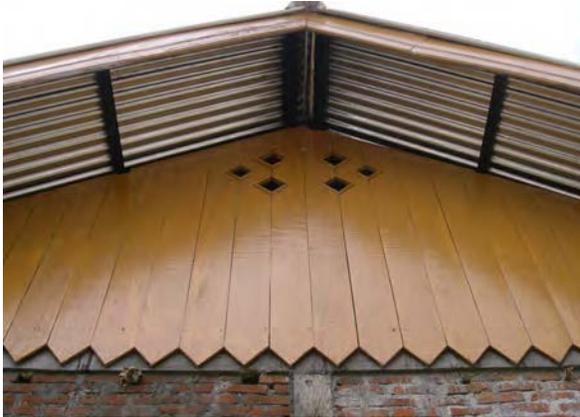
Figure 6. Papan Gable (Maimunah's house designed and built by Build Change, Keunue ue, Peukan Bada, Aceh Besar)

Solution: REMOVE THE MASONRY ABOVE THE RING BEAM: Shift the truss over to rest on the wall and use a timber or other lightweight cover (Figure 6). Alternatively, use a hipped roof (Figure 7) which is the lowest cost alternative, and also performs better in high winds.

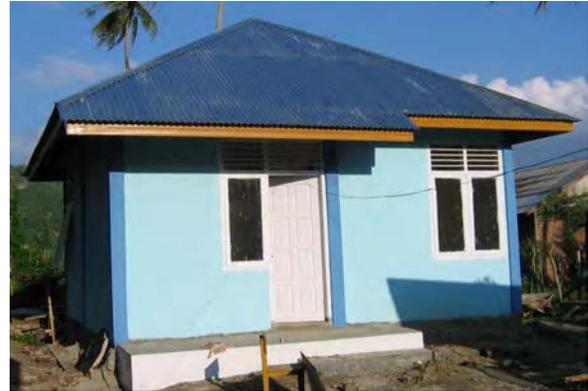
Figure 7. Rabung Empat Roof (Rusdi Razali's house designed and built by Build Change, Keunue ue, Peukan Bada, Aceh Besar)

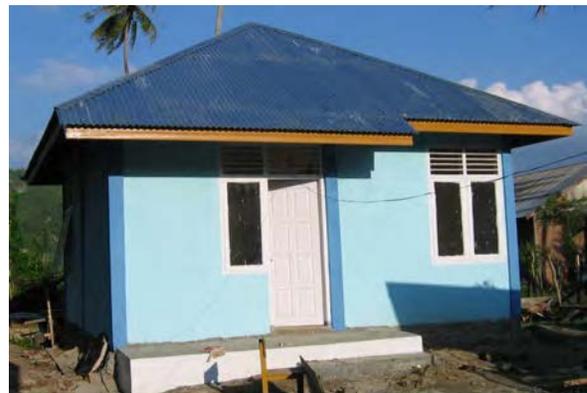
Figure 10. Rabung Empat Roof (Rusdi Razali's house designed and built by Build Change, Keunue ue, Peukan Bada, Aceh Besar)

Solution (Figure 10):

- (1) Reduce the weight above the openings by following the previous recommendation about gable walls,
- (2) Reduce the number and area of windows, and consolidate them to provide longer, continuous shear walls,
- (3) Add vertical confining elements to all openings with area greater than 2.5m^2 . To reduce cost, shift openings from the middle of the panel to the corner, and
- (4) Add horizontal reinforcement to the wall every seven courses and above and below openings.

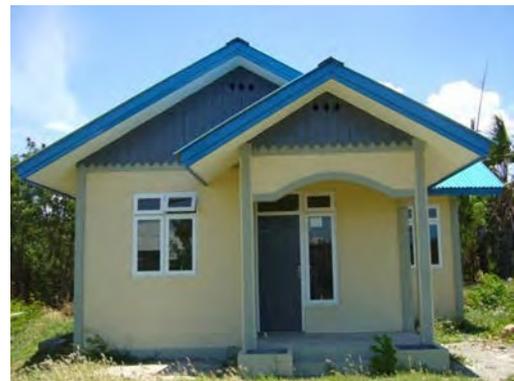
Figure 15. Covered terrace with lightweight wall, Build Change designed house for Catholic Relief Services (Aceh Besar)

- (1) Avoid the covered terrace by using a simple extended overhang, as shown in Figure 10. Note that this requires good quality timber, or bracketing to support the overhang. Or,
- (2) Reduce the mass above the open frame by replacing the masonry, and ensure the connections are detailed properly (Figure 15).
