## **OVERVIEW**

## Permanent ground displacement and strong shaking appear to have contributed to heavy damage and partial collapse of the bridge near Gao Yuan.

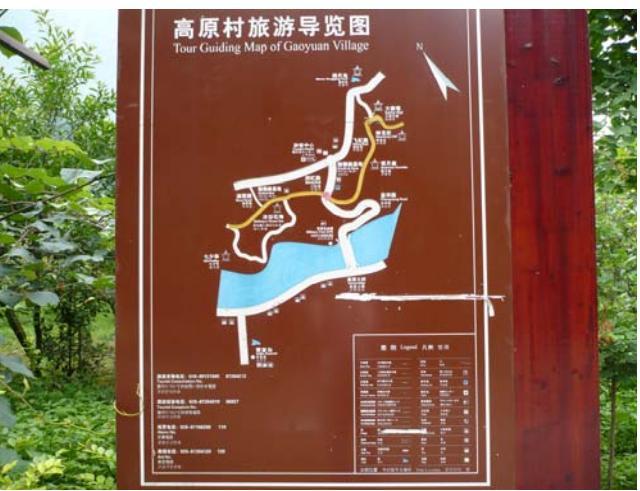
*Fig 2.* Tourist Map of Gao Yuan, note location of retaining wall and road heave near pink dot, pathway buckling to the east along the yellow road. IMG0509.
