LONG-TERM CHANGE IN CONSTRUCTION PRACTICE THROUGH POST-EARTHQUAKE RECONSTRUCTIONS

Elizabeth HAUSLER¹

SUMMARY

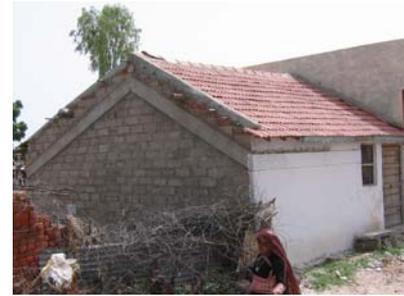
Fig. 1. Missing gable band, seismic belt added (Bhuj EQ)

- Although Bhuj guidelines cover a gable roof with tiles on timber rafters and purlins, they are vague in their guidance on the proper connection between the gable band and the roof structure. Most of the pitched-roof, owner-built houses surveyed in the Bhuj area visit had omitted the gable band (Fig. 1).
- In the Chamoli reconstruction guidance, design of an RC slab roof was omitted completely; yet most owners who built new houses opted for an RC slab.
- Masonry confined by RC columns and beams was prevalent in all three affected areas for houses built by wealthier owners.¹ Although the Indian Seismic Standards address reinforced concrete detailing, no guidance was produced for this type of construction. Many design and construction quality issues were observed (e.g., Fig. 2).

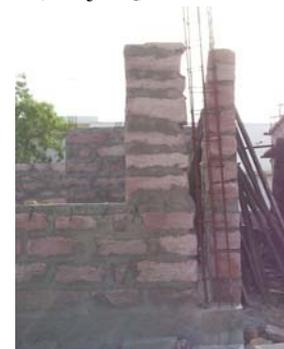
Fig. 2. Confined masonry under construction, note large openings, wide gap between stone and rebar, rebar out of plumb (Bhuj)

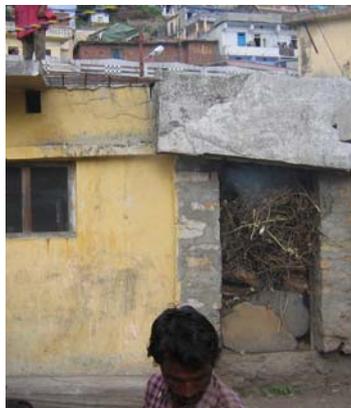
Fig. 3. Partially collapsed, newly built RC slab roof (Chamoli EQ)

The house should be durable, or capable of withstanding earthquakes, heavy rainfall and other natural conditions throughout its useful life. For example, Fig. 3 shows an RC slab roof overhang that partially collapsed shortly after construction. A precast plank and joist system used in the Chamoli reconstruction was widely reported as prone to leakage and cracks (Fig 4).

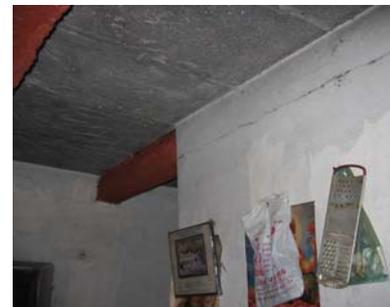
Fig. 4. Precast plank and joist system with crack along joist-wall interface, leakage between planks (Chamoli EQ)

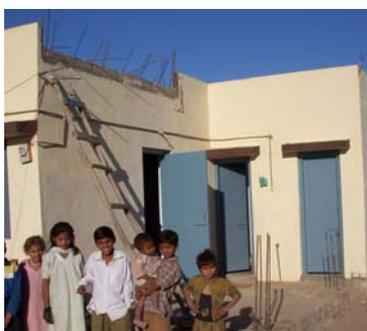
Fig. 5. Preparations for a second story. Toilet on right. (Bhui EO)

- If a structure is built with a flat roof, it is likely that a second story will be added as the family expands (Fig. 5). Many foundations for one-story structures with flat roofs were not designed to carry the load imposed by a second story.

windows, some homeowners blocked in openings and created others in more preferable locations. Not a single homeowner interviewed expressed a preference for locating the toilet and bathing facilities inside the main living area; all residents prefer a separate structure with a separate entrance (Fig. 5). Those toilets that were built inside the structure were used as storage spaces. Provisions for shelves, fan fixtures, and traditional or religious features were also absent in some of the donor-built houses.

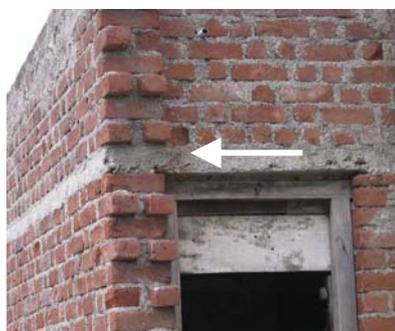
Fig. 6. Masonry bond for extension; short rebar length (Killari EQ)

- If a structure is built from prefabricated components produced in distant cities, it is difficult for rural residents to obtain additional components for expansion or repair. Similarly, prefabricated structures are typically unable to support the weight of a second story built with locally available, heavy masonry materials.
- Where reinforced concrete columns or bands are used, it is common to extend the steel beyond the existing structure in anticipation of an extension (Fig. 6). The steel rebar was often of insufficient length to provide adequate overlap. Also, the condition of the rebar deteriorates over time as it is exposed to moisture.
- Continuing the masonry beyond a corner so that the proper bond can be taken up when the owner extends (Fig. 6), although somewhat common, was not always done in the preferred location (Fig. 7).

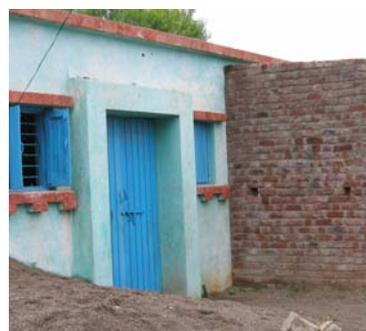
Fig. 7. Extension without proper connection (Killari EQ)

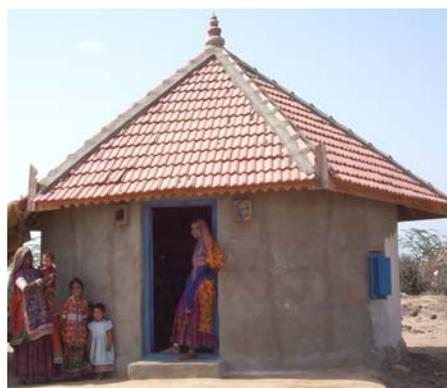
Fig. 8. Circular, stabilized earth-walled structure with pitched roof, appropriate for hot climate (Bhuj EQ)

The materials and form of the structure should be suitable to the climate. For hot climates, thick (earth, masonry) walls are preferable to thin (prefabricated panels, asbestos or CGI sheets). When air conditioners are beyond the economic reach of the homeowners, pitched or domed roofs provide better air circulation than flat roofs (Fig. 8). Small, covered openings are recommended (Fig. 9). If flat-roofed houses are built in hot climates, the roof should be strong enough to support a ceiling fan. There was a preference in many hot climate villages for a covered verandah for socializing and sleeping on warm nights. In cold climates with heavy rains, lightweight roofing materials were rejected (see discussion under alternative technology).

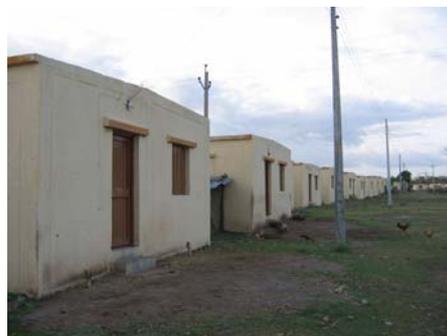
Fig. 10. Relocated village that is predominantly unoccupied due to lack of water (Killari EQ)

In the case of relocated houses and villages, the layout of individual plots and the organization of the village should be appropriate to local culture and lifestyle. If the homeowners keep animals, an enclosed plot is necessary. The character of the place should be preserved or modernized, depending on the preferences of the people. Water and electricity should be available in the village. Relocating a village away from a water source could result in a village that is predominantly unoccupied (Fig. 10).

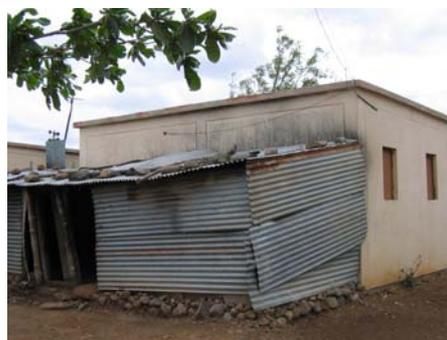
Fig. 11. CGI sheet extension (Killari EQ)

Finally, people must trust that the structure is earthquake-resistant and safe to live in. In some of the most severely affected villages in the Killari area, residents were not sleeping inside their house, even 10 years after the earthquake. Instead, they had built extensions with corrugated galvanized iron (CGI) sheets (Fig. 11). In some Bhuj-area villages, residents are waiting one year before sleeping inside the house so that the house can be tested by aftershocks. Villagers reported that they had observed poor construction practices, or had not been involved in the construction.
